Site Accessibility Evaluation

DOT Calhan Office

**1010 Golden St
Calhan, CO 80808**

Accessibility Evaluation

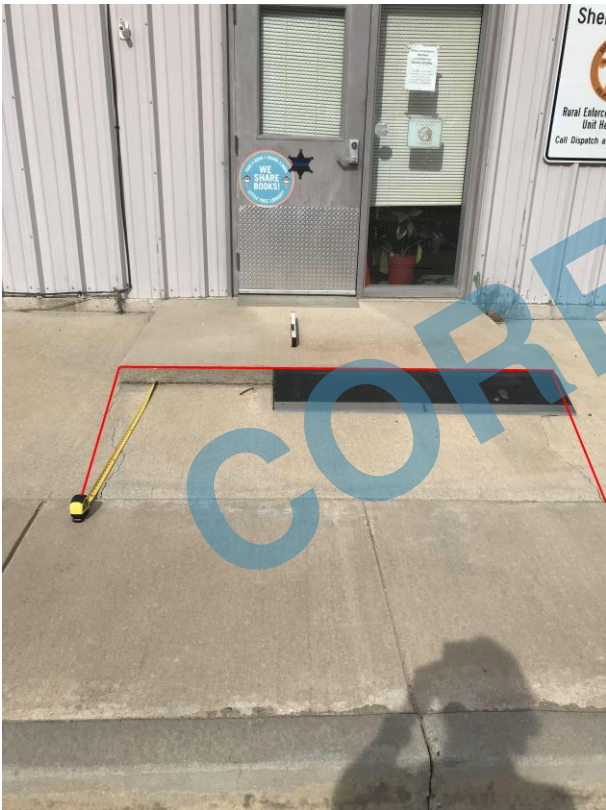
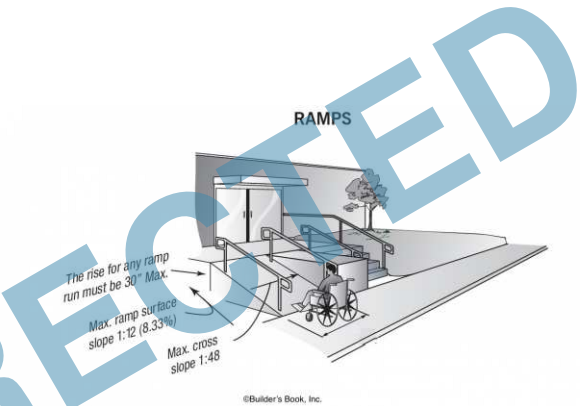
Finding 297746 Main Photo

Sheriffs Office Rural Enforcement Entrance

Finding: 1

The ramps slope exceeds the maximum running slope (direction of travel) allowable of 8.33%.

2010 ADAS Section 405.2

Ramp runs shall have a running slope not steeper than 1:12.

19.20 % running slope

Create new concrete ramp and remove existing detachable metal ramp. New ramp at 4 feet in length would meet ada compliance at 8.33%.

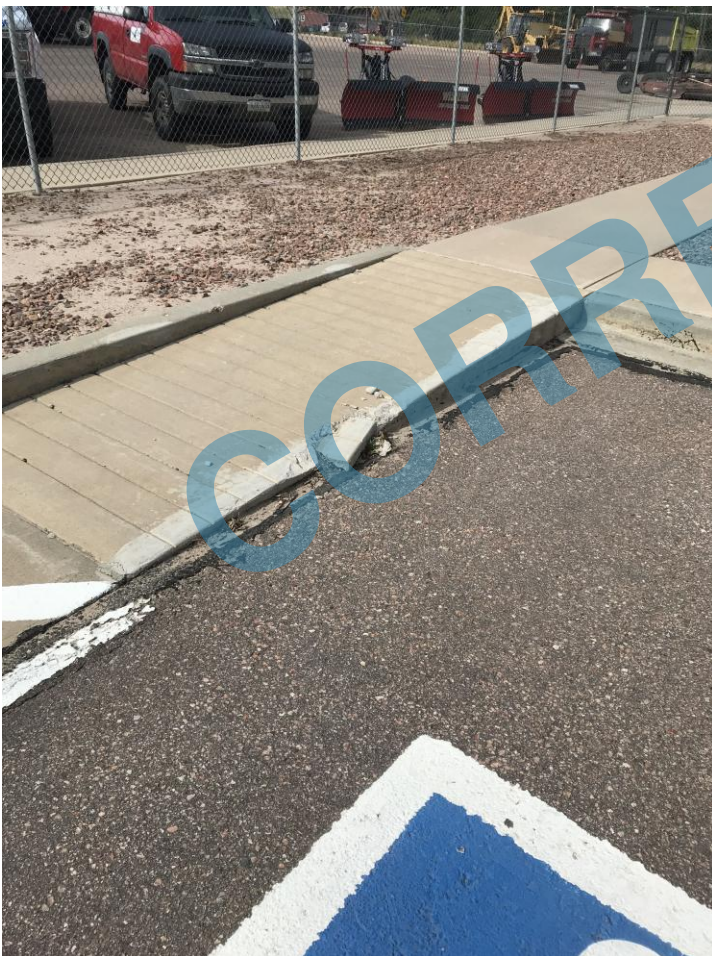
Finding 297747 Main Photo

Parking Lot Path of Travel

Damage to existing
path of travel

Re-construct existing path of travel ramp/sidewalk. Built to not exceed a 5.75 inch rise, 5% running slope and 2% cross slope to avoid treating path of travel as a ramp that will require hand rails and edge protection.
