Site Accessibility Evaluation

Homestead Ranch Regional Park

Accessibility Evaluation

Inspection Date: 01/30/2018

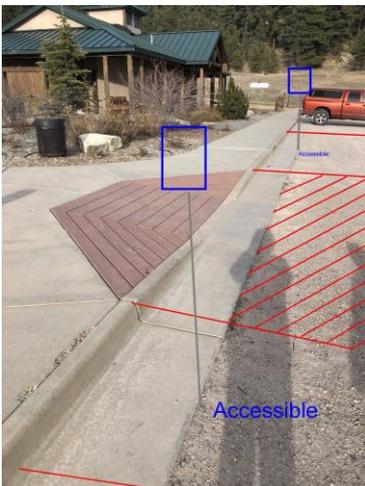
Finding 99591 Main Photo

Parking Area

There are no accessible parking stalls.

No accessible aisles
nor accessible stalls.

Based on 9 ft - width parking stall measurements it was determined that there are 50 stalls available, which would require two accessible parking stalls. Recommend making both Van accessible w/proper international symbol of accessibility signage. This means that the area that needs to be paved would include two accessible parking stalls with accessible aisle leading directly to pedestrian ramp.

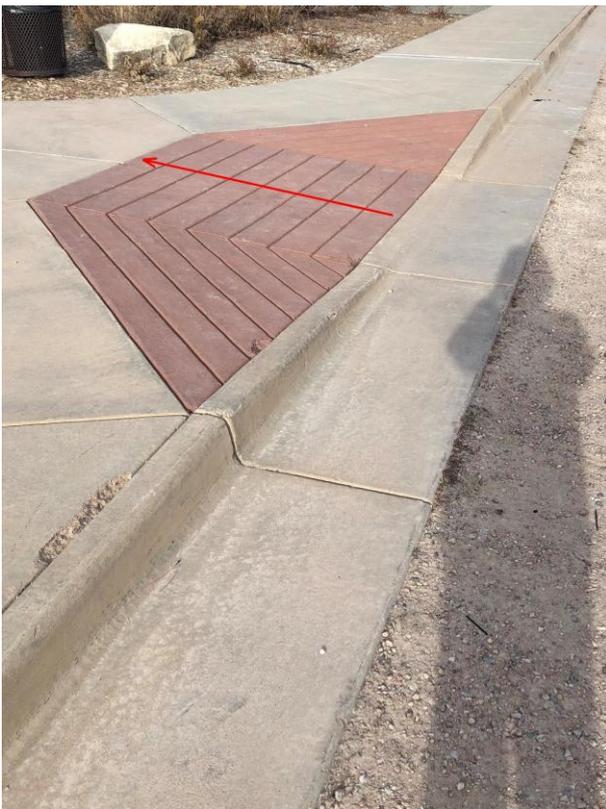
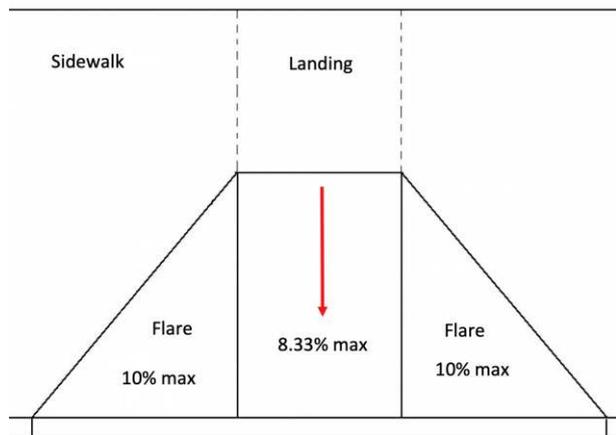
Finding 100876 Main Photo

Curb Ramp from Main Parking Lot

The curb ramp slope exceeds the maximum running slope (direction of travel) allowable of 8.33%.

Curb ramp slope is
10.07%

Curb ramp must be reconstructed to meet the maximum running slope allowed of 8.33%.

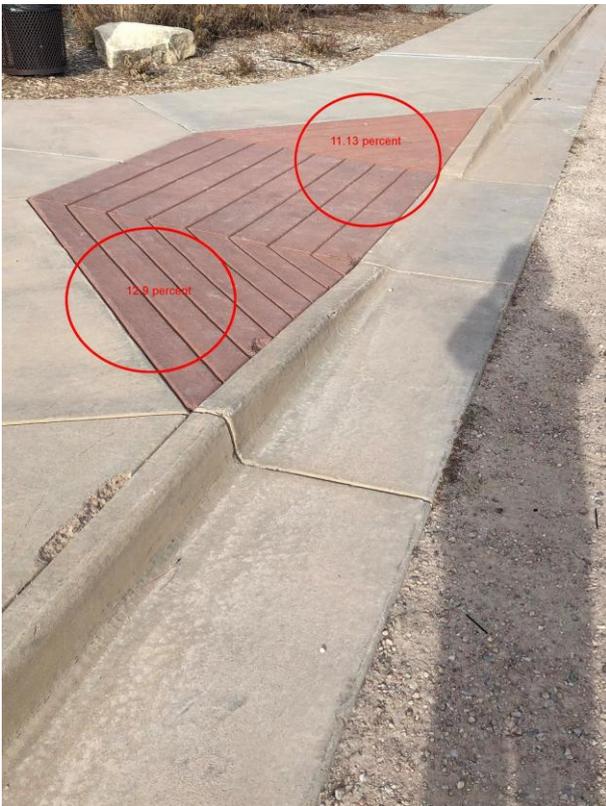
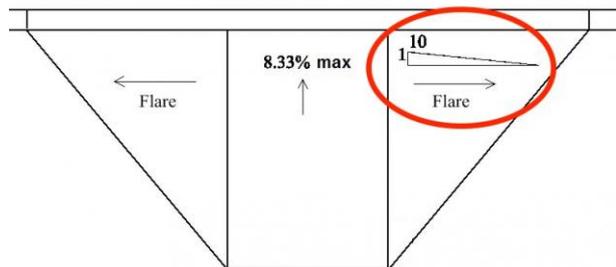
Finding 100878 Main Photo

Curb Ramp from Main Parking Lot

The curb ramp side flares are too steep.

Ramp flares exceed the maximum allowed. Left 12.19% and Right 11.13%

Reconstruct flares/ramp to meet the maximum 1:10 slope.

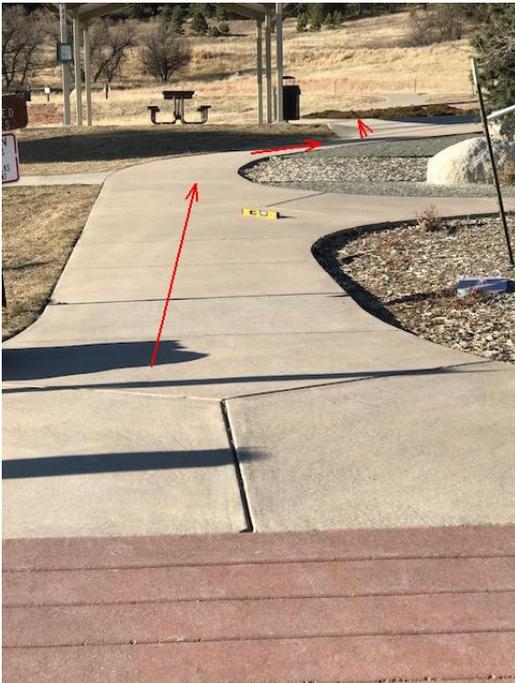
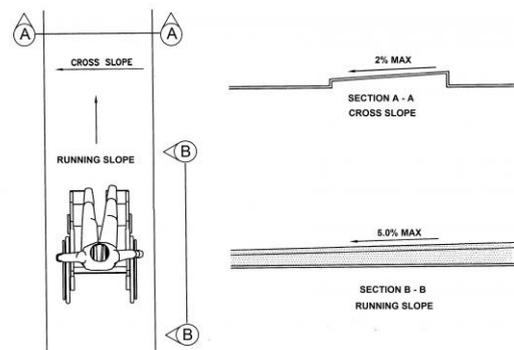
Finding 103411 Main Photo

Main Path of Travel to Restrooms and Play Areas

The accessible route contains running slopes greater than 5 percent and cross slopes greater than 2 percent across the width of the walk and has not been constructed as a ramp (i.e. handrails, wheel guides, etc.).

Some sections of the route exceed the maximum running and cross slope allowed.

Replace and/or adjust each section to meet ADA requirements.

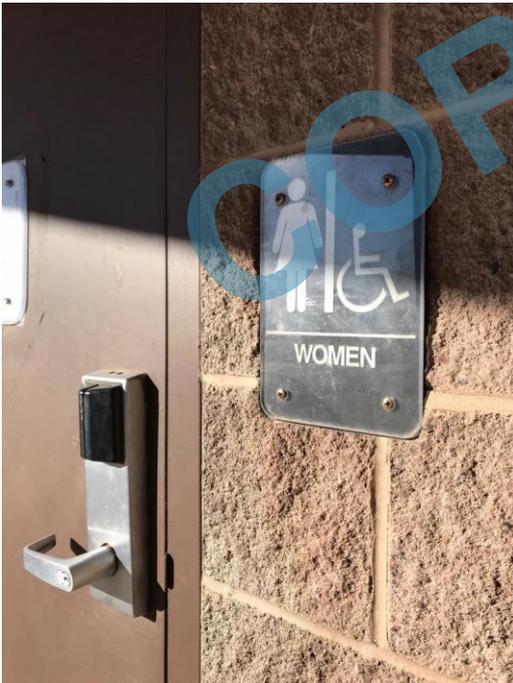
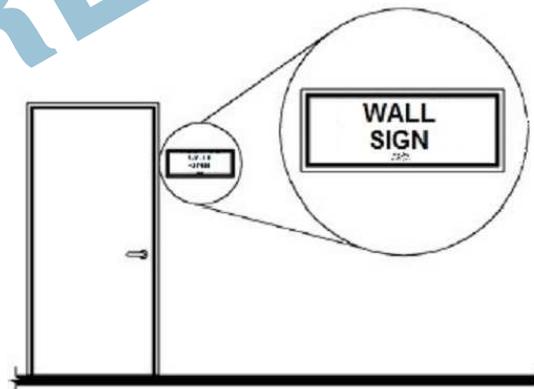
Finding 100797 Main Photo

The tactile sign is incorrectly installed behind acrylic polymer.

Sign installed behind acrylic polymer

Remove acrylic polymer.

Corrective Action: work order # 420302 submitted on 1/31/18.

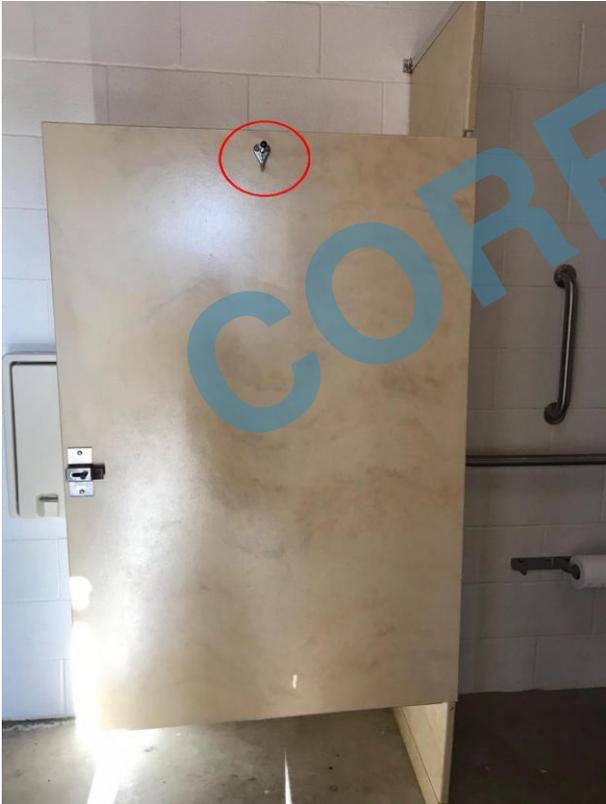
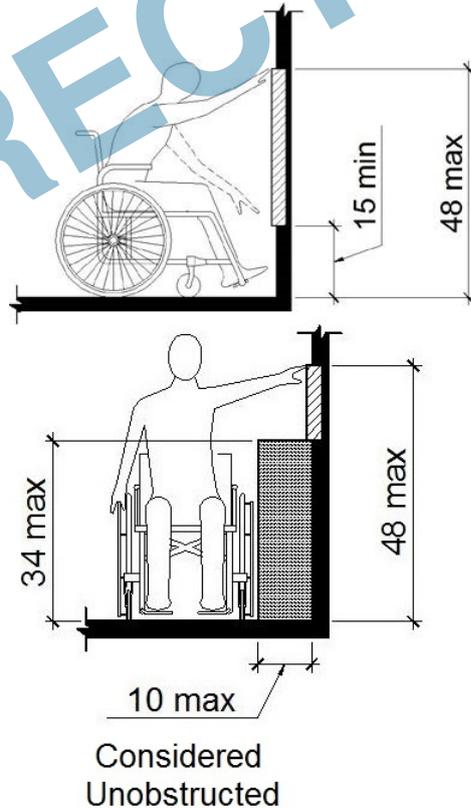
Finding 100806 Main Photo

The coat hook is installed greater than 48 inches above the finished floor.

Coat hook is installed at 60 inches above finished floor.

Remove and relocate coat hook at 48 inches maximum above finished floor or install a second coat hook between 15 and 48 inches.

Corrective Action: work order # 420303 submitted on 1/31/18.

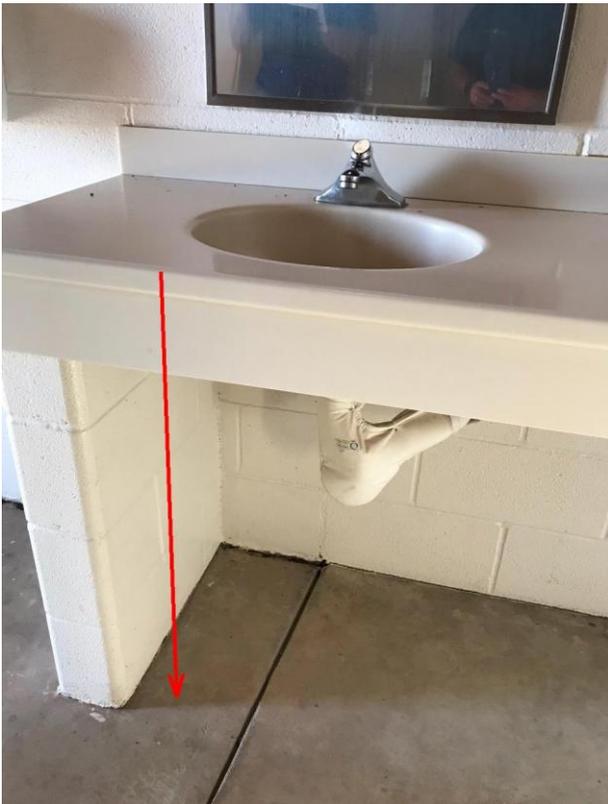
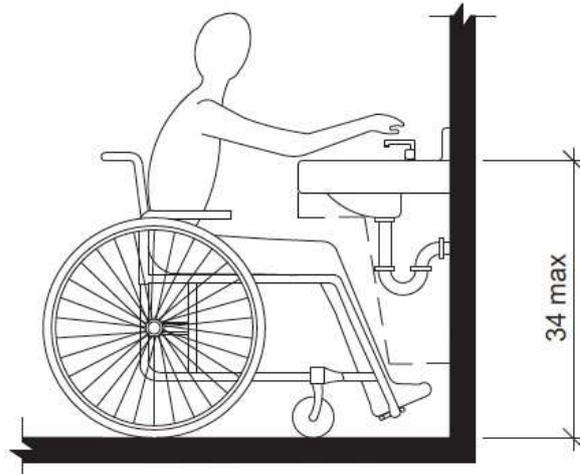
Finding 100809 Main Photo

The top rim of the lavatory is too high.

Lavatory installed at 35 inches.

Lower to 2010 ADAS of 34 inches maximum above finished floor.

Corrective Action: work order # 420305 submitted on 1/31/18.

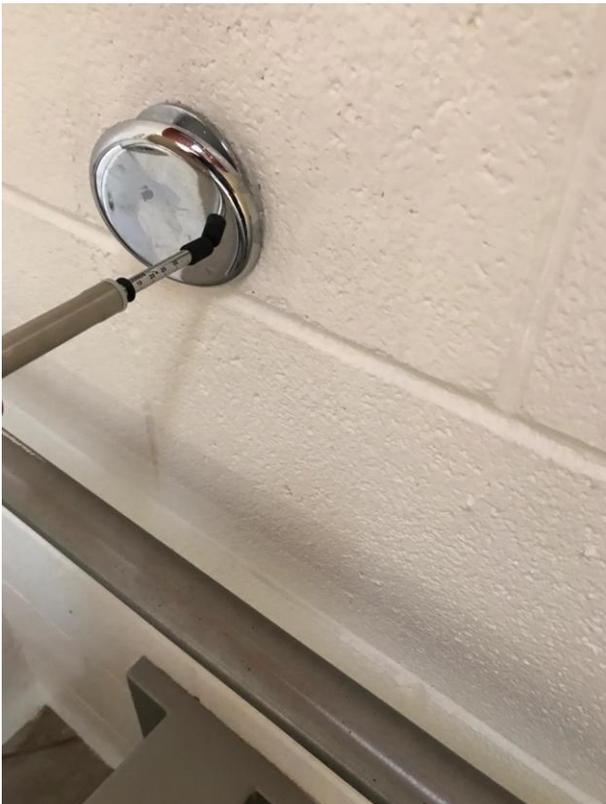
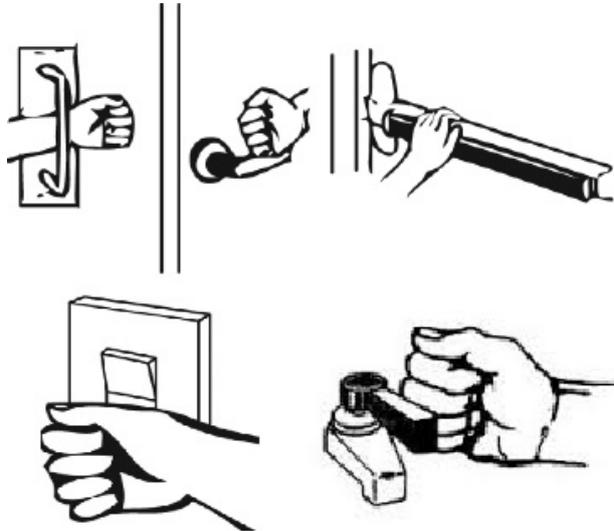
Finding 100815 Main Photo

The force required to operate the element exceeds the maximum.

Flush control force to operate is set at 10 lbs.

Adjust flush control force to activate to 5 lbs maximum force.

Corrective Action: work order # 420304 submitted on 1/31/18.

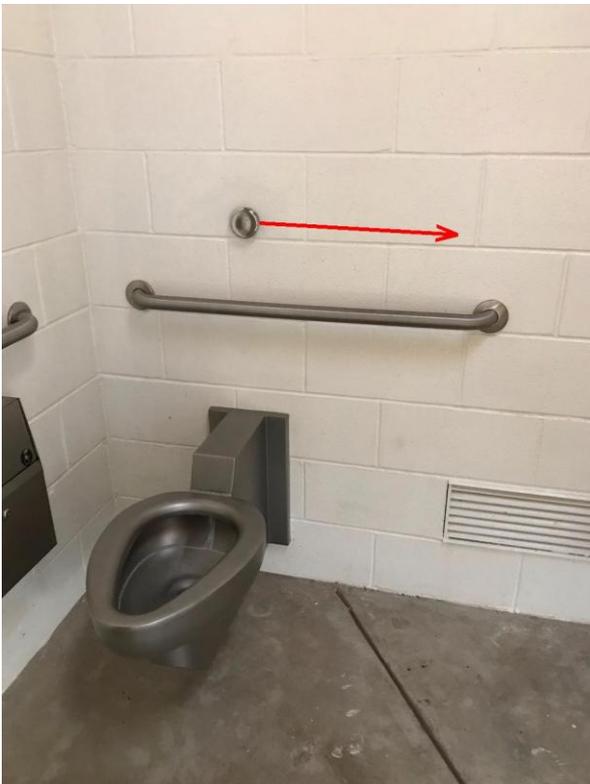
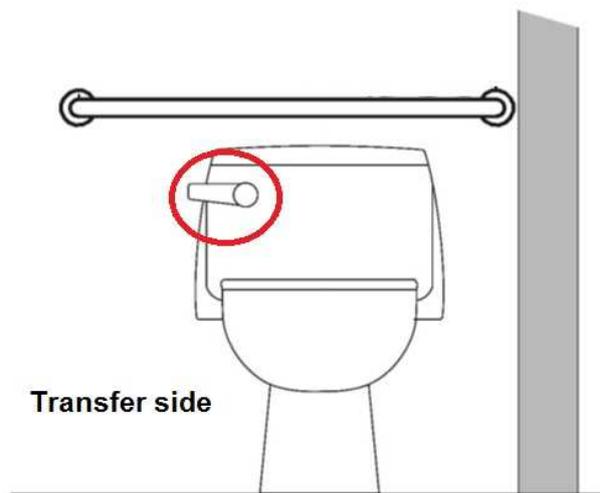
Finding 100817 Main Photo

The flush handle is located on the wrong side of the toilet.

Flush control not located on open side of water closet.

Install flush control on open side of water closet no more than 44 inches above finished floor.

Corrective Action: work order # 420301 submitted on 1/31/18.

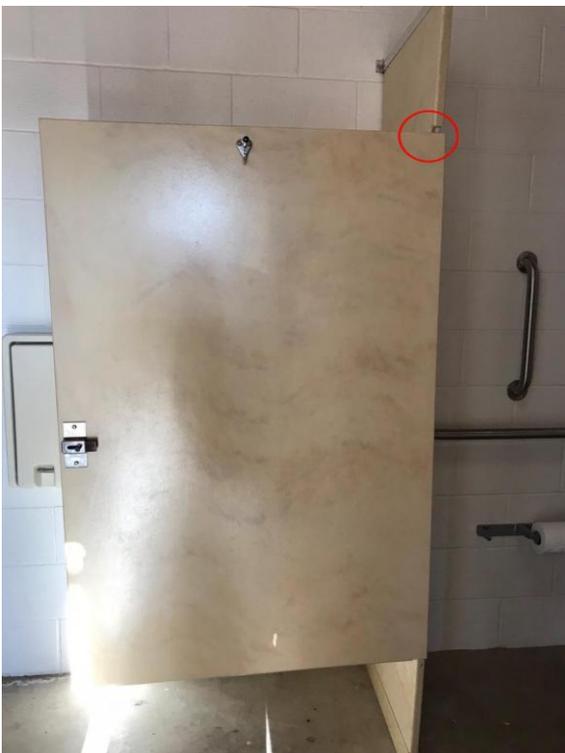
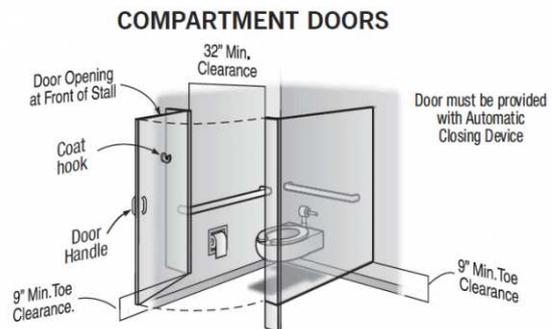
Finding 100819 Main Photo

The compartment door is not self closing.

Not self closing.

Install an automatic self closing device to toilet compartment door.

Corrective Action: work order # 420355 submitted on 1/31/2018

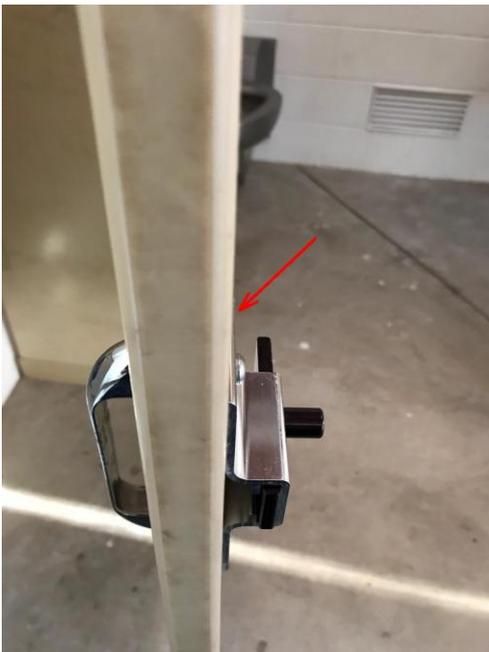
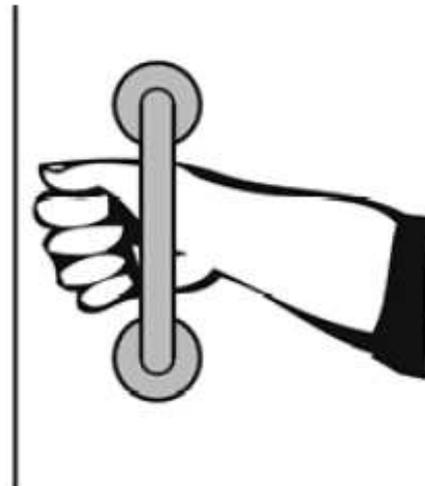
Finding 100823 Main Photo

The water closet compartment door is missing a loop handle on the inside.

No loop handle installed.

Install loop handle on inside of toilet compartment door.

Corrective Action: work order # 420354 submitted on 1/31/2018

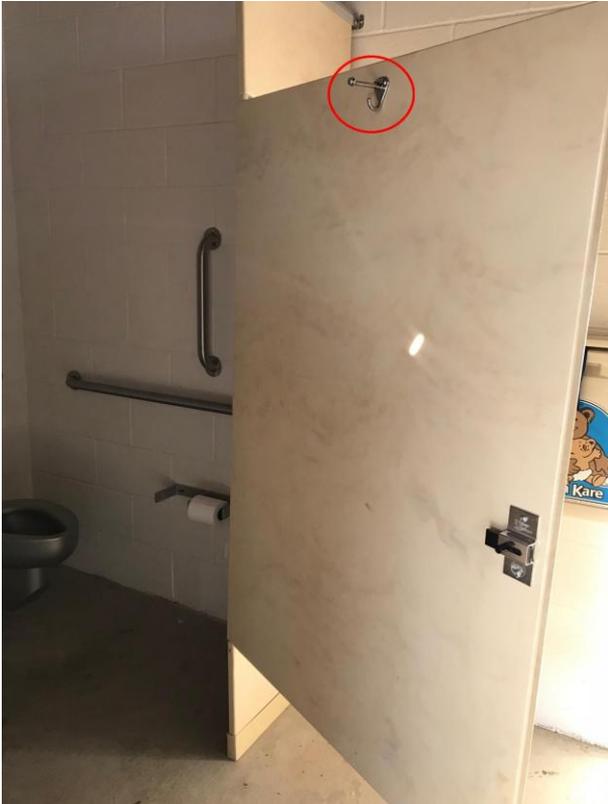
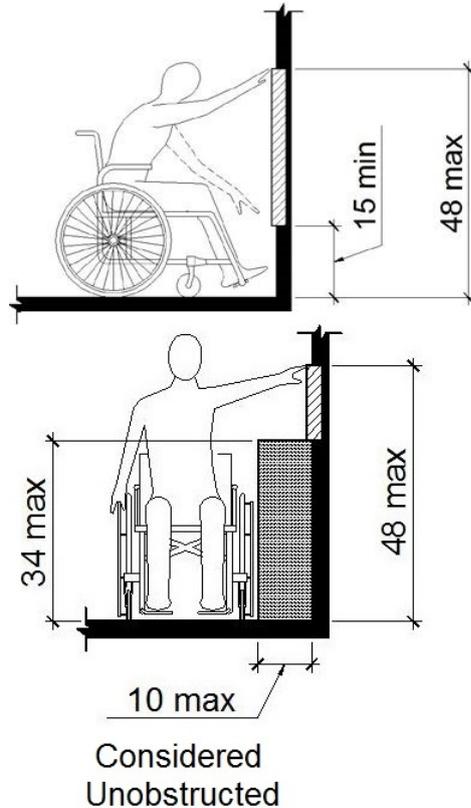
Finding 100807 Main Photo

The coat hook is installed greater than 48 inches above the finished floor.

Coat hook is installed at 60 inches above finished floor.

Remove and relocate coat hook at 48 inches maximum above finished floor or install a second coat hook between 15 and 48 inches.

Corrective Action: work order # 420353 submitted on 1/31/2018

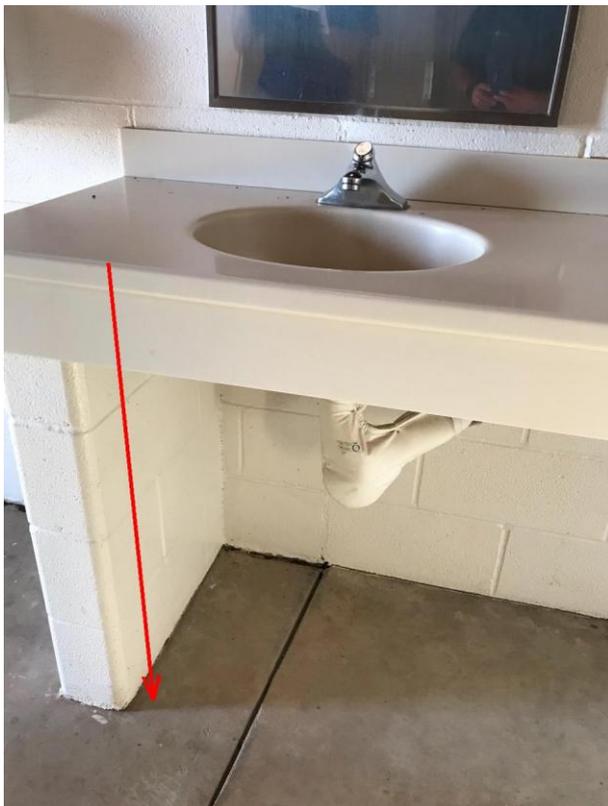
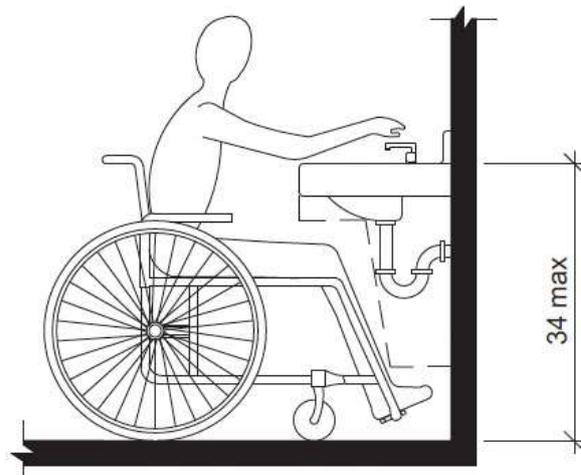
Finding 100810 Main Photo

The top rim of the lavatory is too high.

Lavatory installed at 35 inches.

Lower to 2010 ADAS of 34 inches maximum above finished floor.

Corrective Action: work order # 420352 submitted on 1/31/2018

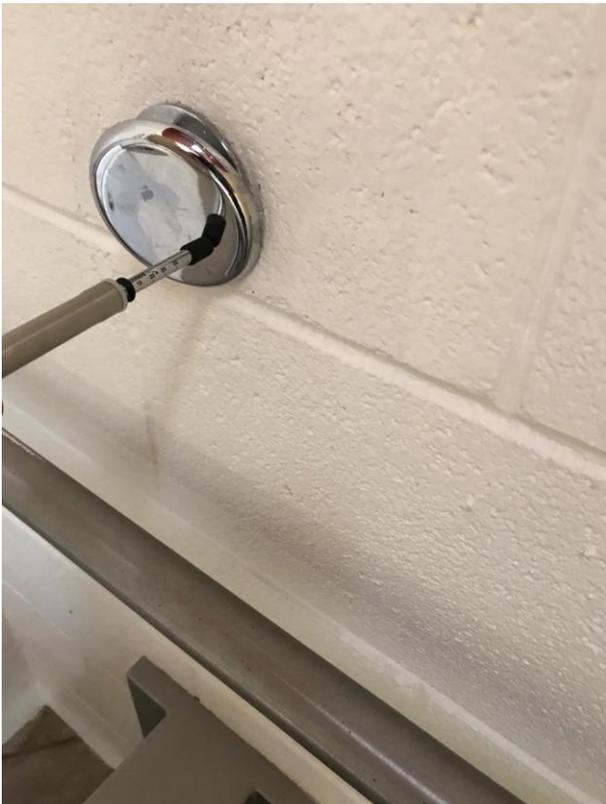
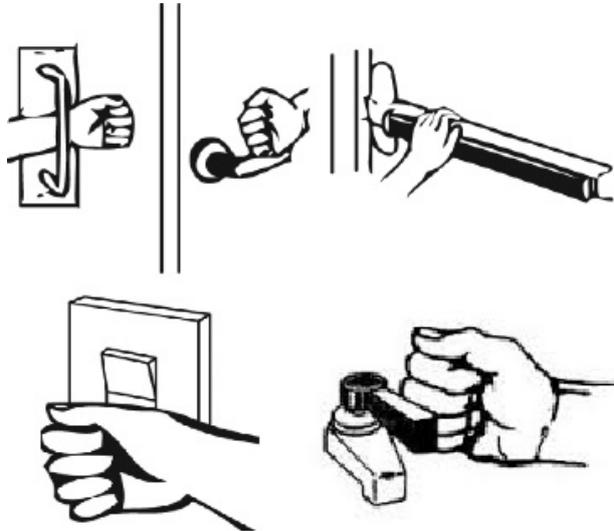
Finding 100816 Main Photo

The force required to operate the element exceeds the maximum.

Flush control force to operate is set at 17 lbs.

Adjust flush control force to activate to 5 lbs maximum force.

Corrective Action: work order # 420351 submitted on 1/31/2018

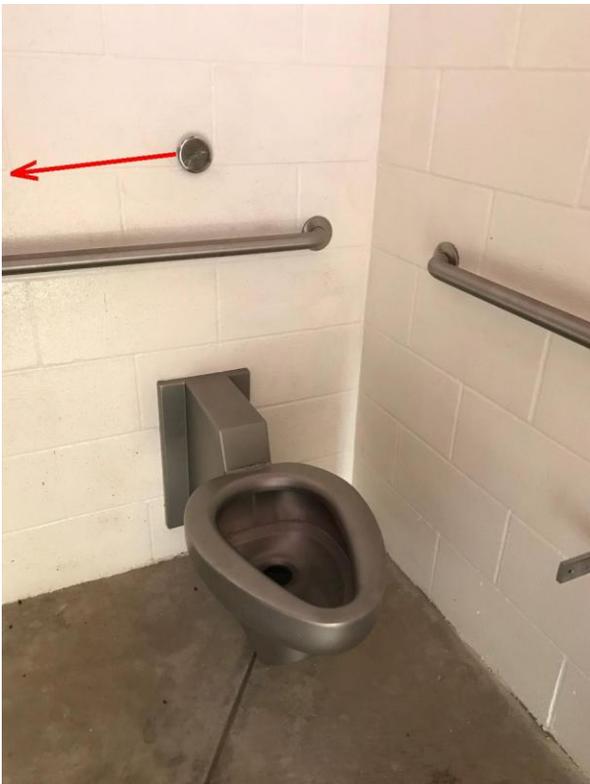
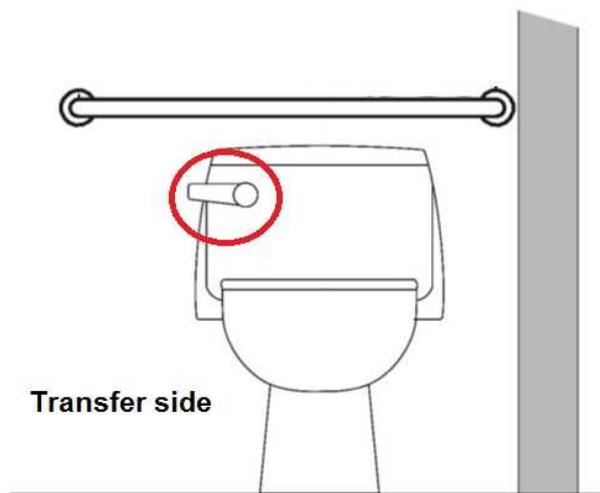
Finding 100818 Main Photo

The flush handle is located on the wrong side of the toilet.

Flush control not located on open side of water closet.

Install flush control on open side of water closet no more than 44 inches above finished floor.

Corrective Action: work order # 420331 submitted on 1/31/2018

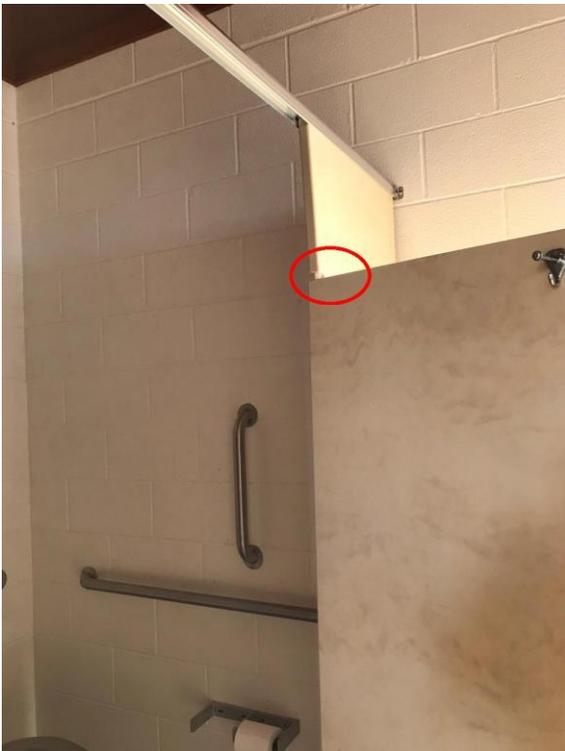
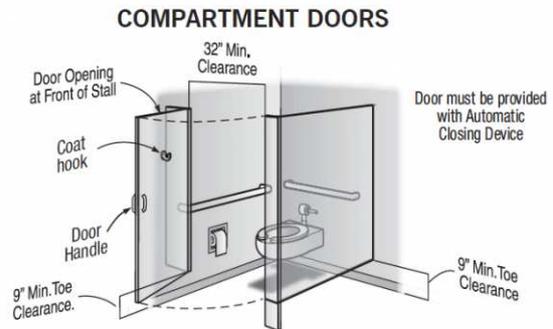
Finding 100820 Main Photo

The compartment door is not self closing.

Not self closing.

Install an automatic self closing device to toilet compartment door.

Corrective Action: work order # 420330 submitted on 1/31/2018

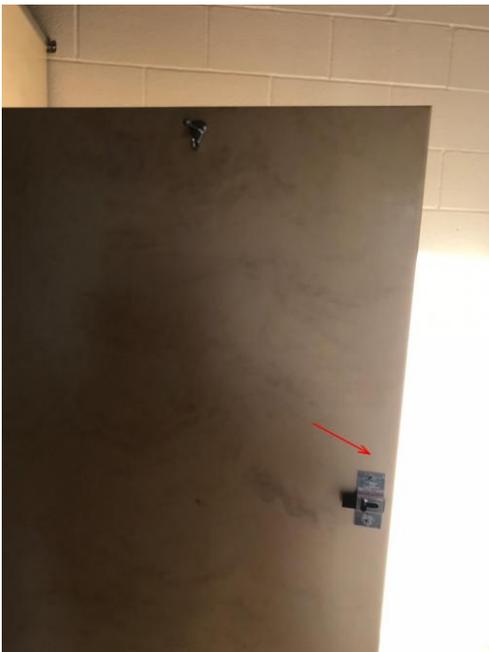
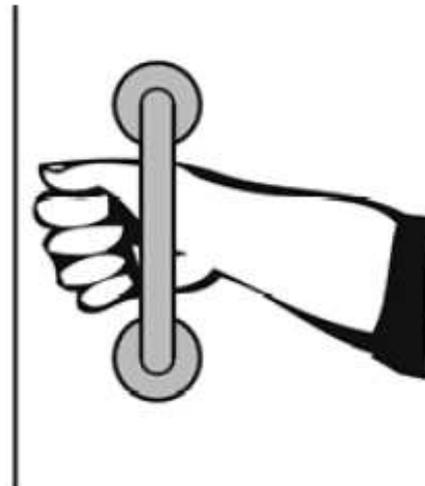
Finding 100824 Main Photo

The water closet compartment door is missing a loop handle on the inside.

No loop handle installed.

Install loop handle on inside of toilet compartment door.

Corrective Action: work order # 420329 submitted on 1/31/2018

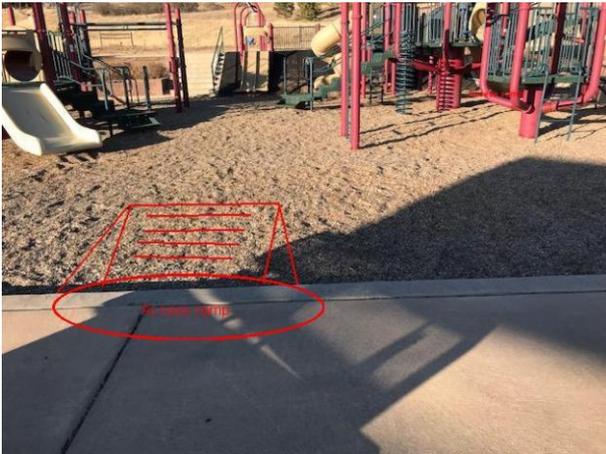
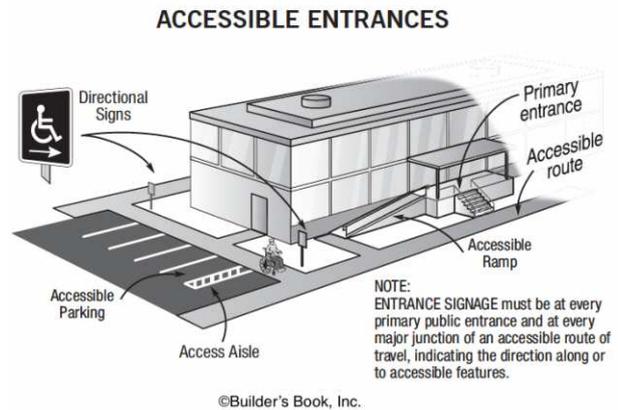
Finding 111564 Main Photo

There is no accessible route to the play area.

No accessible route.

Install accessible ramp to play area.

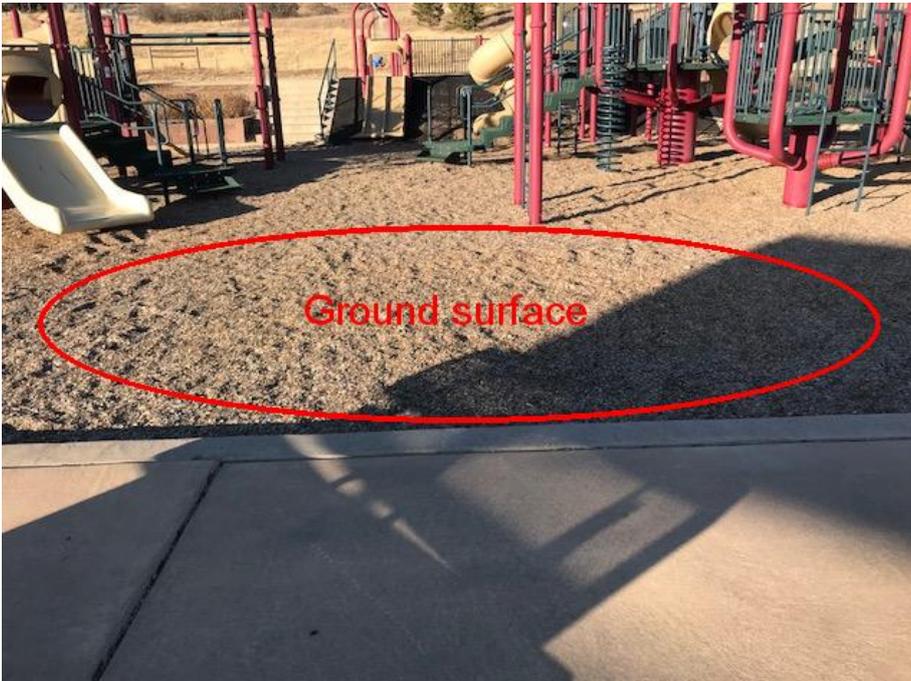
Finding 106756 Main Photo

Compliance with ASTM F 1951 for accessibility for ground surfaces on accessible routes, clear floor or ground spaces, and turning spaces has not been determined.

Ground surfaces not compliant with ASTM F 1951.

Provide a compliant ground surface that meets the minimum ASTM standard on the entry and exit points of the elevated play structure and ground level components. Note: Budget range is reflective of what type of material will be used such as Engineered Wood Fiber (EWF), Poured in Place Rubber (PPR), or Recycled Rubber Tiles (RRT) and whether the County or contractor will install.

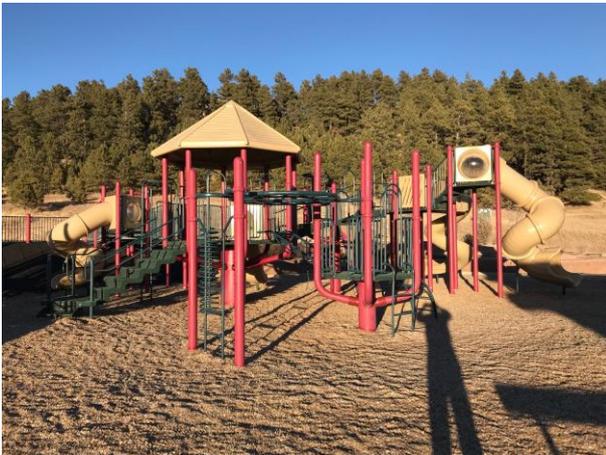
Finding 106742 Main Photo

There are not enough accessible ground level play components based on the number of elevated play components.

Large elevated play composite structure with 18 elevated play components but no ground level components exist.

Provide 6 ground level play components to include 3 that are different play experiences.

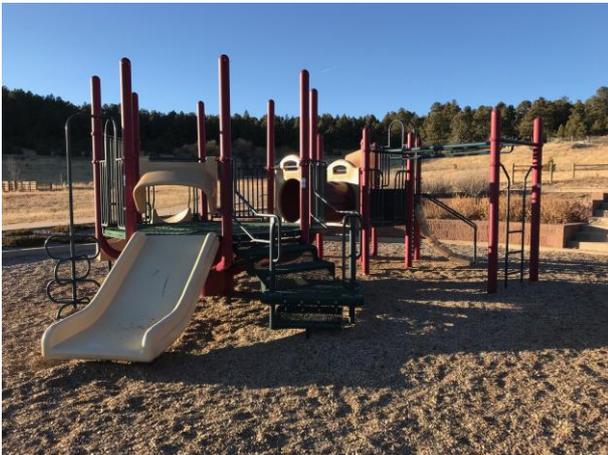
Finding 106743 Main Photo

There are not enough accessible ground level play components based on the number of elevated play components.

Small elevated play composite structure with 11 elevated play components but no ground level components exist.

Provide 4 ground level play components to include 3 that are different play experiences.

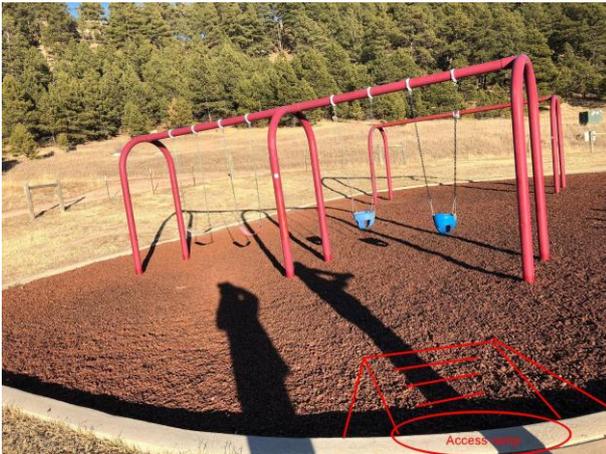
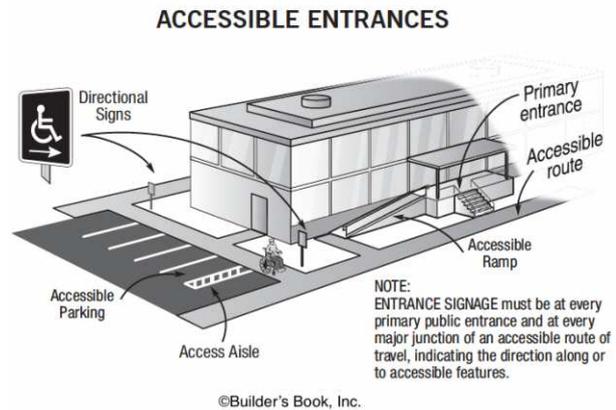
Finding 106784 Main Photo

There is no accessible route to the play area.

No accessible route.

Install accessible ramp to play area.

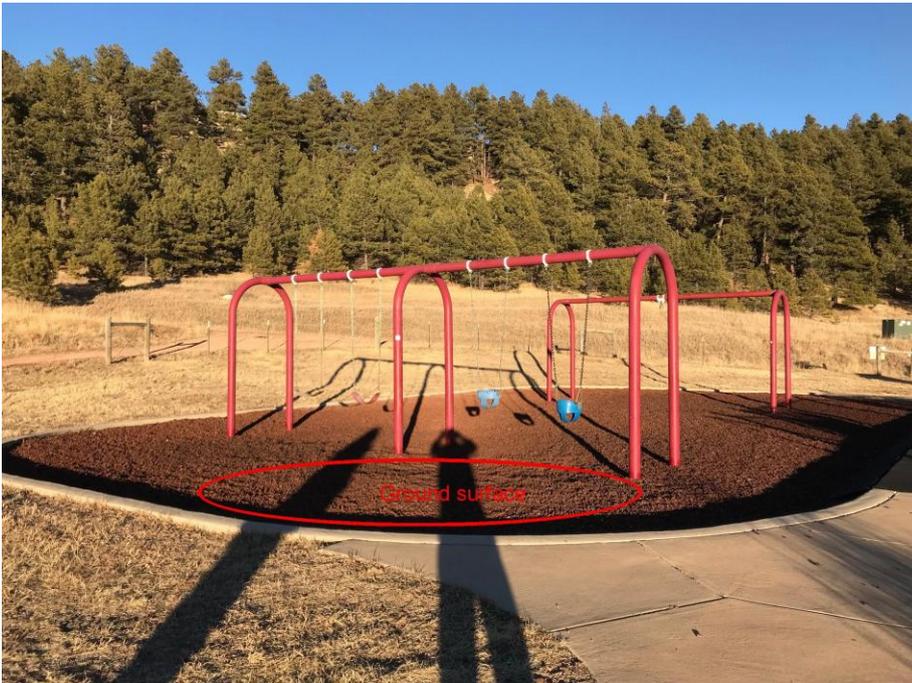
Finding 106762 Main Photo

Compliance with ASTM F 1951 for accessibility for ground surfaces on accessible routes, clear floor or ground spaces, and turning spaces has not been determined.

Ground surfaces not compliant with ASTM F 1951.

Provide a compliant ground surface that meets the minimum ASTM standard at the entry and exit point of at least one compliant swing seat. Note: Budget range is reflective of what type of material will be used such as Engineered Wood Fiber (EWF), Poured in Place Rubber (PPR), or Recycled Rubber Tiles (RRT) and whether the County or contractor will install.
