# Site Accessibility Evaluation

## Americans with Disabilities Act Title II (Public Services: State and Local Government)

### **DOT Operations Center**

***Inspection Date: 09/27/2016  
Inspector: David Mejia***

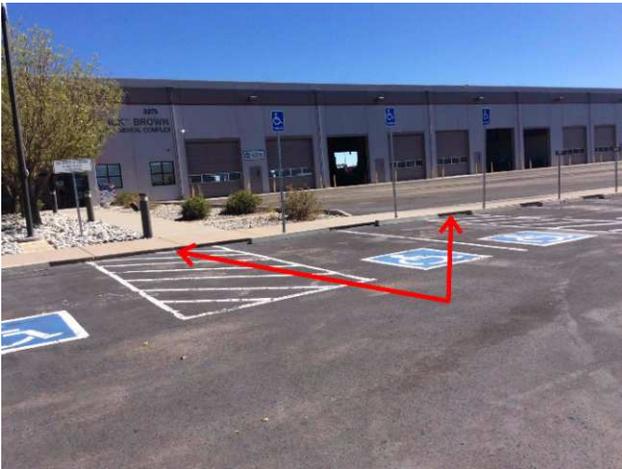
Finding 19554 Main Photo

The accessible parking is not located on an accessible route of travel to the accessible building entrance.

Pedestrian ramp does not align w/aisle

Submit w/o for correction. Area needs to be re-striped and access aisle to sidewalk path of travel needs to align w/accessible ramp.

Corrective Action: Parking area was repaved to meet seamless transition from access aisle to access route. Corrected 18 Oct 2016.

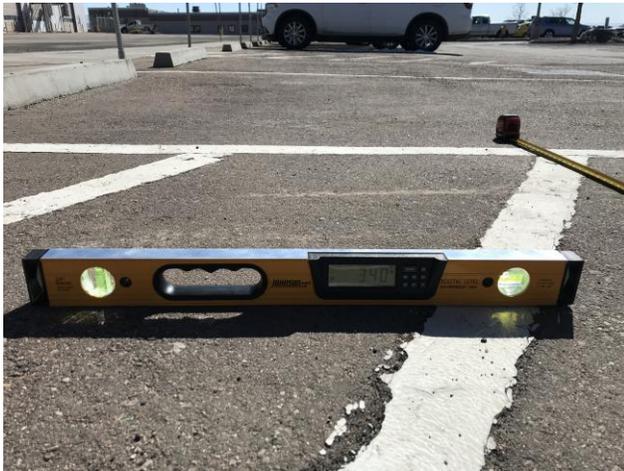
Finding 299216 Main Photo

The running slope of the access aisle (long dimension) exceeds 2%.

Running slope ranges  
from 1% and 9.5%

Re-pave access aisle and ensure a 2% maximum cross and running slope for the full length and width of the access aisle.

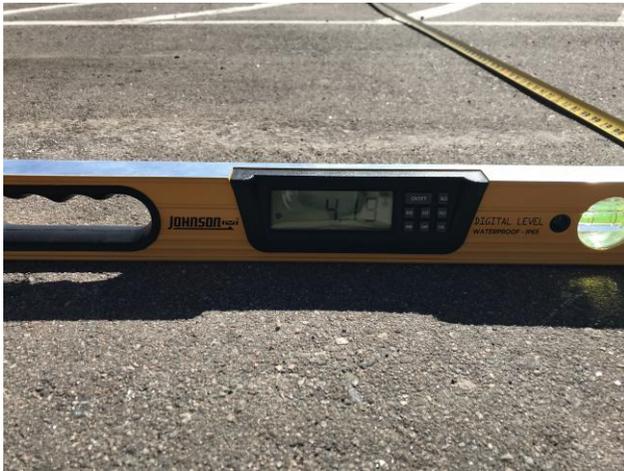
Finding 299217 Main Photo

The running slope (long dimension) of the accessible parking stall exceeds 2%.

Running slope ranges  
from 1% up to 9.5%

Re-pave designated ADA parking stalls and ensure a 2% maximum cross and running slope for the full length and width of the parking stalls.

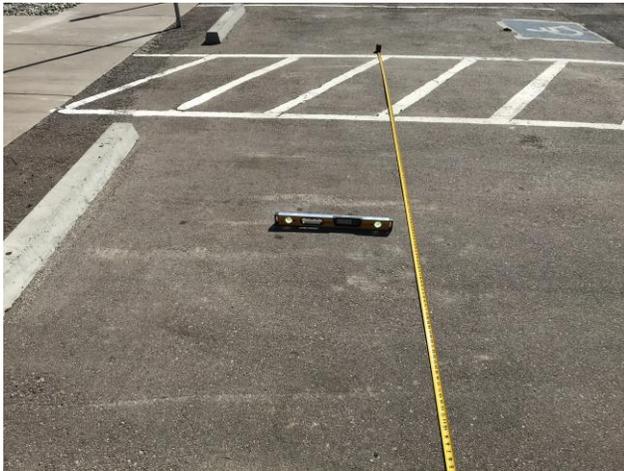
Finding 299218 Main Photo

The accessible parking stall is not wide enough.

Van parking stall  
measures 9.8 feet in  
width

Re-stripe ADA parking stall/s and access aisle/s. ADA parking stalls shall measure 8 ft minimum in width measured to the centerline of the paint stripes. Access aisles shall measure 5 ft minimum in width measured to the centerline of the paint stripes. Ensure ADA van parking stall/s are 8 feet wide minimum with an access aisle of 8 feet wide minimum or 11 feet wide minimum with an access aisle of 5 feet wide minimum measured to the centerline of the paint stripes.

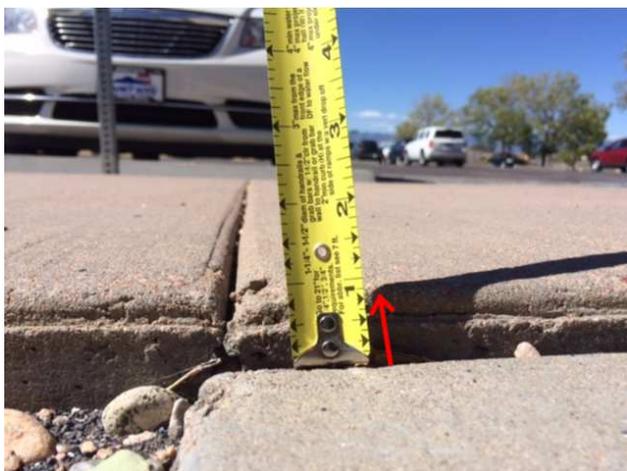
Finding 19562 Main Photo

The walkway contains abrupt vertical edges and/or variations over a 1/4 inch.

3/4 of an inches upheaval.

Submit a work order to have sidewalk area shaved.

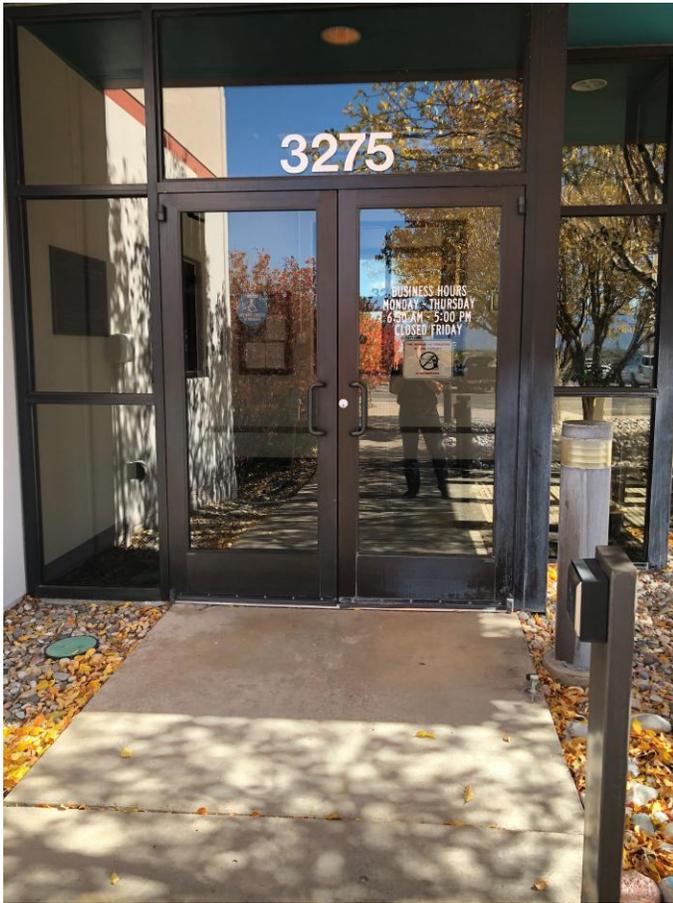
Front door ADA push plate not working

Front door ADA push plate malfunctioning / inoperable.

Inspect and replace batteries on All ADA push plates.

Corrective Action: Work order # 403142 submitted for correction. Work order completed on 9/7/17.

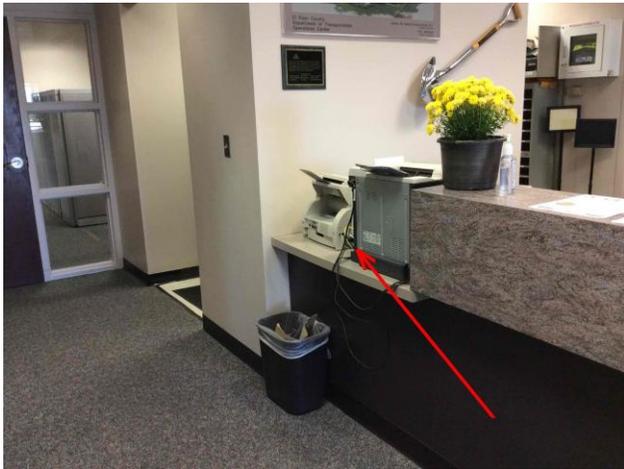
Finding 19555 Main Photo

Counter not accessible due to fax/printer.

Not accessible due to fax/printer on accessible counter area

Relocate fax/printer in order to clear counter for service.

Corrective Action: Relocated to provide clear counter area on 18 Jan 2017.

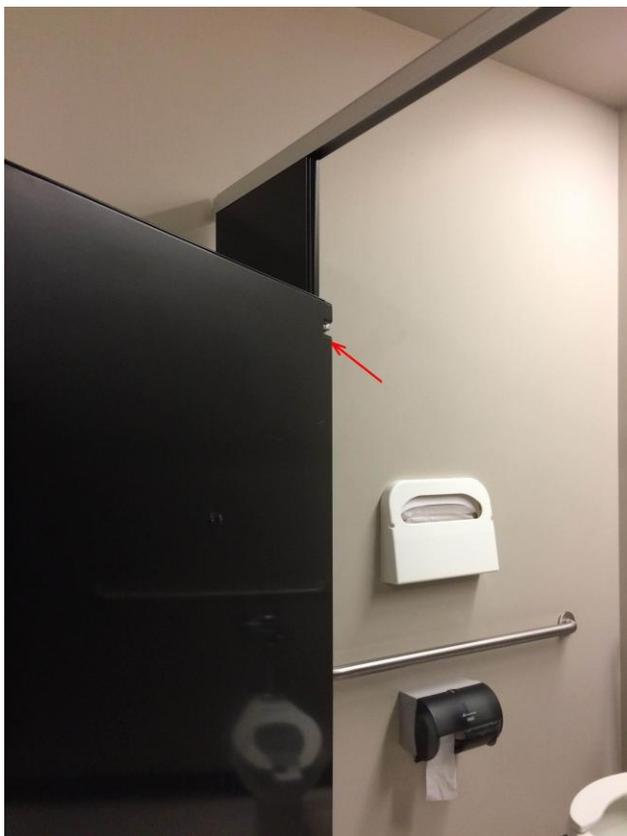
Finding 27939 Main Photo

The compartment door is not self closing.

Compartment door not self closing

Adjust or install automatic closing hinges.

Corrective Action: W/O 381195 submitted.

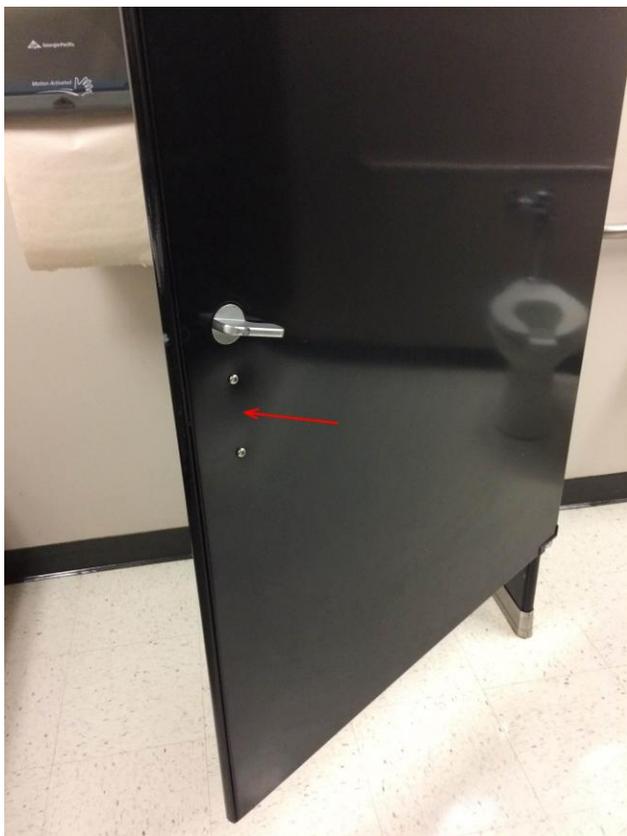
Finding 27940 Main Photo

The water closet compartment door is missing a loop handle on the inside.

Missing inside loop handle on compartment door

Install loop or U-shaped handle on inside of compartment door.

Corrective Action: W/O 381194 submitted. Installed loop handles on inside/outside of stall door-completed 3/10/2017.

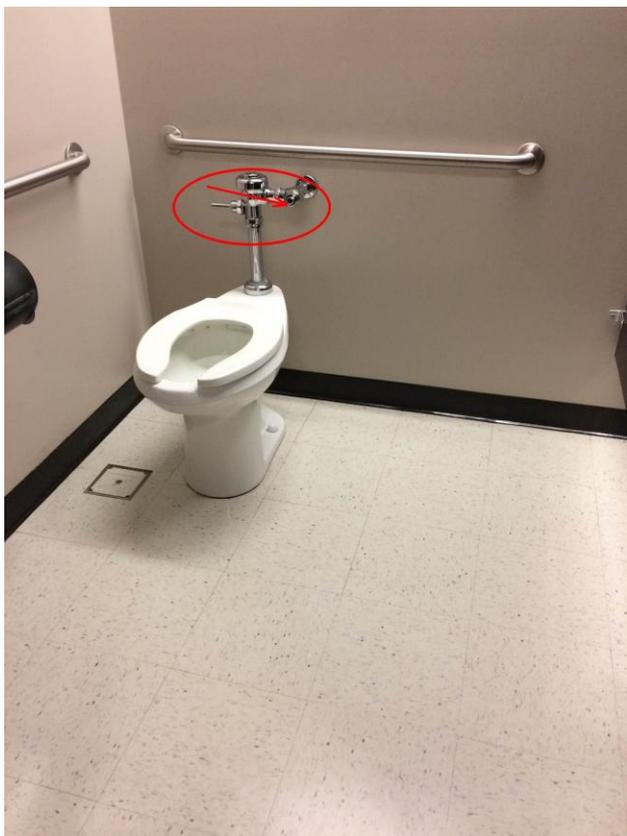
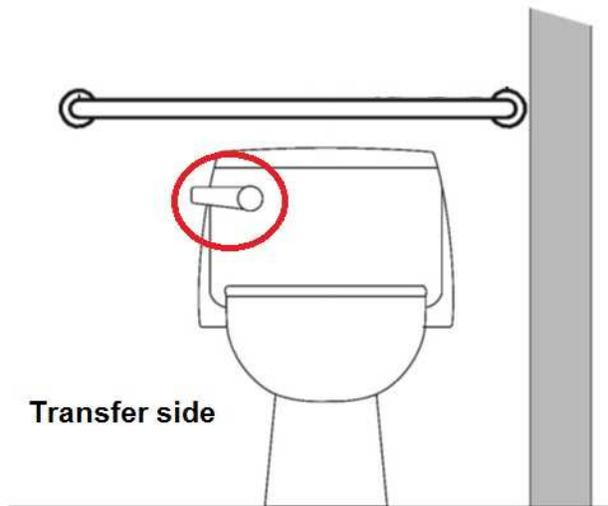
Finding 27941 Main Photo

The flush handle is located on the wrong side of the toilet.

Flush handle located  
on closed side

Relocate flush handle to opposite side (open side of toilet area).

Corrective Action: W/O 381193 submitted. Installed new sensor type flush valve 3/14/2017.

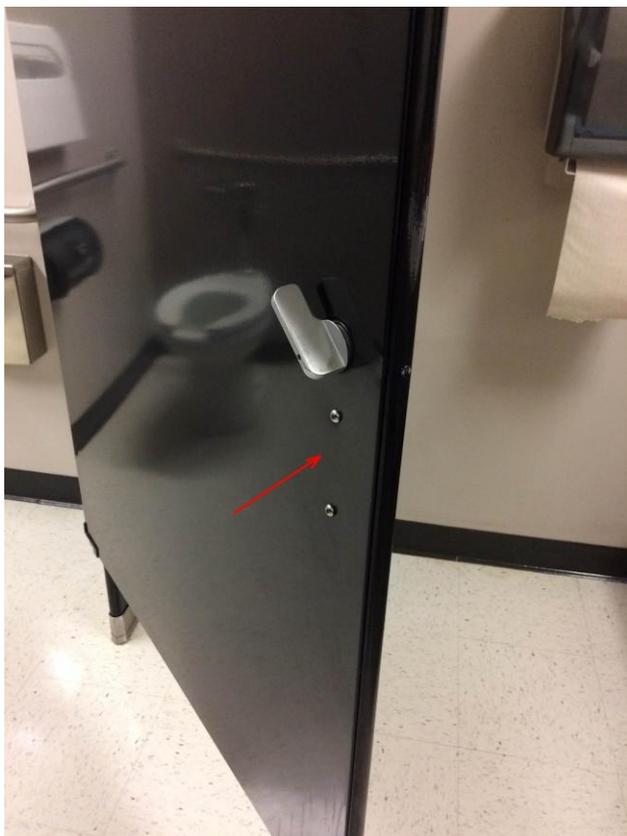
Finding 27945 Main Photo

The water closet compartment door is missing a loop handle on the inside.

Missing inside loop handle on compartment door

Corrective Action: W/O 381188 submitted. Installed loop handles on inside/outside of stall door-completed, 3/10/2017.

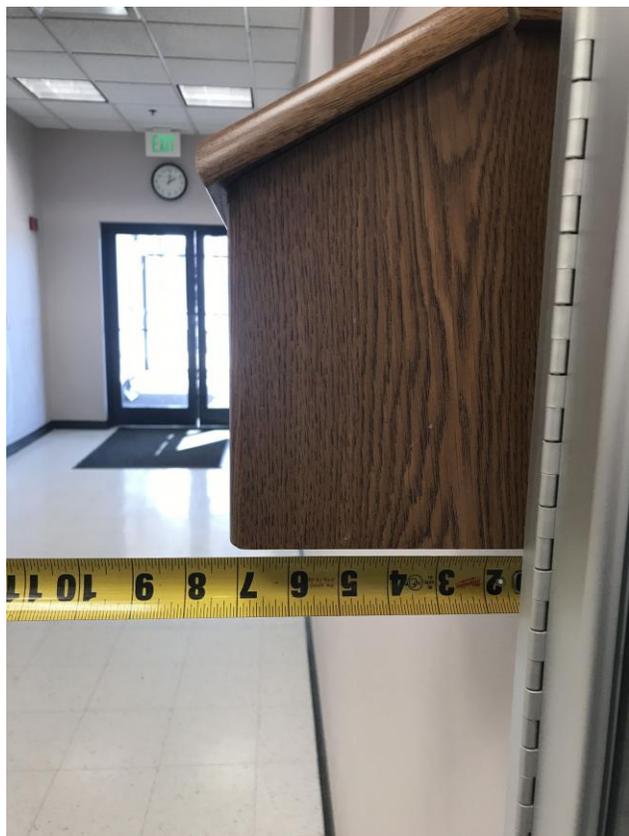
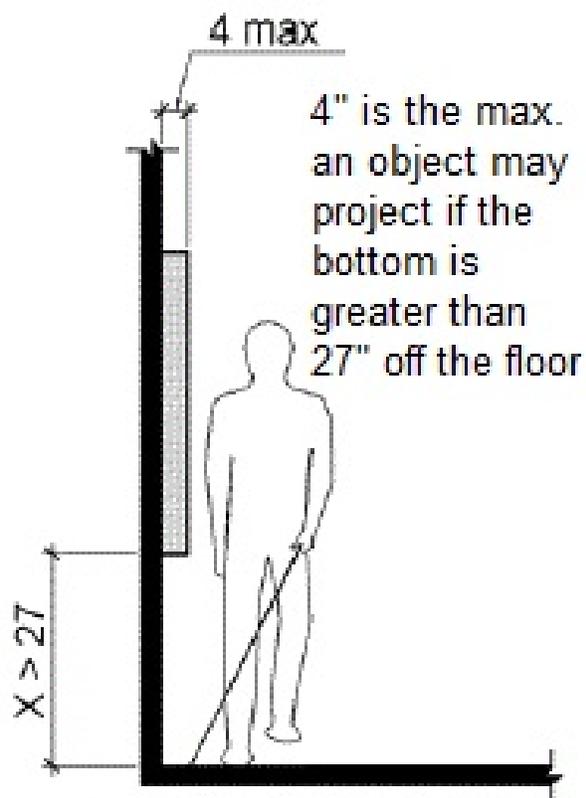
Finding 299210 Main Photo

Wall-mounted objects that have leading edges between 27 inches and 80 inches from the floor must not project more than 4 inches into the circulation path. Protruding objects that extend to the floor or within 27 inches of the floor are cane detectable and are therefore not hazardous. Where it is necessary or desirable to have objects protrude from the wall, a manner of cane detection must be provided.

Replace suggestion box with low profile box or place existing suggestion box in different location and not in a main path of travel.
