Site Accessibility Evaluation

Centennial Hall

Accessibility Evaluation

Inspection Date: 05/14/2019

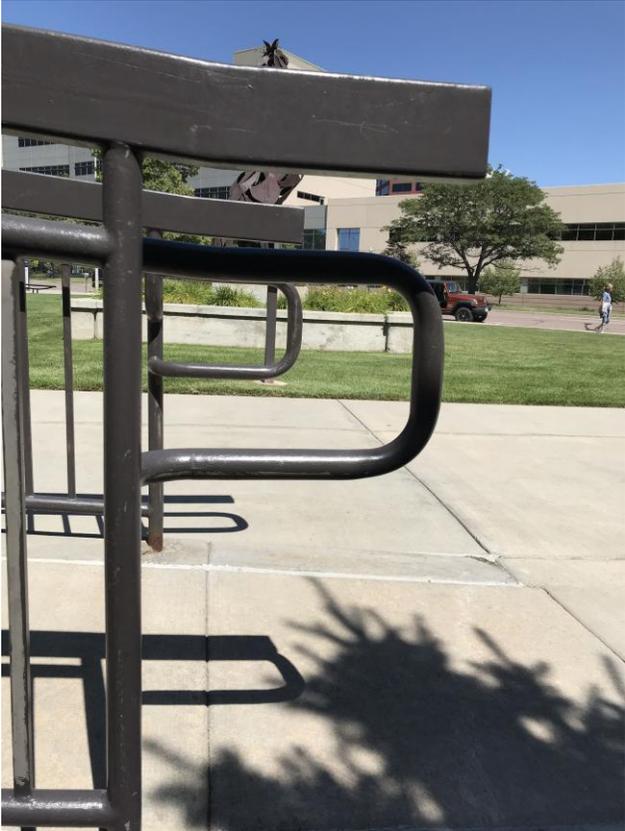
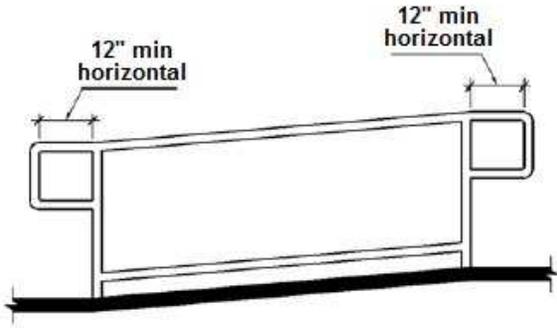
Finding 297822 Main Photo

The handrail does not extend horizontally.

2010 ADAS Section 505.10.1

Handrail does not extend full length of ramp

Modify existing handrails to extend the full length of the ramp.

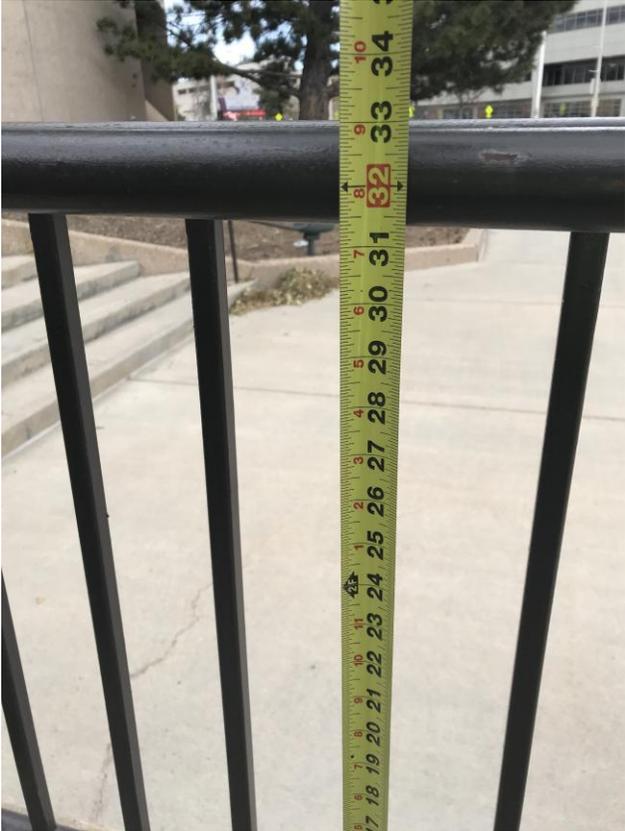
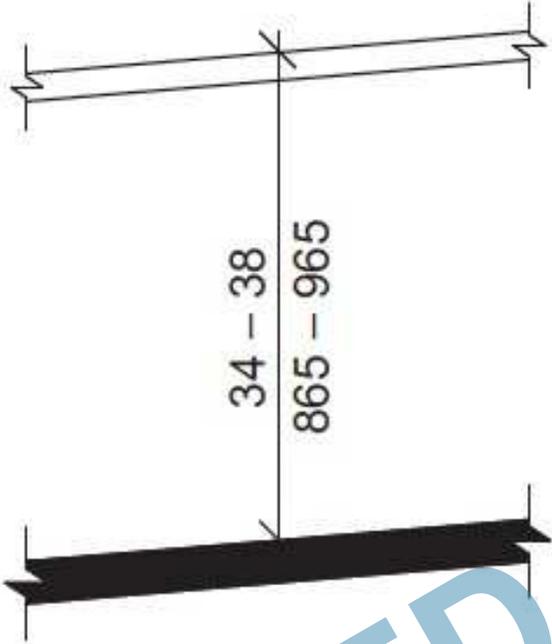
The handrails are mounted too low.

2010 ADAS Section 505.4

Handrail height
between 32 and 33
inches above finished
floor

Modify existing handrails and ensure handrails are installed between 34 inches and 38 inches above finished floor.

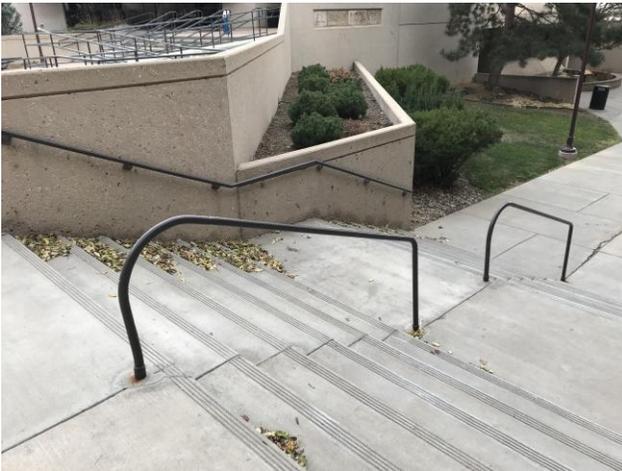
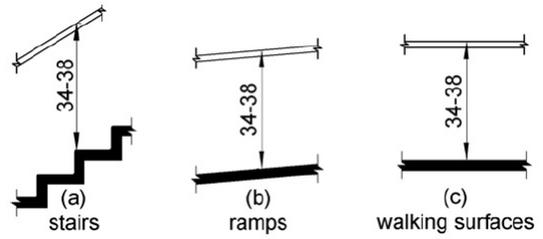
Finding 297823 Main Photo

The handrails as well as the handrail extensions are not at the correct height.

2010 ADAS Section 505.4

Handrails below 34 inches minimum height required

Re-place existing handrails with handrails no lower than 34 inches from the top of the gripping surface and ensure extensions are also included at the top and bottom landings.

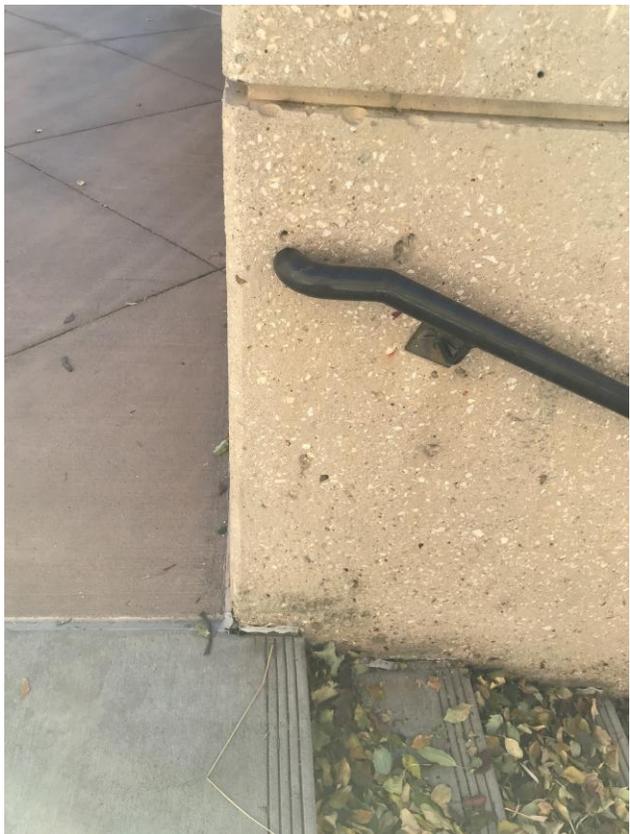
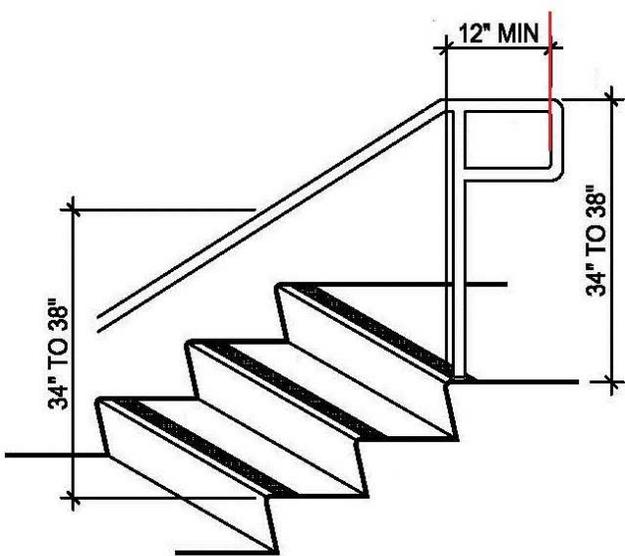
Finding 298357 Main Photo

The handrail projects less than 12 inches beyond the landing at the top of the stairs parallel to the floor or ground.

2010 ADAS Section 505.10.2

31.75 inches above finished floor

Full length of extension must be **HORIZONTAL**

Re-construct or modify existing handrails and ensure handrails are installed between 34 inches and 38 inches above finished floor and extend horizontally above the landing for 12 inches minimum.

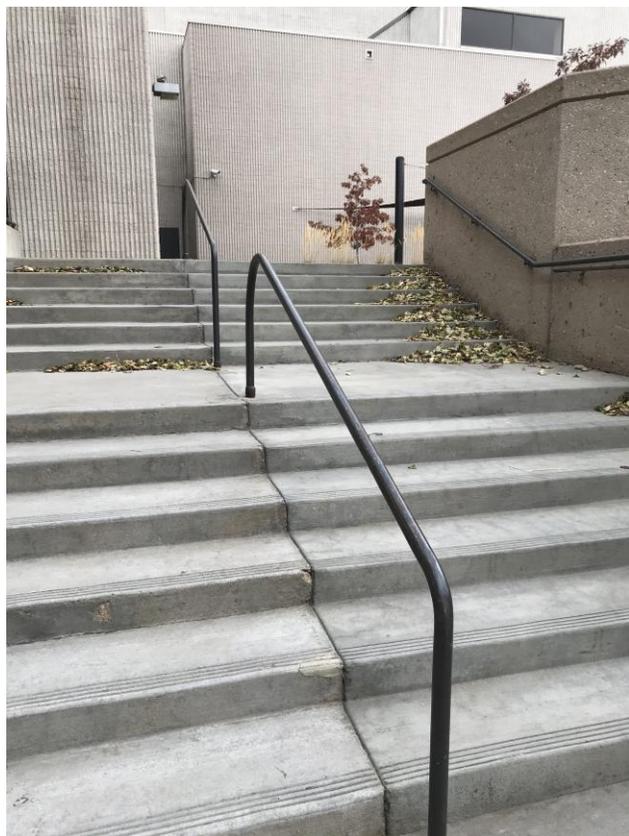
Finding 298358 Main Photo

The handrail does not have a compliant extension at the bottom of the stair flight.

2010 ADAS Section 505.10.3

Does not extend the length of one tread

Re-construct or modify existing handrails and ensure handrails are installed between 34 inches and 38 inches above finished floor and extend a horizontal distance at least equal to one tread depth beyond the last riser nosing.

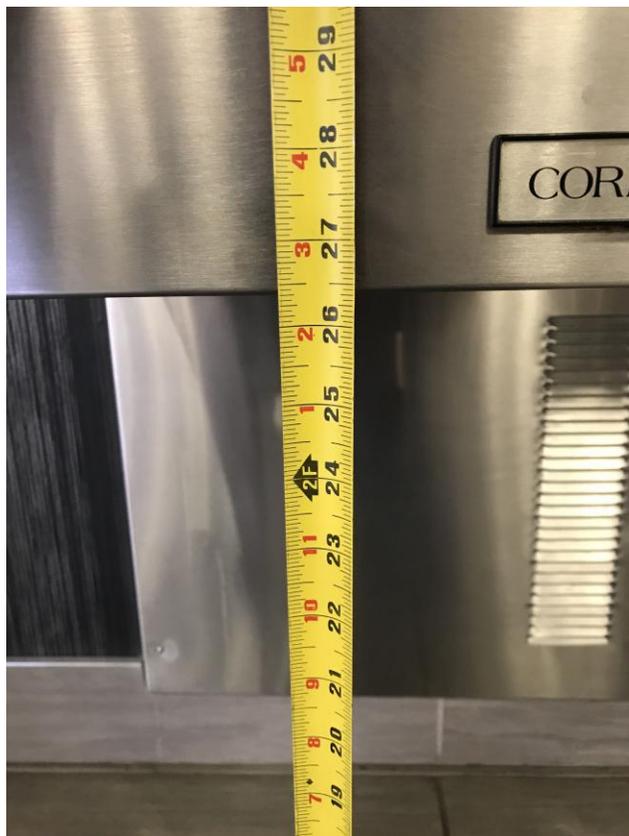
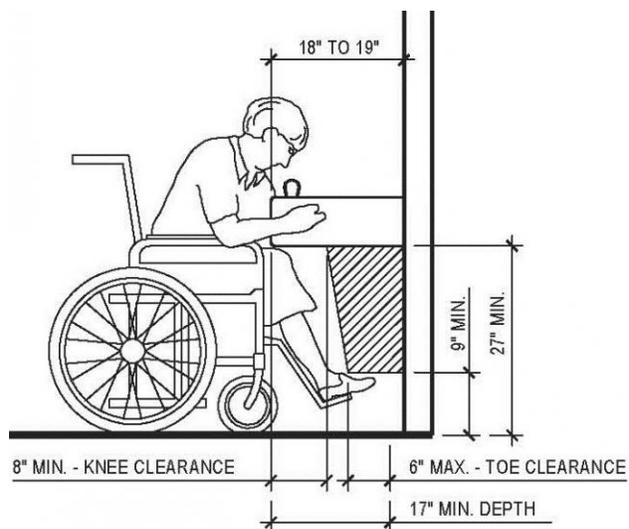
Finding 297764 Main Photo

There is not enough knee clearance under the drinking fountain.

2010 ADAS Section 602.2

Bottom edge of
drinking fountain at
26.5 inches

Adjust drinking fountain height to provide 27 inches of clearance.

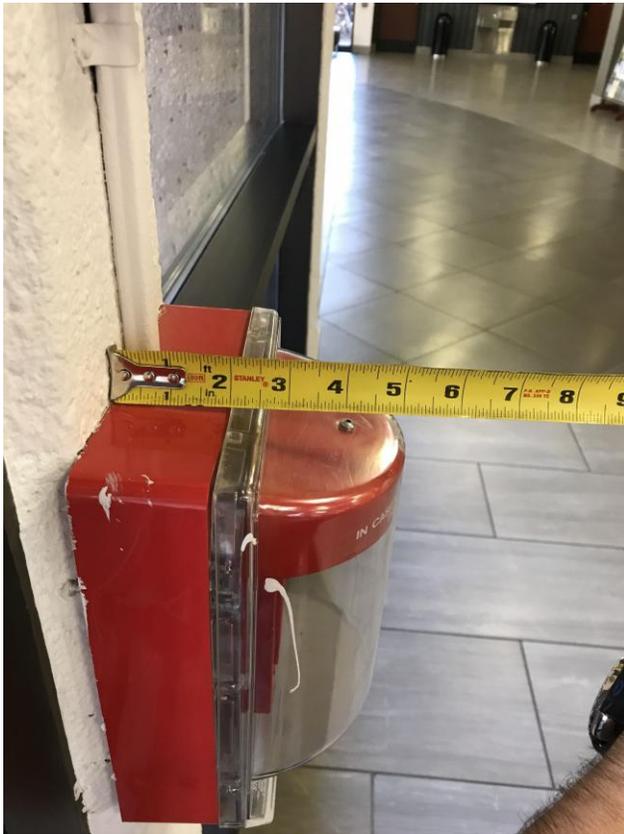
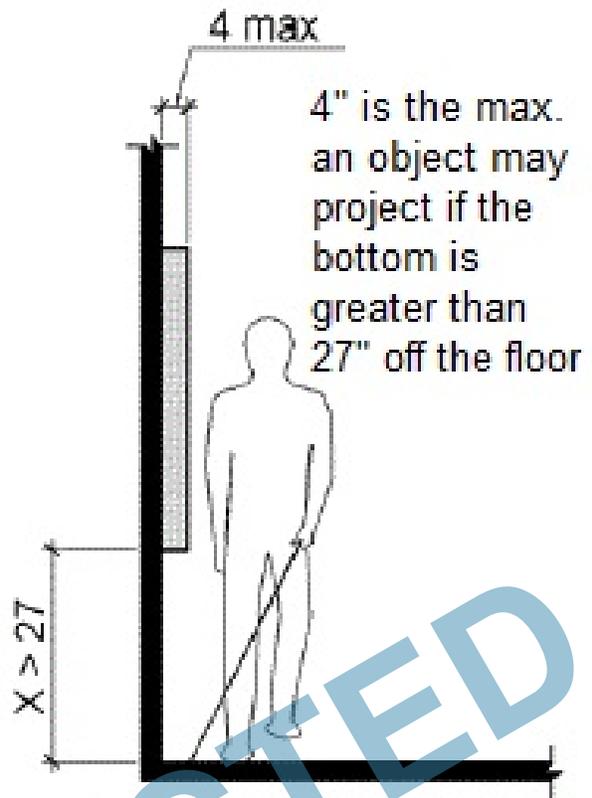
Finding 297765 Main Photo

The fire alarm housing projects more than 4 inches into the circulation path.

2010 ADAS Section 307.2

Protrudes 6 inches
from wall

If possible, replace fire alarm housing with low profile housing or recess housing into wall to meet the 4 inch maximum protrusion.

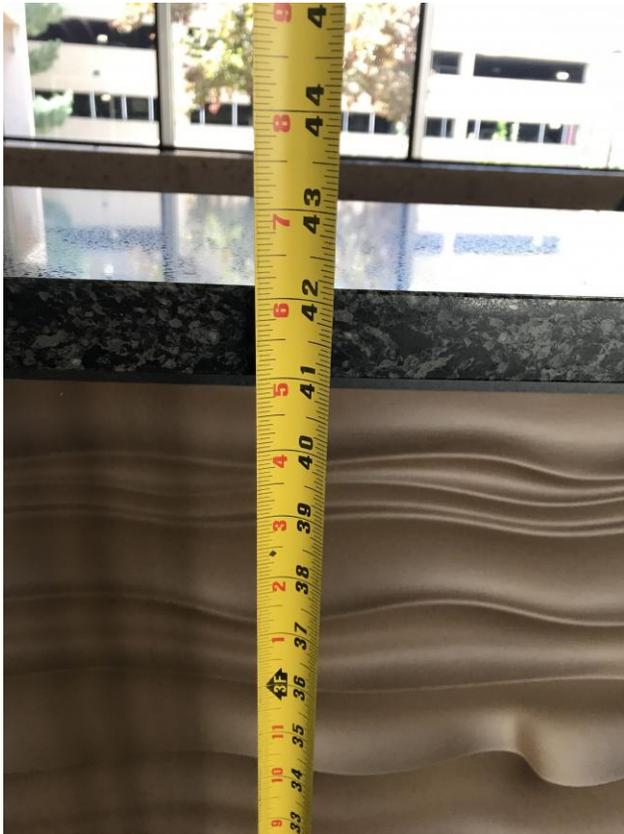
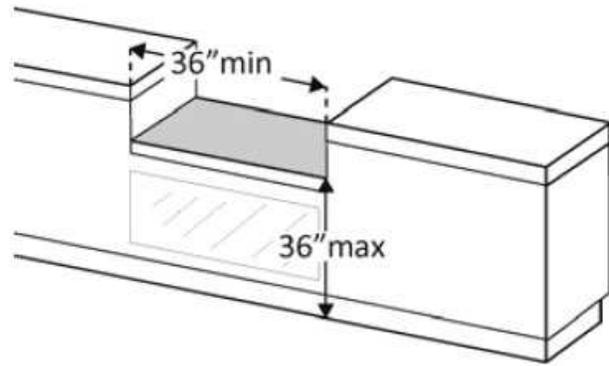
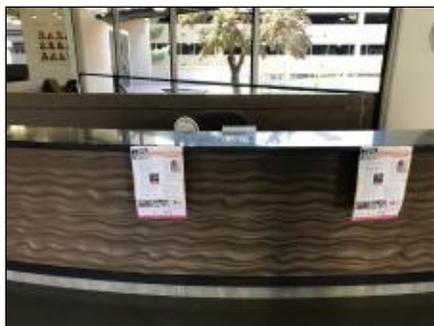
Finding 297766 Main Photo

The transaction counter is too high.

2010 ADAS Section: 904.4.2, 904.4.1

42 inches above
finished floor

Install compliant service counter or addition to existing service counter that includes a section of counter surface that is 36 inches long minimum and 36 inches high maximum.

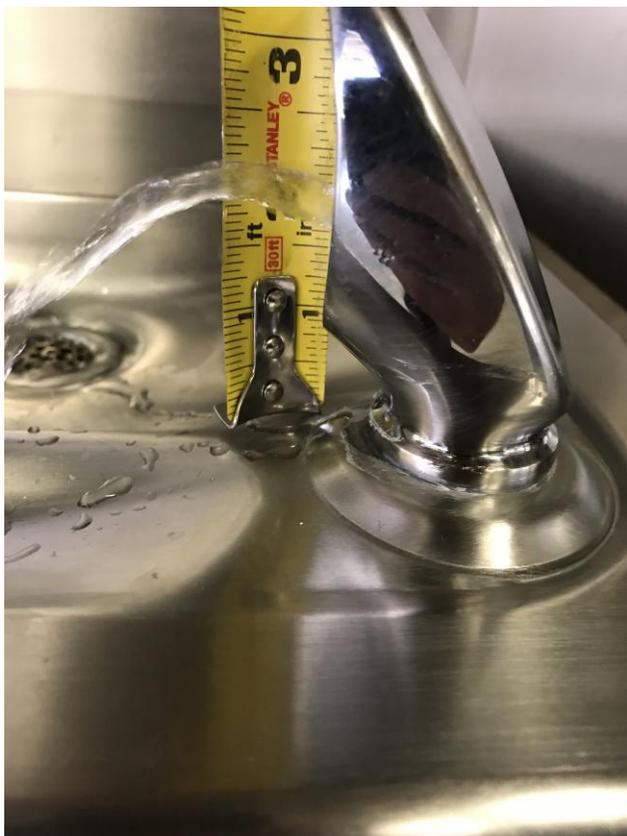
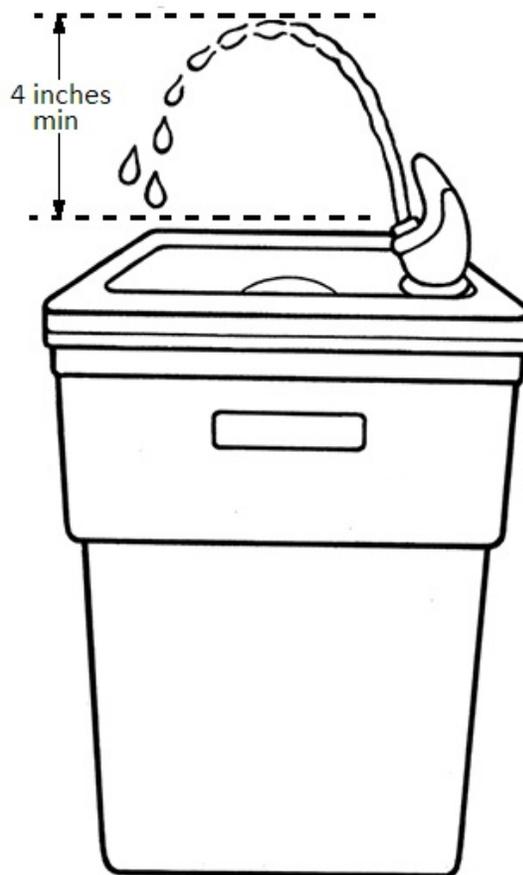
Finding 297815 Main Photo

The water flow from the spout is too low..

2010 ADAS Section 602.6

1.5 inches flow of water

Adjust water flow pressure to provide flow of water 4 inches high minimum.

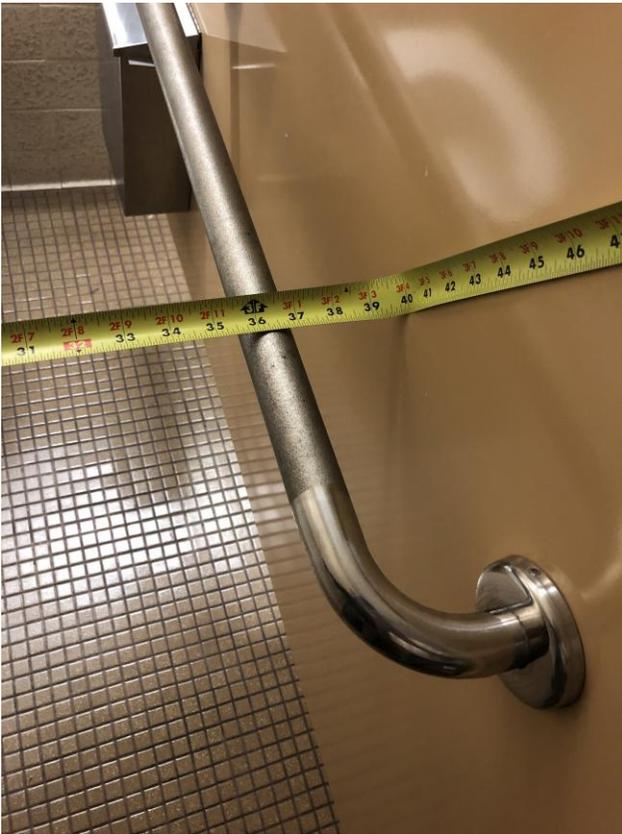
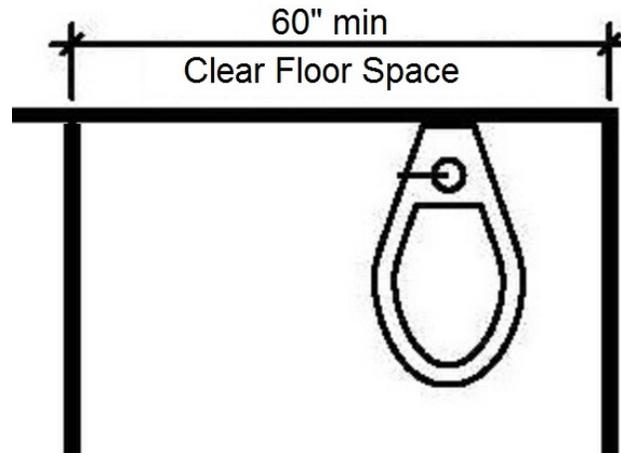
Finding 297049 Main Photo

The toilet compartment is not wide enough.

2010 ADAS Section 604.8.1.1

40 inches wide

Re-design and remodel restroom to meet compliance to the extent feasible.

Corrective action: Work order #350373 submitted on 04/29/2016

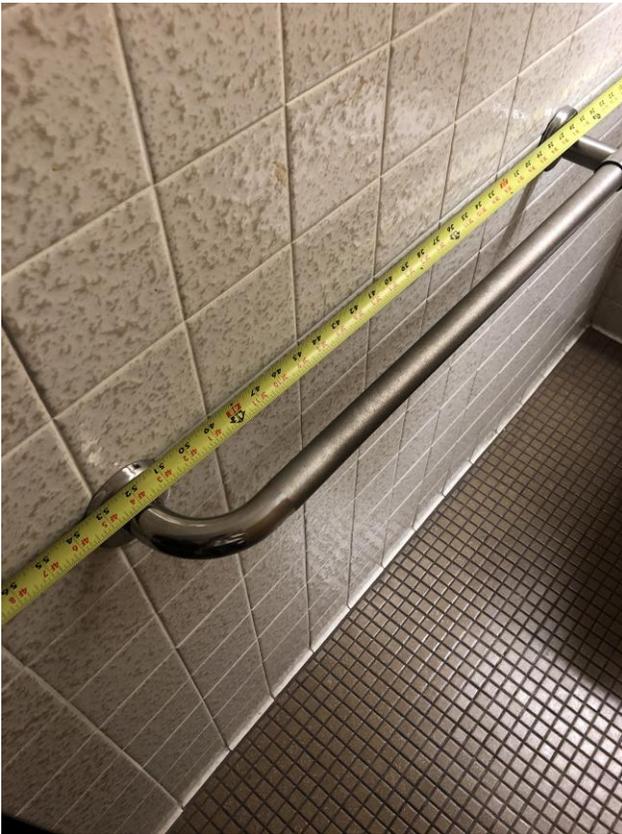
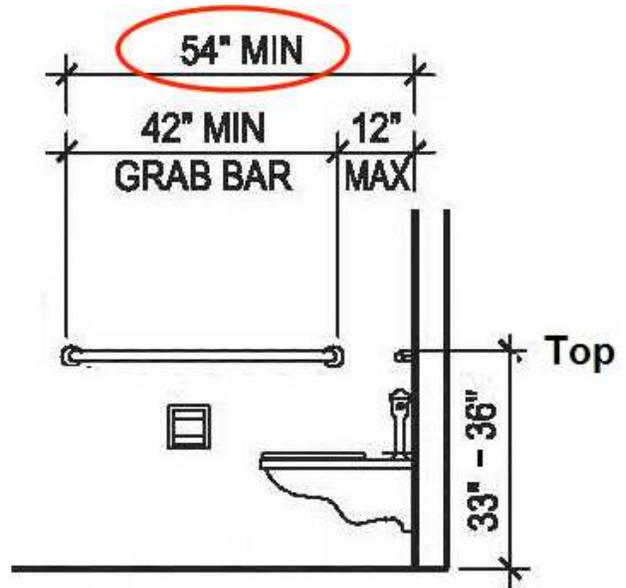
The side grab bar does not extend far enough from the rear wall.

2010 ADAS Section 604.5.1

10 inches from rear wall

Upon remodel install new side grab bar to meet compliance.

Corrective action: Work order #350373 submitted on 04/29/2016

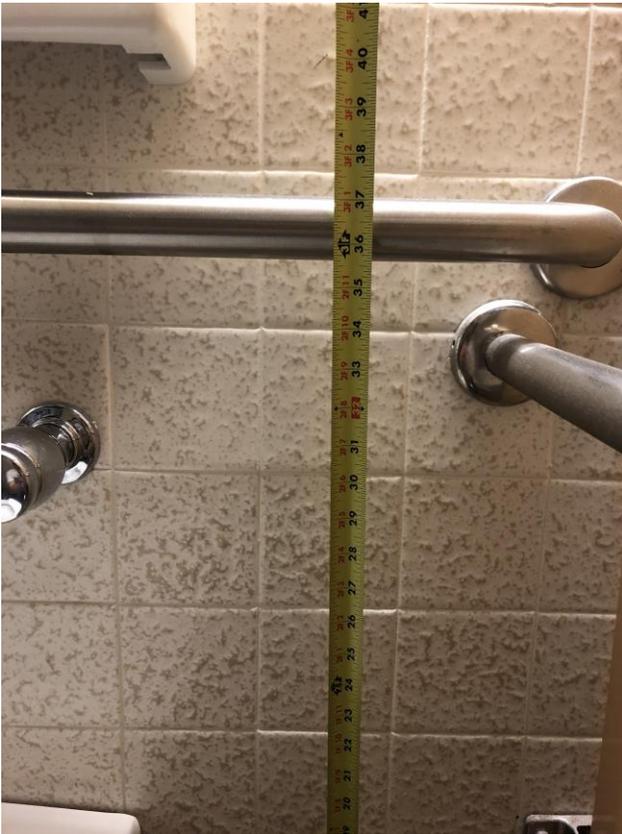
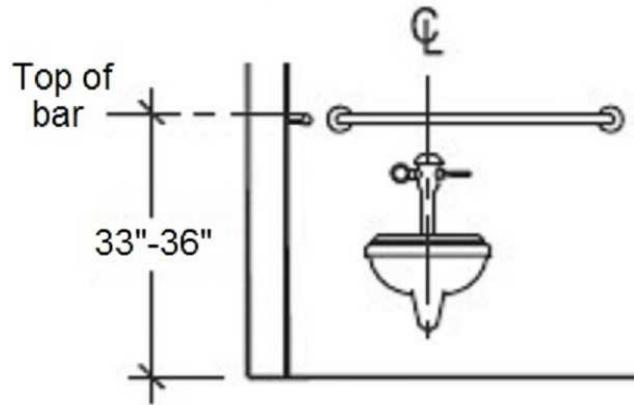
Finding 297051 Main Photo

The rear grab bar is too high.

2010 ADAS Section 609.4

37 inches above
finished floor

Lower grab bar between 1 and 3 inches to meet compliance.

Corrective action: Work order #350373 submitted on 04/29/2016

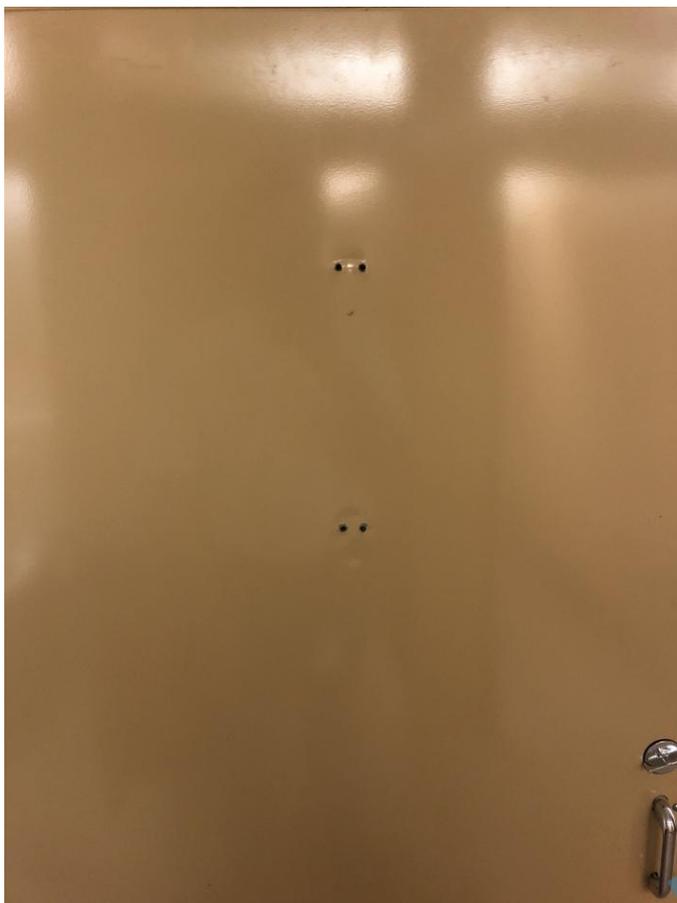
Finding 297047 Main Photo

The coat hook is missing.

Corrective action: Work order #350373 submitted on 12/16/2015

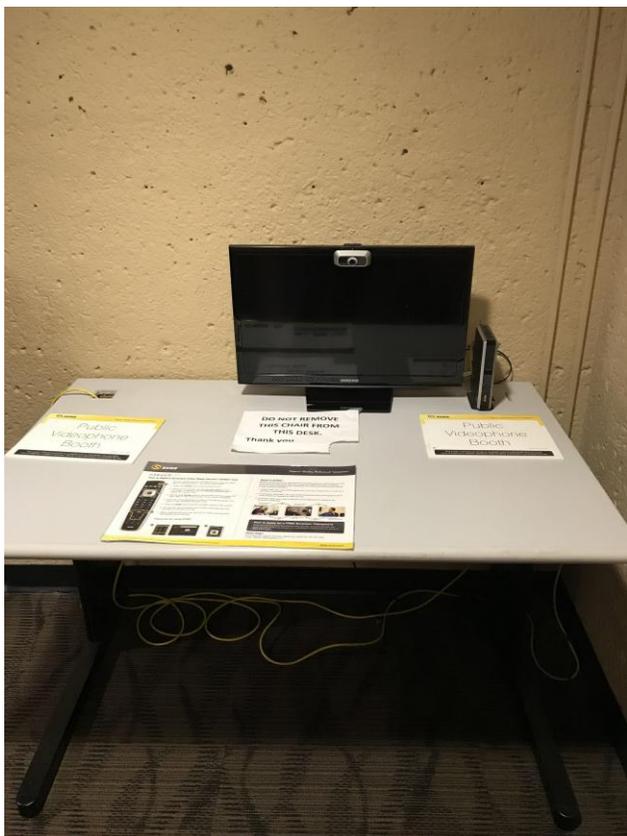
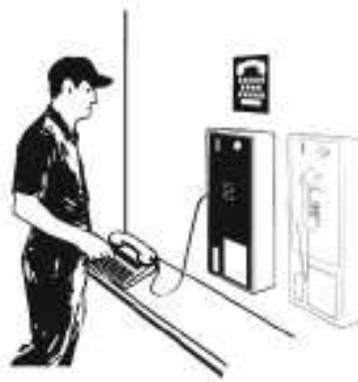
Finding 297768 Main Photo

Video phone missing
monitor remote

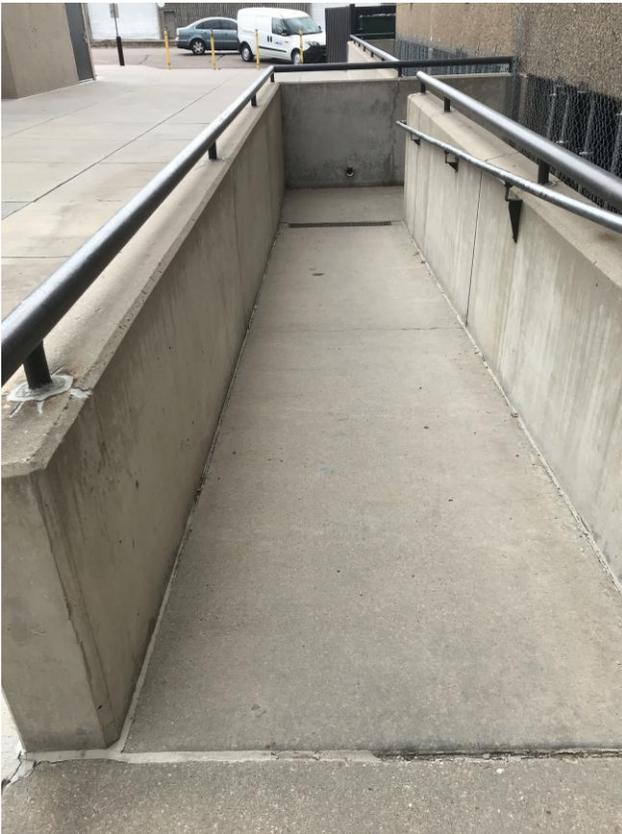
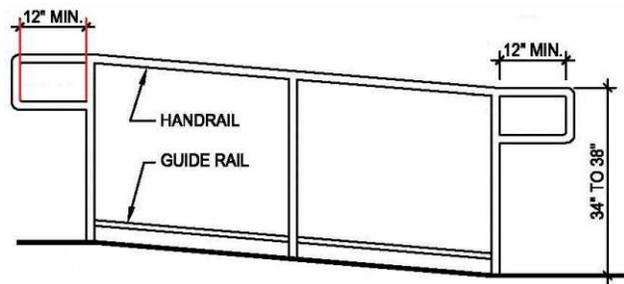
Finding 297771 Main Photo

Missing handrail on
one side of ramp

Install missing handrail for entire length of ramp between 34 and 38 inches to top of gripping surface measured above the finished floor. Handrail must extend beyond the top and bottom of the ramp 12 inches and be parallel to the floor or ground surface
