# Site Accessibility Evaluation

## Americans with Disabilities Act Title II (Public Services: State and Local Government)

### County Professional Building

*Inspection Date: 07/24/2017*  
*Inspector: David Mejia*

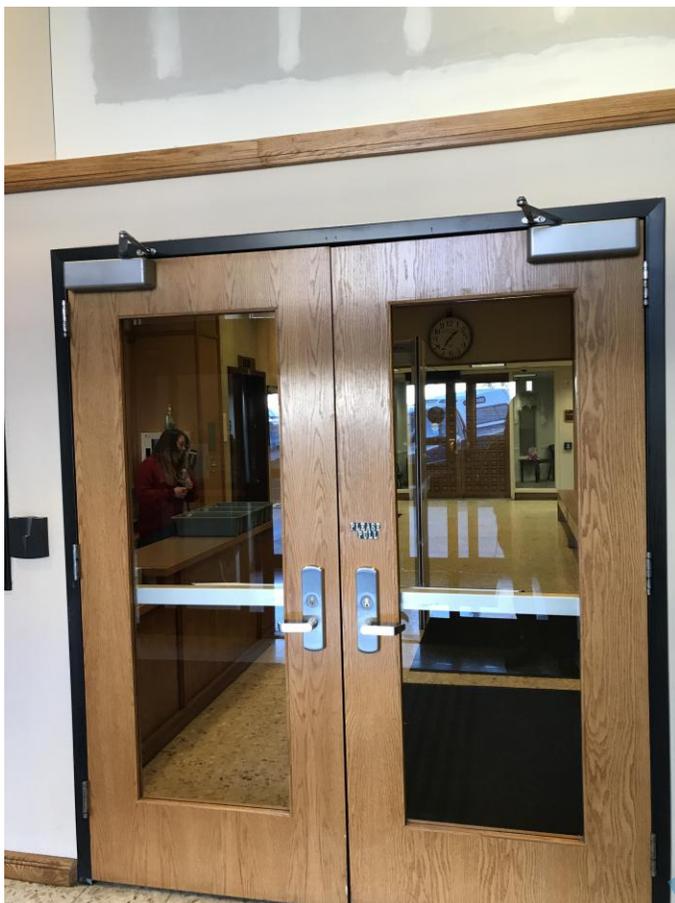
Finding 299101 Main Photo

Doors to main lobby/security desk area are ADA compliant but due to a unique and special circumstance they are not practical for an employee with a qualified disability.

Employee Accommodation: Install automatic door opener to main lobby/security desk for employee access due to qualified disability.

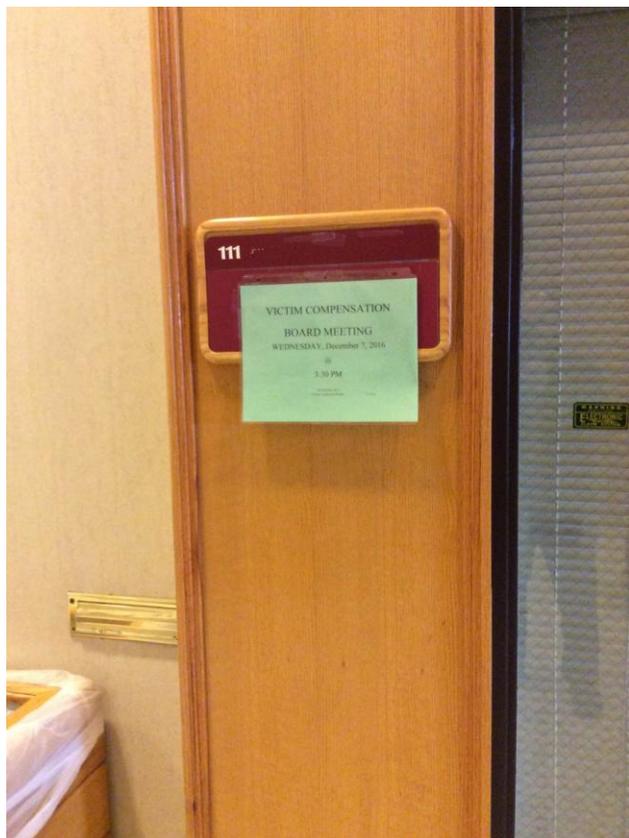
Finding 25855 Main Photo

The wall sign is mounted too high.

2010 ADAS Section: 703.4.1

62 inches  
high/character missing

Submit work order to have proper sign installed at proper height.

Corrective Action: W/O 381215 completed 381215.

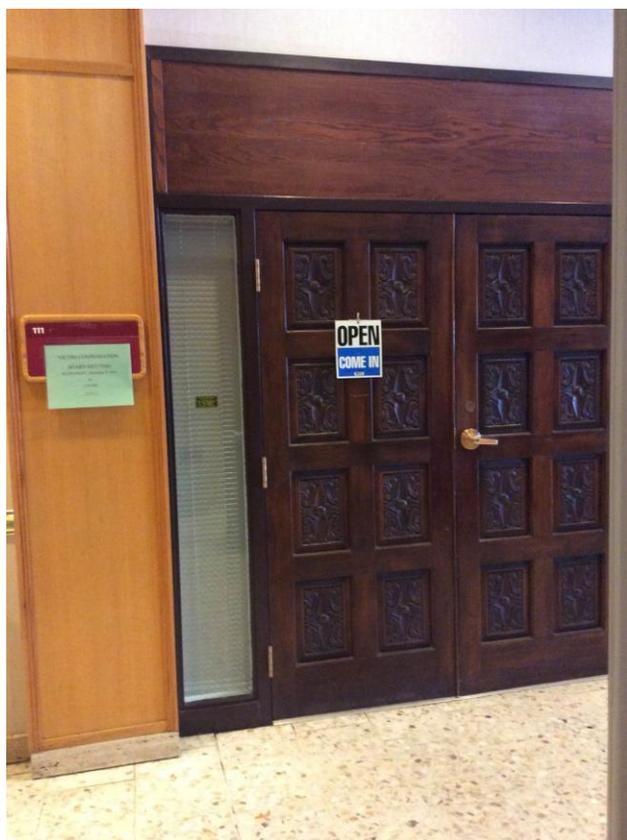
Finding 25854 Main Photo

The door opening does not provide at least 32 inches between the face of the door and the opposite stop.

2010 ADAS Section: 404.2.3

Double door, each side  
opens 29 inches

Submit a work order to have doors adjusted/replaced. Bill Dieter spoke w/Kim Short, she said that the public no longer uses this area and that when the public goes through security they are directed to the reception area in room 101 straight down the hall.

Corrective Action: W/O 381260 submitted. Corrective Action no longer needed due to process change.

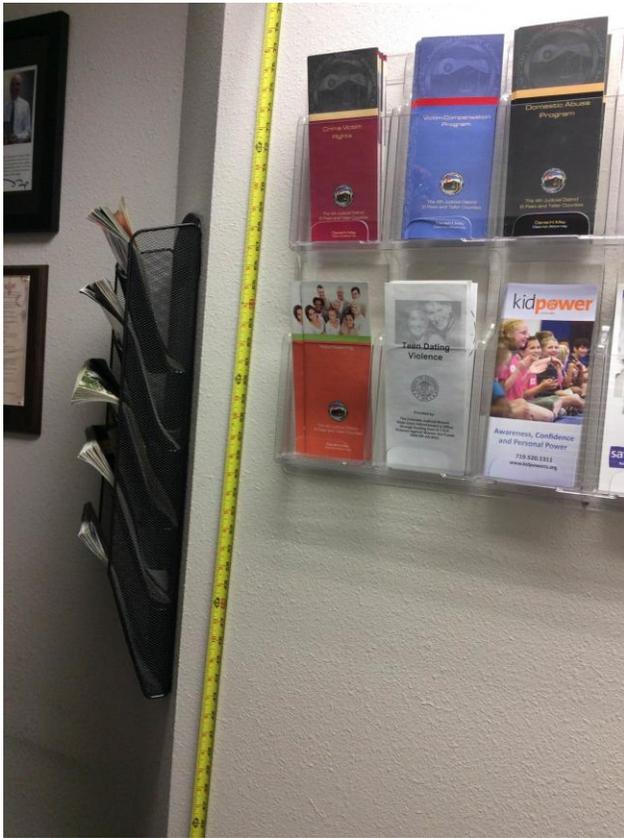
Finding 25857 Main Photo

The clear floor space only allows for a forward approach and the brochure rack is out of reach range.

*2010 ADAS Section 308.2.2*

Corrective Action: W/O 381214 completed 02/09/2017.

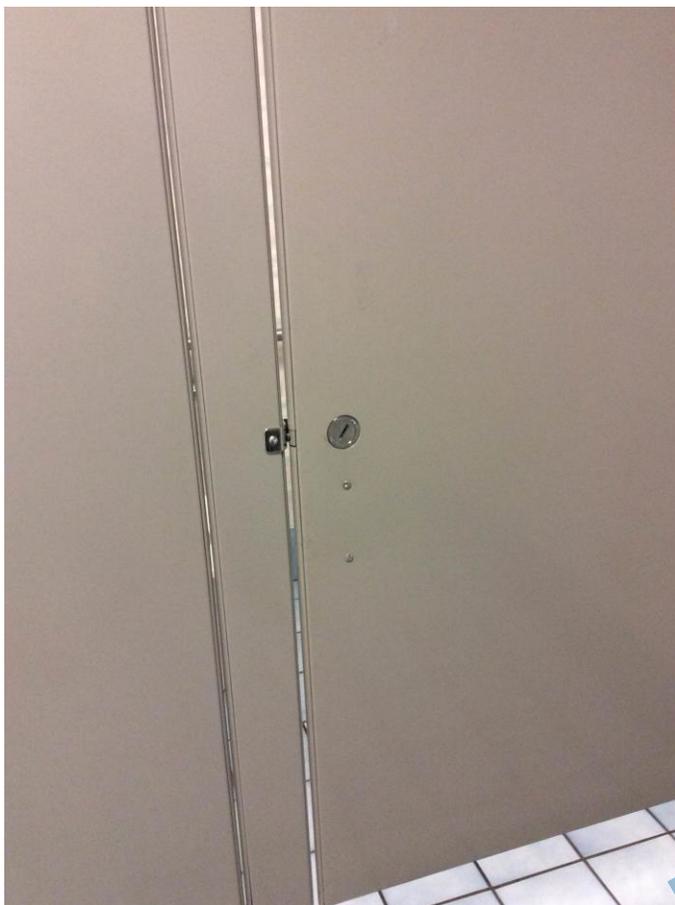
Finding 25859 Main Photo

The water closet compartment door is missing a loop handle on the outside.

Missing loop handle  
on outside of door

Corrective Action: W/O 381207 completed 381207.

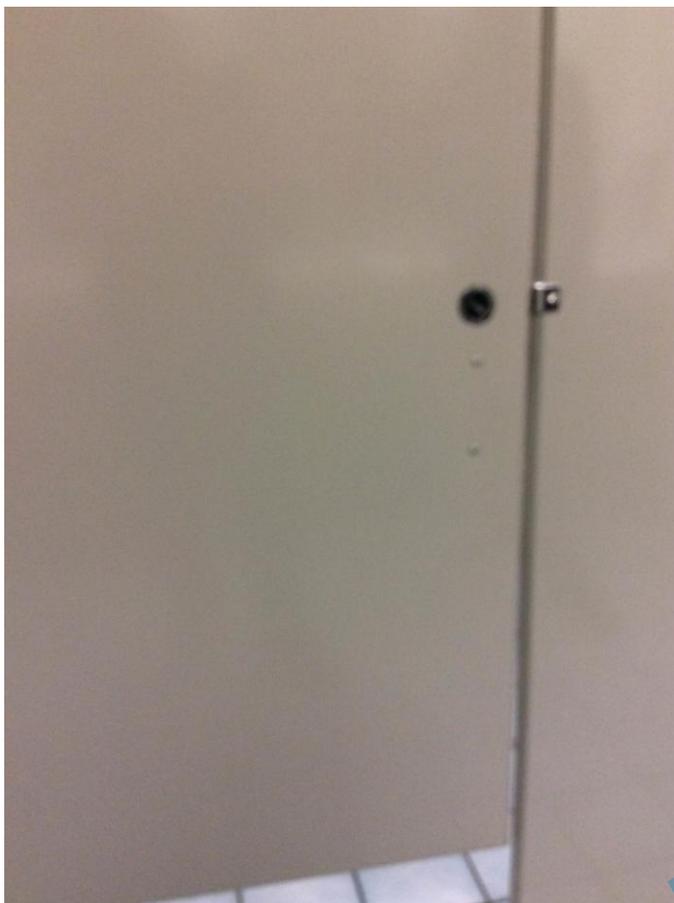
Finding 25870 Main Photo

The water closet compartment door is missing a loop handle on the outside.

Corrective Action: W/O 381201 completed 381201.

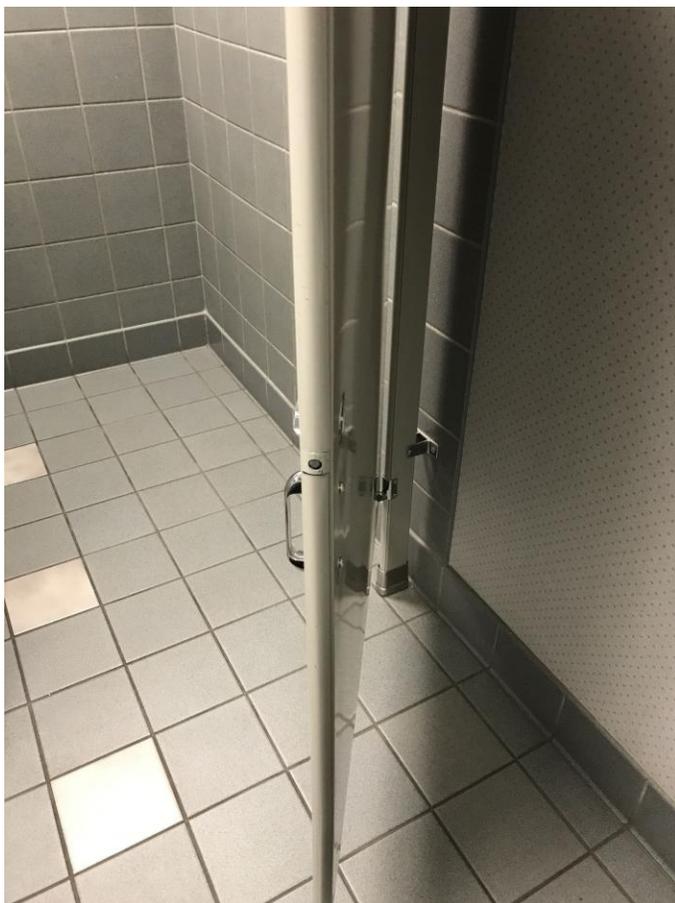
Finding 299122 Main Photo

The water closet compartment door is missing a loop handle on the outside.

Missing loop handle  
on outside of door

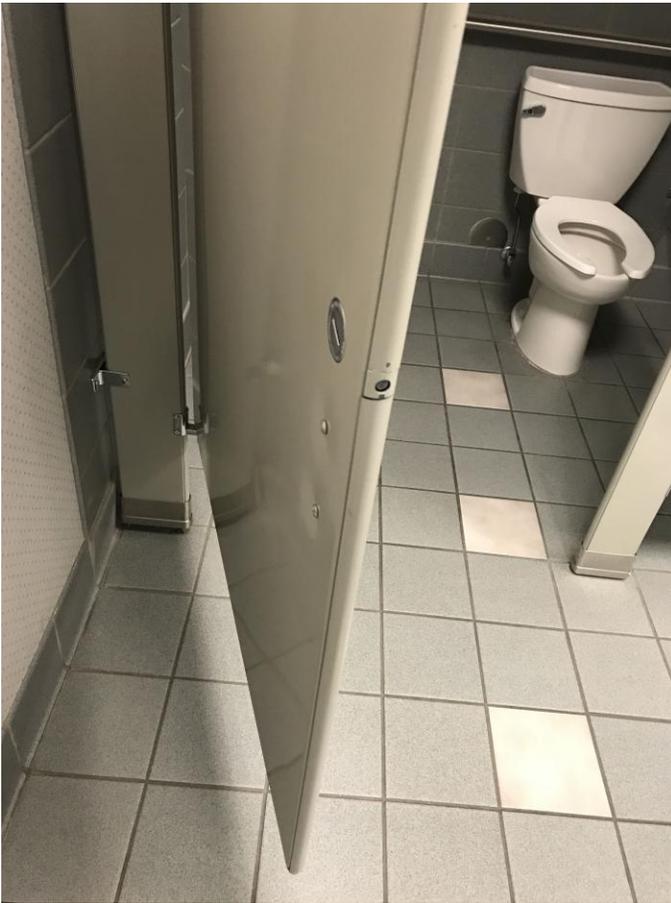
Finding 299132 Main Photo

The water closet compartment door is missing a loop handle on the outside.

Missing loop handle  
on outside of door

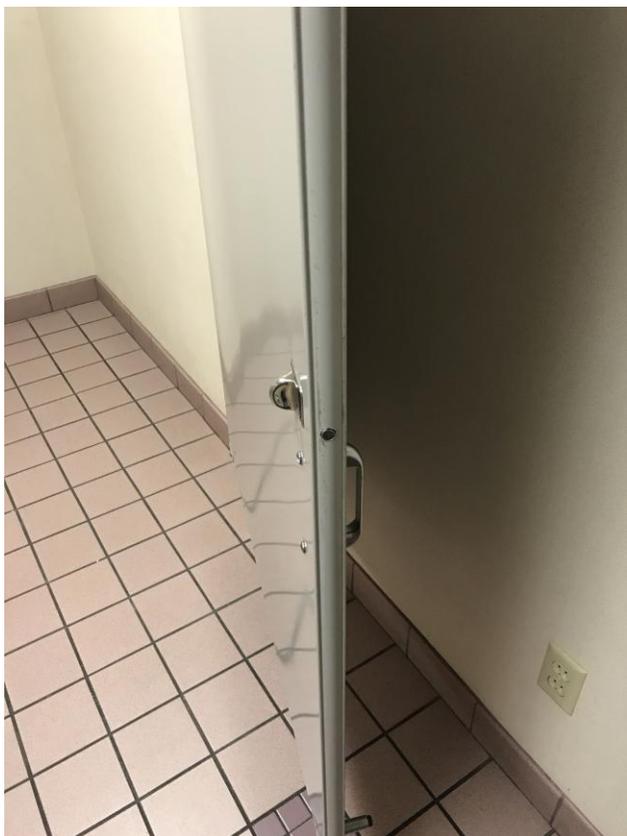
Finding 299106 Main Photo

The water closet compartment door is missing a loop handle on the inside.

Missing loop handle  
on inside of door

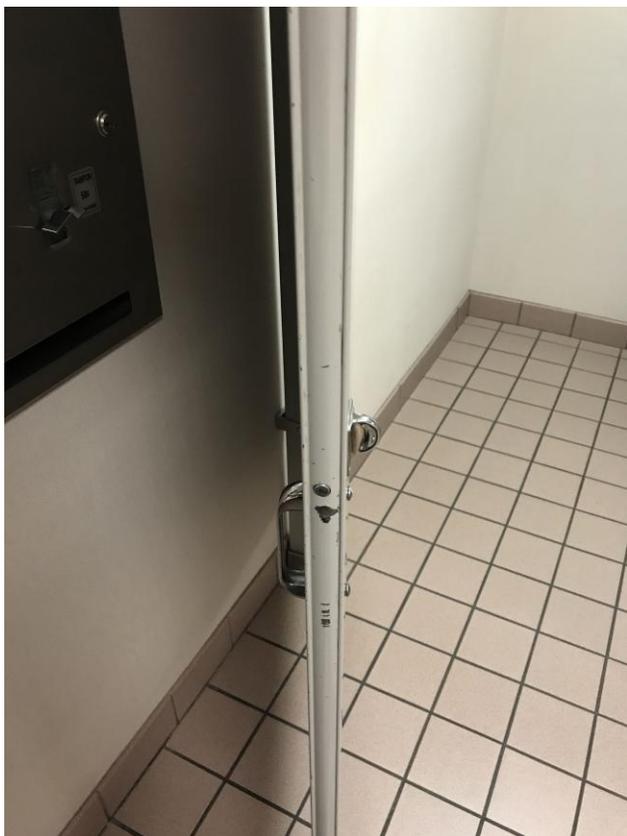
Finding 299113 Main Photo

The water closet compartment door is missing a loop handle on the inside.

Missing loop handle  
on inside of door
