Site Accessibility Evaluation

Centennial Hall

Accessibility Evaluation

Inspection Date: 05/14/2019

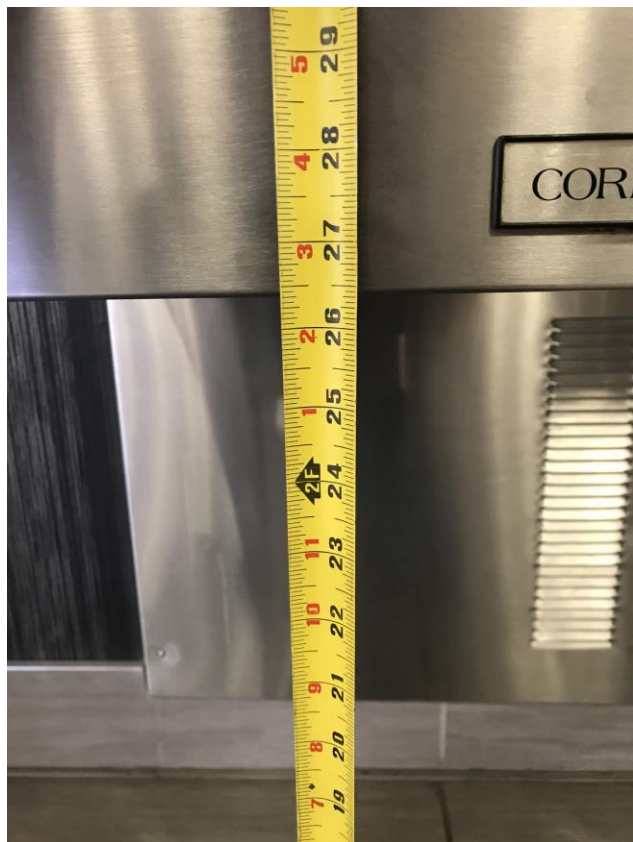
Finding 297764 Main Photo

There is not enough knee clearance under the drinking fountain.

The drinking fountain must have a clear knee space between the bottom of the drinking fountain and the floor not less than 27 inches in height, 30 inches in width, and 8 inches in depth.

2010 ADAS Section 602.2

Bottom edge of
drinking fountain at
26.5 inches

4 (Low): Should be completed as soon as possible due to being a technical violation, but may not result in providing greater access to persons with disabilities. (Includes; Findings that are technically violations but provide a moderate to low increase in accessibility compared to the financial impact on the entity)

Adjust drinking fountain height to provide 27 inches of clearance.

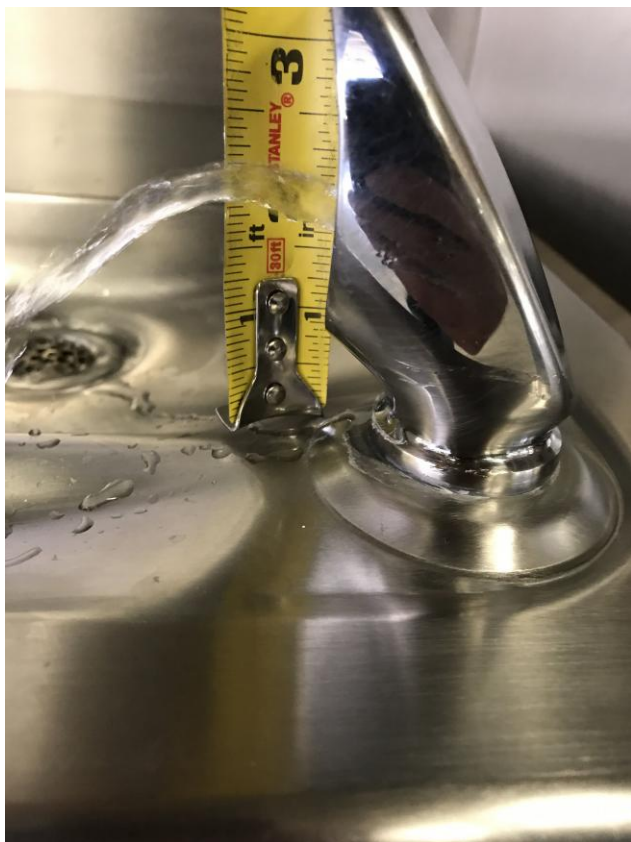
Finding 297815 Main Photo

The water flow from the spout is too low..

The spout shall provide a flow of water 4 inches high minimum.

2010 ADAS Section 602.6

1.5 inches flow of water

4 (Low): Should be completed as soon as possible due to being a technical violation, but may not result in providing greater access to persons with disabilities. (Includes; Findings that are technically violations but provide a moderate to low increase in accessibility compared to the financial impact on the entity)

Adjust water flow pressure to provide flow of water 4 inches high minimum.
