# Site Accessibility Evaluation

## Americans with Disabilities Act Title II (Public Services: State and Local Government)

### County Professional Building

*Inspection Date: 07/24/2017*  
*Inspector: David Mejia*

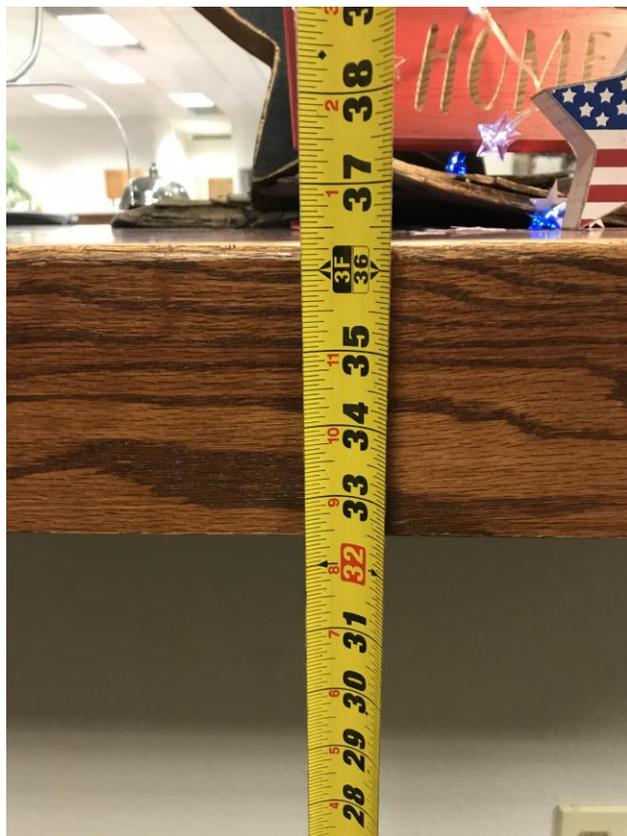
Finding 299326 Main Photo

The transaction counter is too high.

36.25 inches above  
finished floor

Install new counter section that measures 36 inches maximum in height from the finish floor and lengthen that section of the counter to 36 inches minimum. A clear floor or ground space shall be provided for either a parallel or forward approach complying with section 305 and/or 306 respectively.

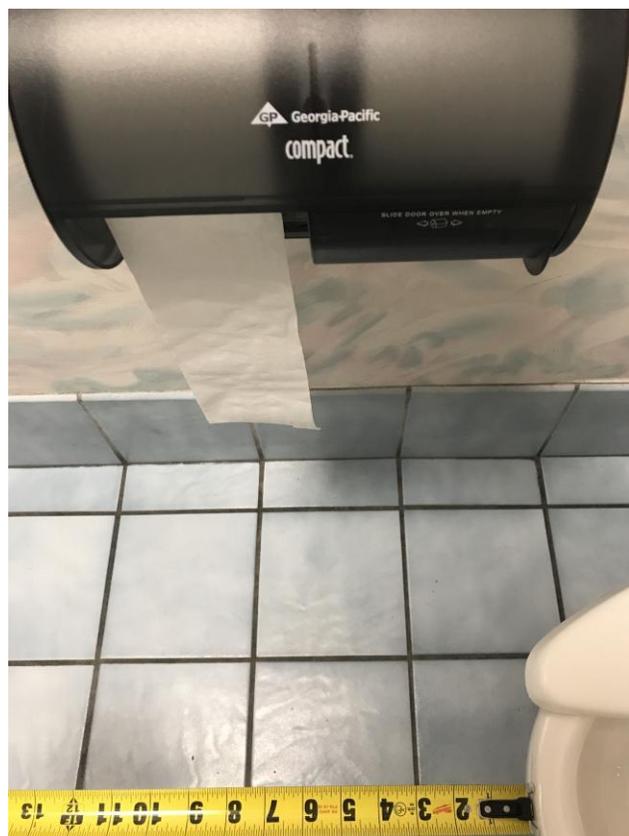
Finding 299092 Main Photo

The toilet paper is not installed within the compliant range.

5 inches in front of toilet

Re-position toilet paper dispenser to be within 7 inches minimum to 9 inches maximum in front of the toilet measured to the centerline of the dispenser.

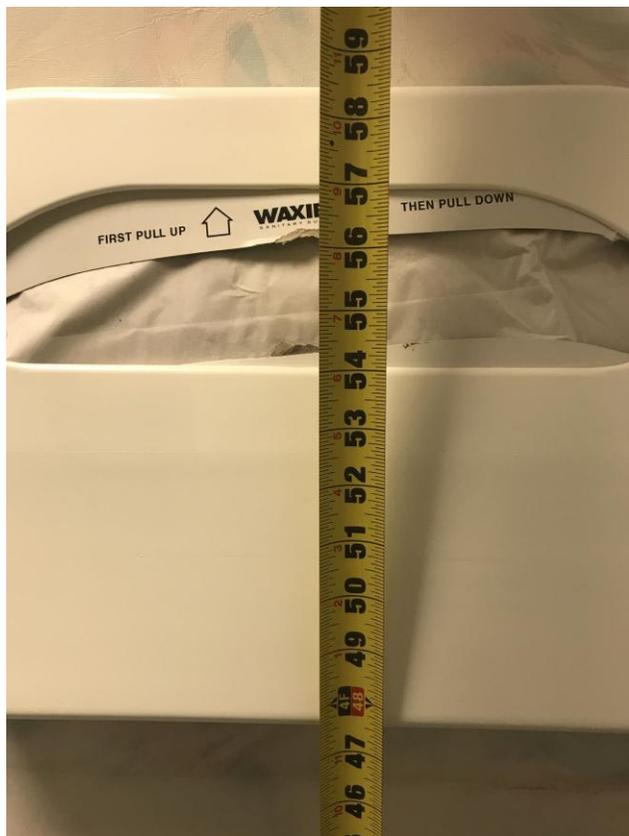
Finding 299093 Main Photo

The toilet seat cover dispenser is mounted too high.

Citation:	As Built:	Budgeting Range:
2010 ADAS Section: 308.1	54 inches above finished floor	\$150 - \$1,500.00

Re-locate toilet seat cover dispenser below either grab bar at least 1.5 inches minimum below grab bars but no less than 15 inches above finished floor to meet compliance.

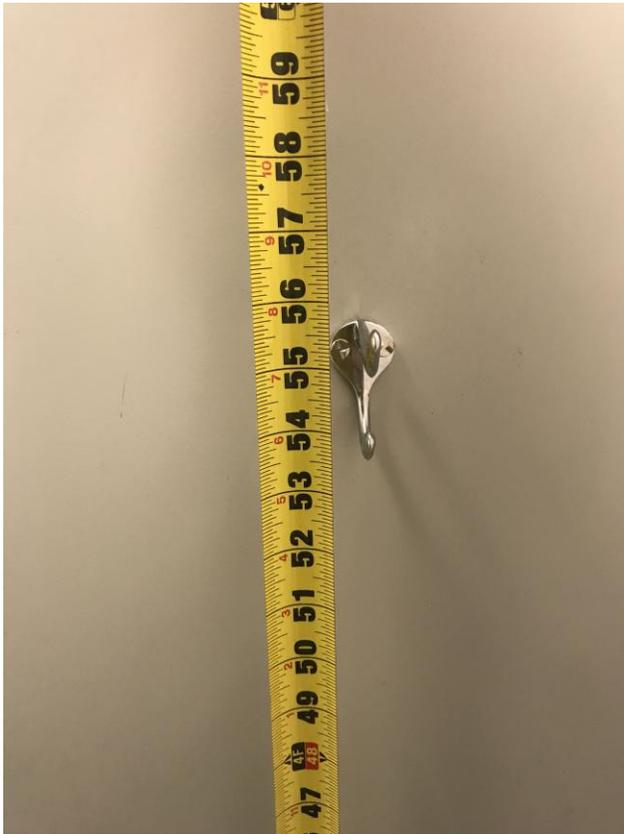
Finding 299094 Main Photo

The coat hook is installed greater than 48 inches above the finished floor.

55 inches above  
finished floor

Lower coat hook 8 inches minimum or install another coat hook not to exceed a maximum height of 48 inches above finished floor.

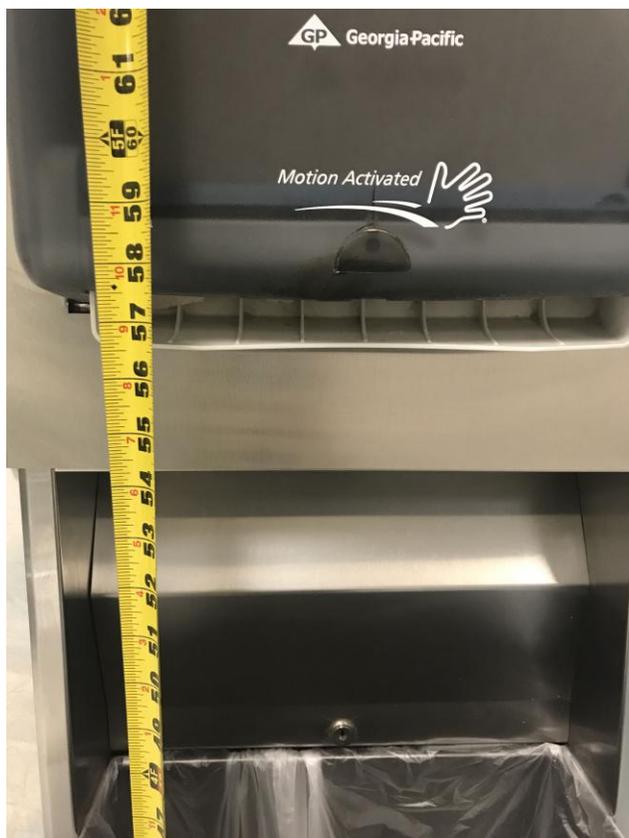
Finding 299095 Main Photo

The paper towel dispenser's operation mechanism is too high off the floor.

58.5 inches above  
finished floor

Lower paper towel dispenser 11 inches to meet compliance. 48 inches maximum height above finished floor for operable parts (sensor).

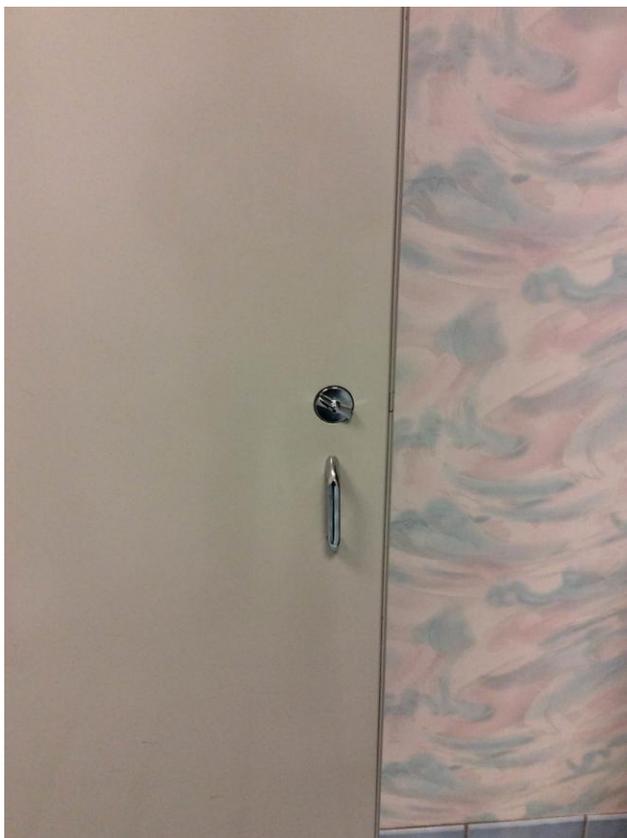
Finding 25860 Main Photo

The locking/latching hardware is not accessible.

Locking hardware  
requires twisting and  
pinching of the wrist

Replace locking hardware with locking lever that does not require tight grasping, tight pinching or twisting of the wrist to operate.

Corrective Action: W/O 381216 completed 381216.

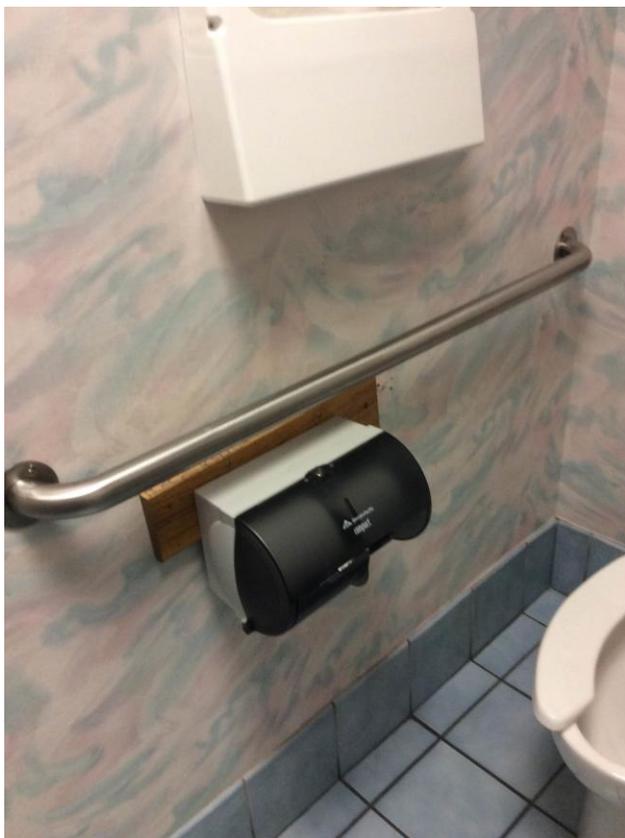
Finding 25868 Main Photo

The side grab bar is located greater than 12 inches from the rear wall.

<b>Citation:</b>	<b>As Built:</b>	<b>Budgeting Range:</b>
2010 ADAS Section: 604.5.1	12.75 inches from rear wall	\$150 - \$1,500.00

Adjust side grab bar not to exceed 12 inches from rear wall. The side grab bar must be 42 inches minimum in length and extend at least 54 inches minimum beyond the rear wall.

Corrective Action: W/O 381204 submitted. Relocated grab bar- 3/23/17.

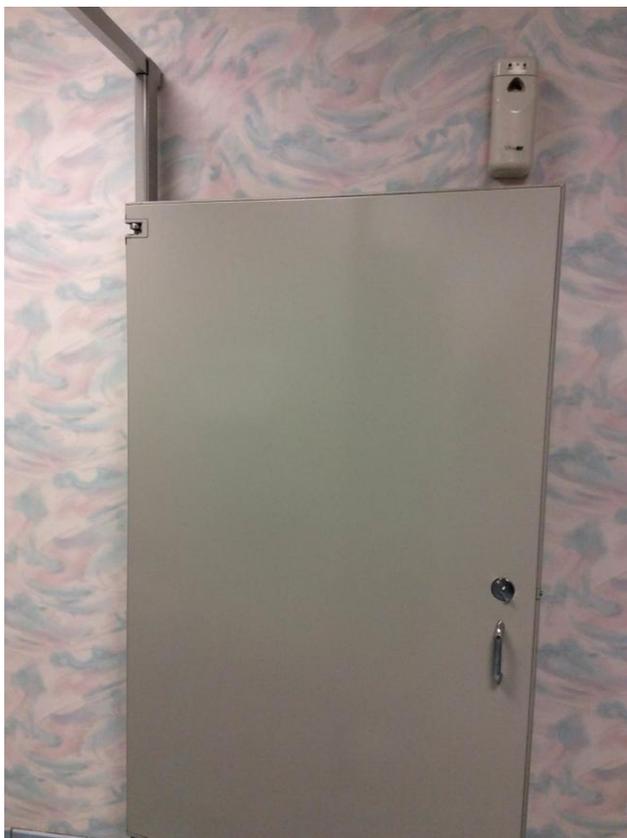
Finding 25858 Main Photo

The compartment door is not self closing.

Stall door does not self-close

Adjust or install automatic closing hinges.

Corrective Action: W/O 381208 submitted. Replaced hinges, parts on hand. 6/19/17.

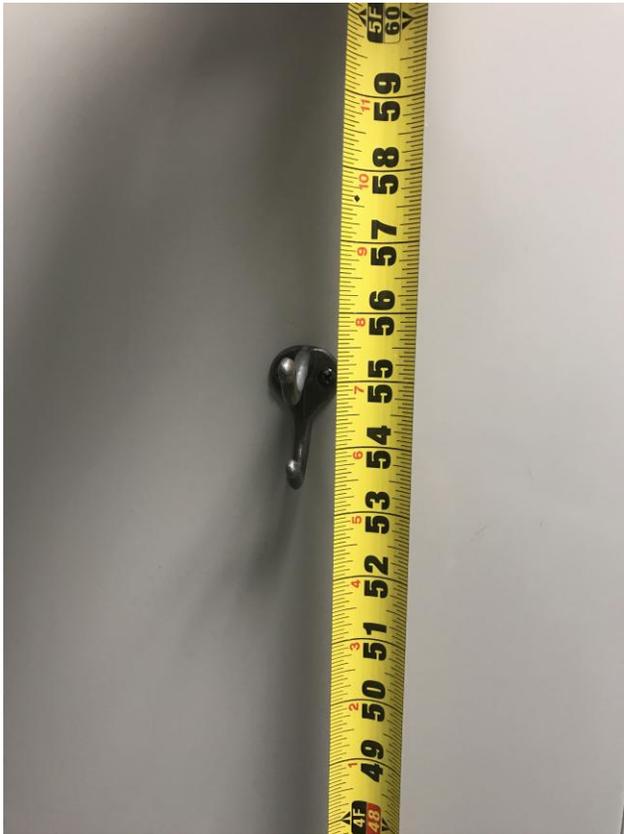
Finding 299096 Main Photo

The coat hook is installed greater than 48 inches above the finished floor.

55 inches above  
finished floor

Lower coat hook 8 inches minimum or install another coat hook not to exceed a maximum height of 48 inches above finished floor.

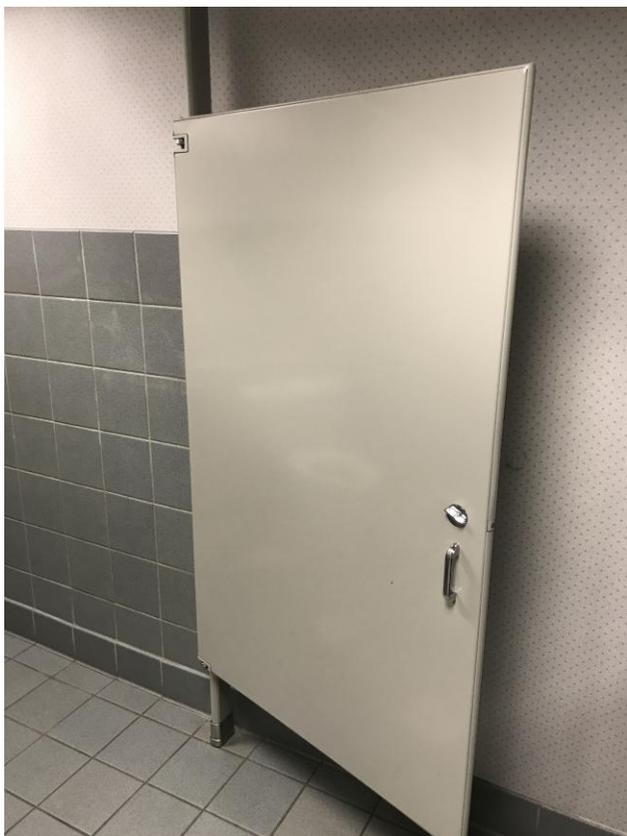
Finding 299121 Main Photo

The water closet compartment door is missing a loop handle on the outside.

Missing loop handle  
on outside of door

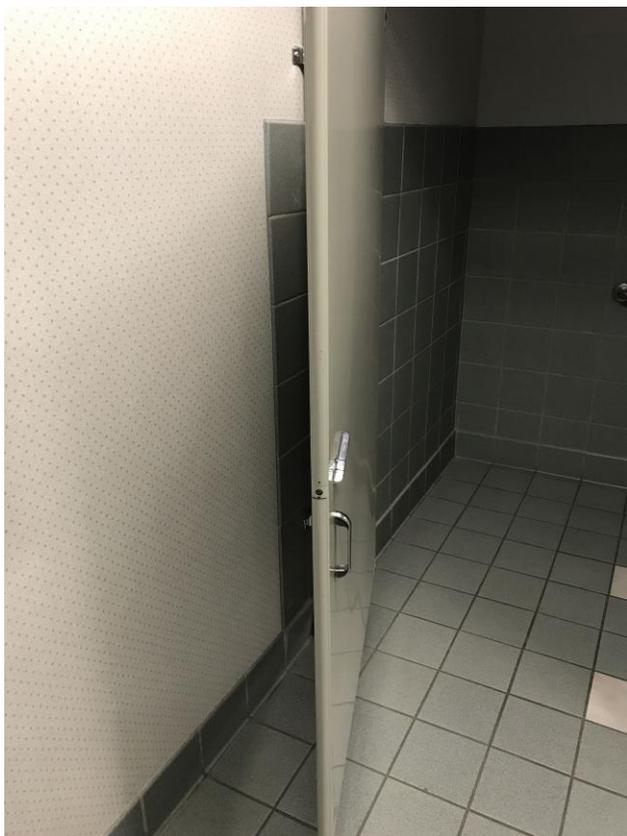
Finding 299131 Main Photo

The water closet compartment door is missing a loop handle on the outside.

Missing loop handle  
on outside of door

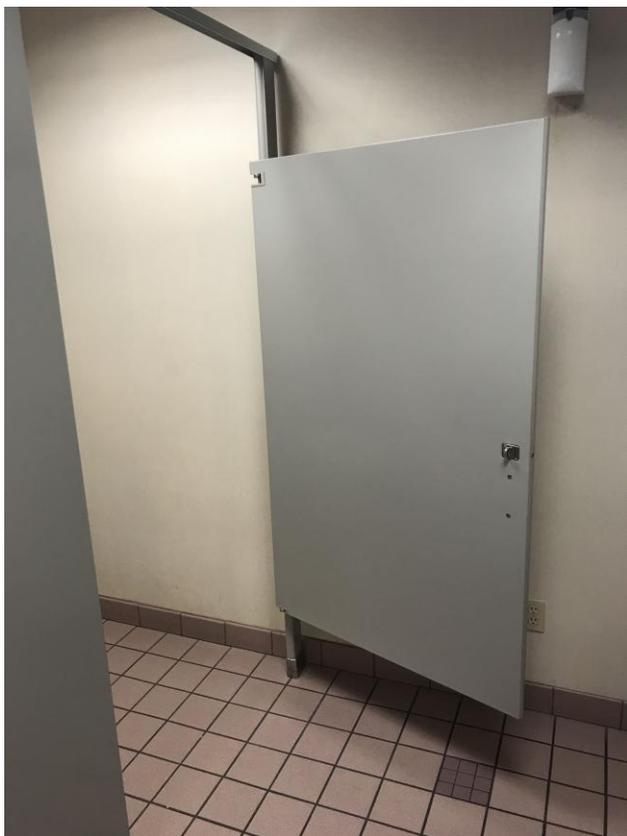
Finding 299105 Main Photo

The water closet compartment door is missing a loop handle on the inside.

Missing loop handle  
on inside of door
