Site Accessibility Evaluation

Environmental Building

**3255 Akers Dr
Colorado Springs, CO
80922**

Accessibility Evaluation

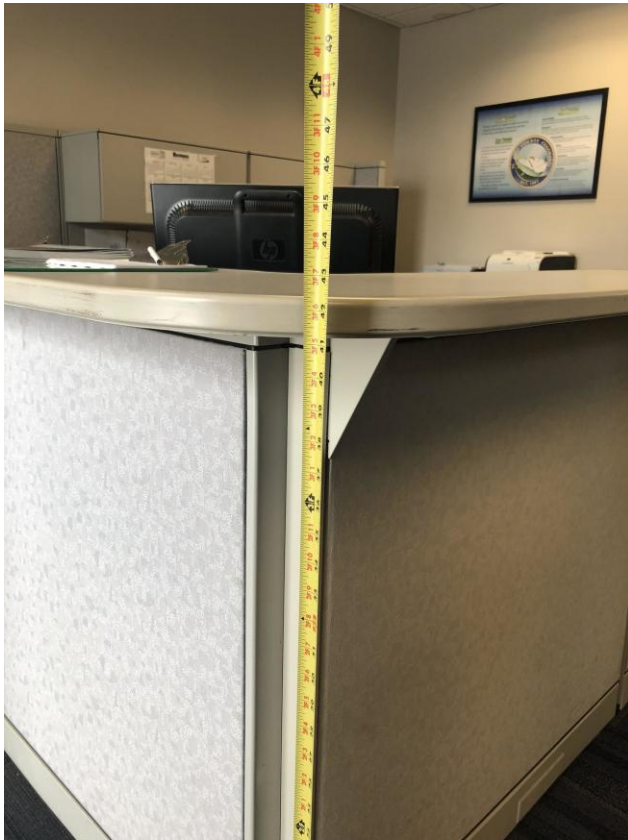
Finding 117888 Main Photo

The transaction counter is too high.

2010 ADAS Section: 904.4.2, 904.4.1

Counter measured at 42.5 inches from surface to floor.

Modify or extend existing service counter or install new counter/section that includes a section of counter surface that is 36 inches long minimum and 36 inches high maximum.

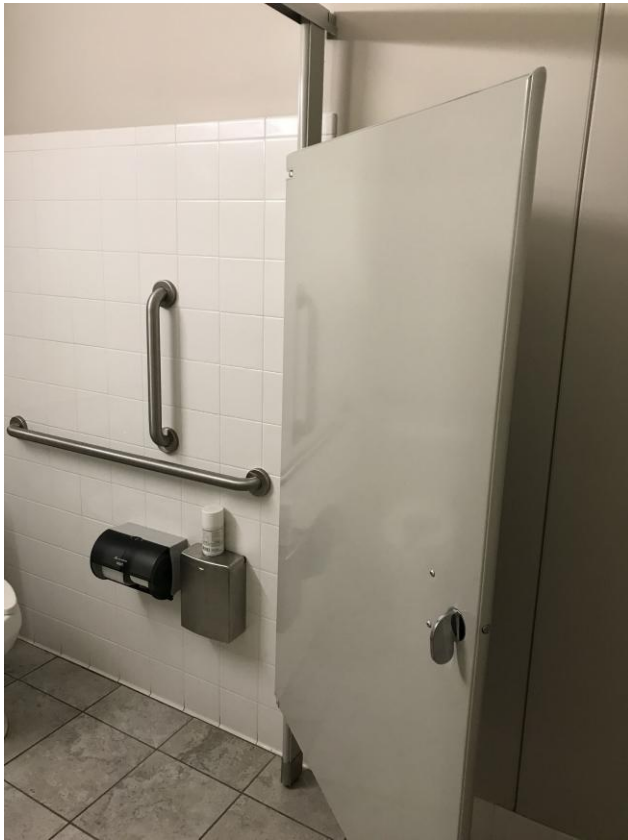
Finding 299176 Main Photo

The compartment door is not self closing.

2010 ADAS Section: 604.8.1.2

Compartment door not self-closing

Adjust or install automatic closing hinges.

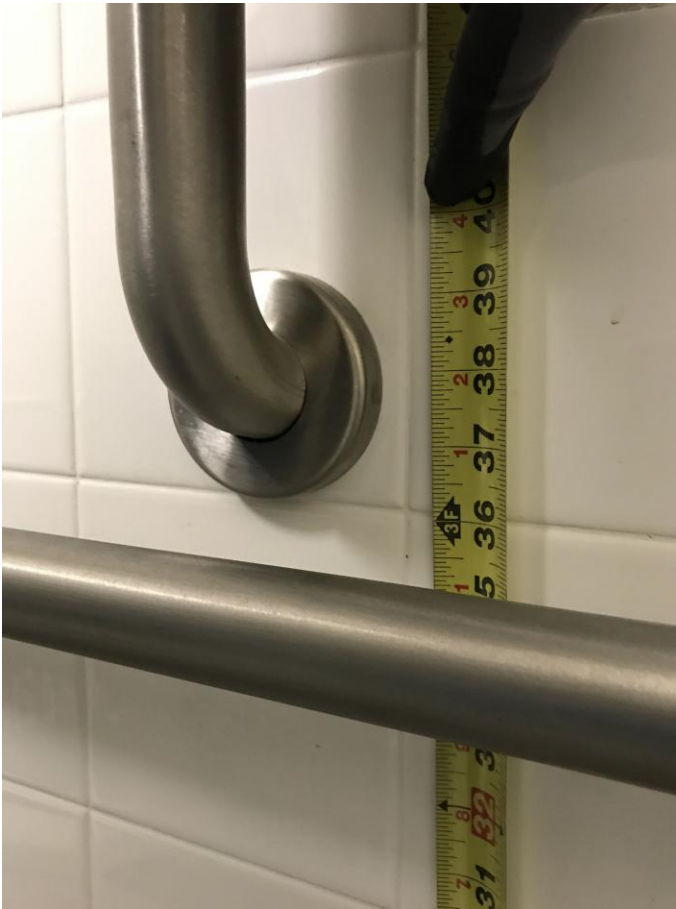
Finding 299473 Main Photo

Although not required per ADA Standards, but required under the ICC/ANSI A117.1

Citation:	As Built:	Budgeting Range:
2010 ADAS Section: Recommended	Vertical grab bar 37 inches above finished floor	\$0 - \$0.00

Re-position vertical grab bar so that bottom of grab bar measures a maximum of 41 inches but no less than 39 inches above finished floor.

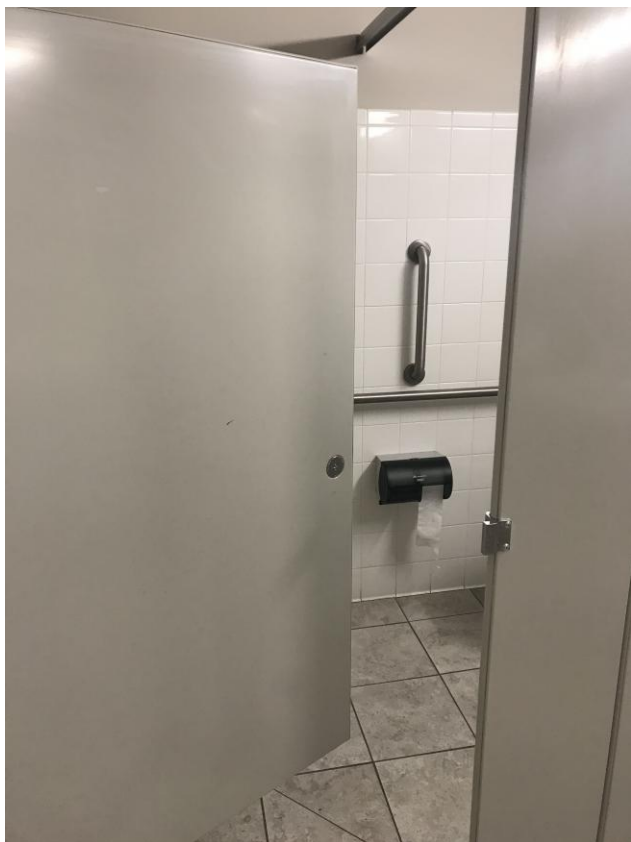
Finding 299182 Main Photo

The compartment door is not self closing.

2010 ADAS Section: 604.8.1.2

Compartment door not self-closing

Adjust or install automatic closing hinges.

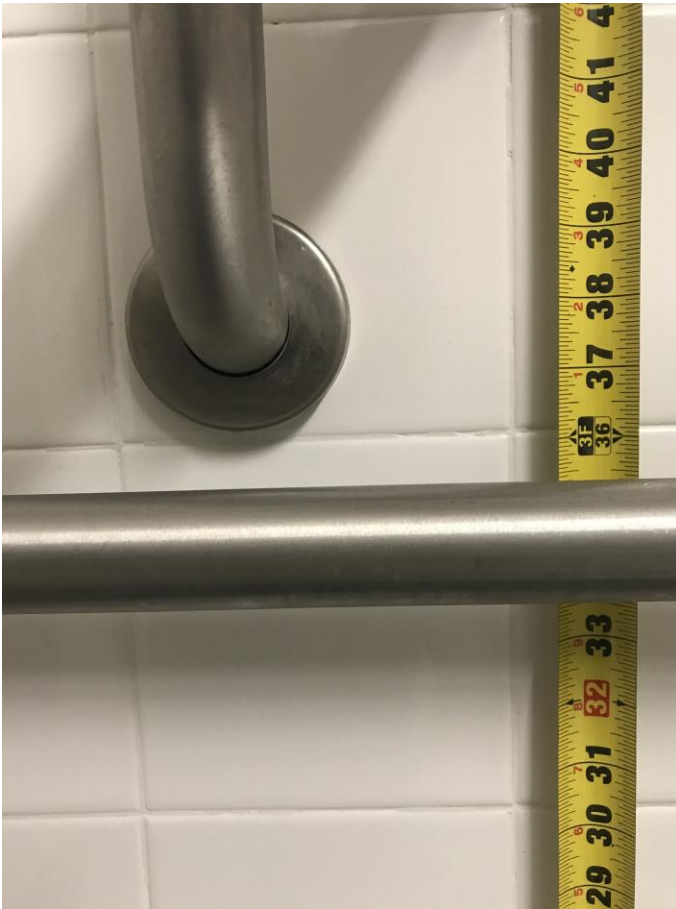
Finding 299185 Main Photo

Although not required per ADA Standards, but required under the ICC/ANSI A117.1

Citation:	As Built:	Budgeting Range:
2010 ADAS Section: Recommended	Vertical grab bar 37 inches above finished floor	\$0 - \$0.00

Re-position vertical grab bar so that bottom of grab bar measures a maximum of 41 inches but no less than 39 inches above finished floor.

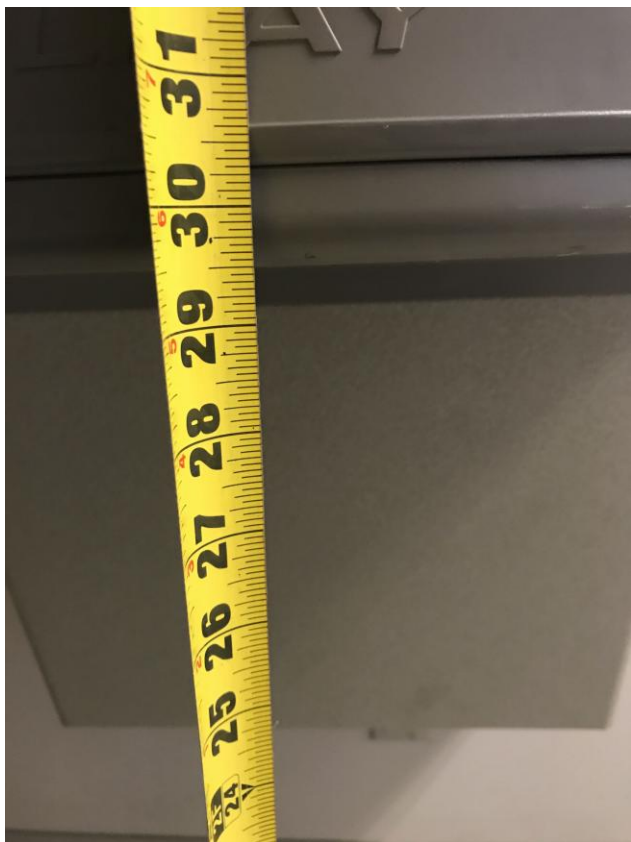
Finding 299188 Main Photo

The drinking fountain is not accessible.

2010 ADAS Section: 403.5.1, 602.1

Drinking fountain protrudes into circulation pathway and not cane detectable

Adjust drinking fountain height to provide exactly 27 inches of clearance or install wing walls, planter or permanent fixture next to drinking fountain in order to make it cane detectable.

Also, adjust spout/water pressure to provide a flow of water 4 inches high minimum.
