# Site Accessibility Evaluation

## Americans with Disabilities Act Title II (Public Services: State and Local Government)

### Fair and Events Complex

***Inspection Date: 10/29/2015***

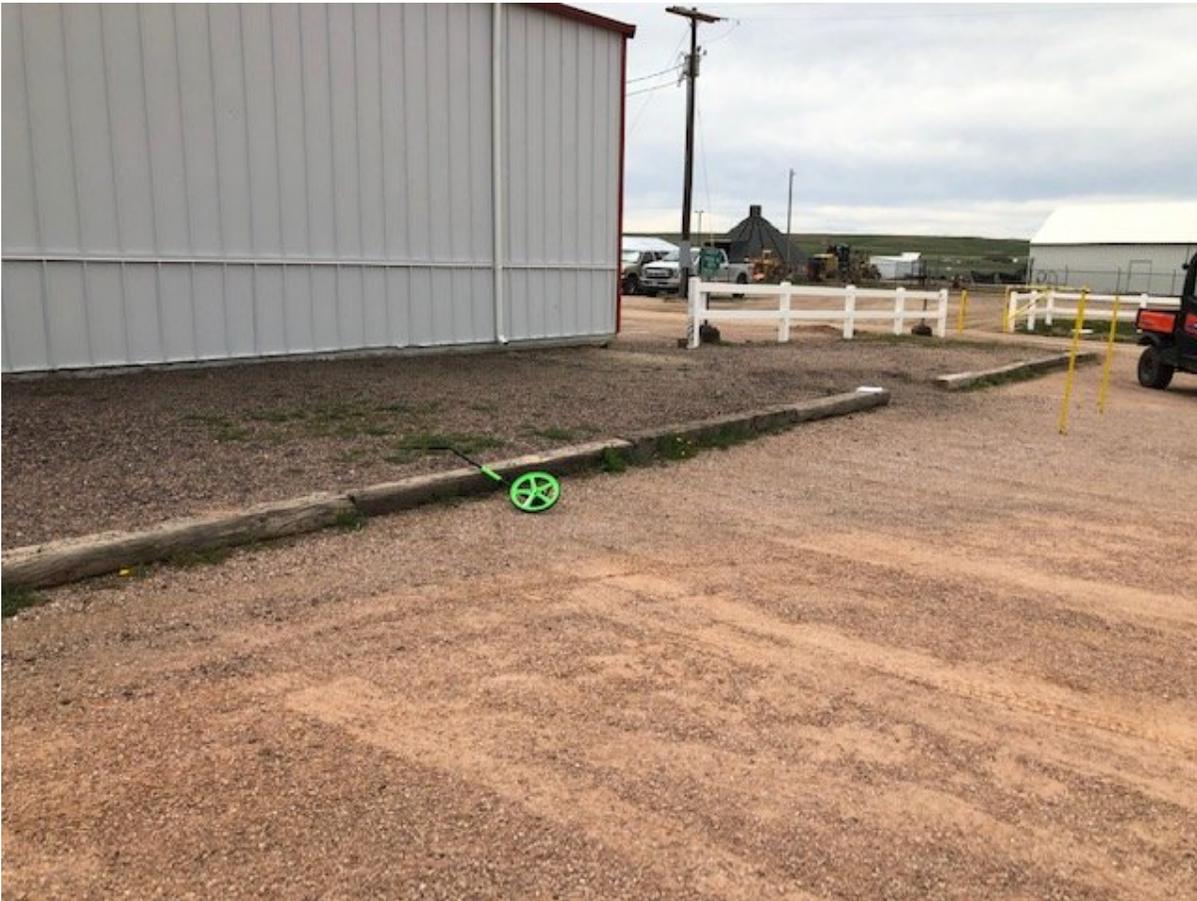
Finding 297090 Main Photo

The surfaces of the accessible parking spaces and access aisles are not firm, stable, and slip resistant.

Gravel / loose dirt

Pave and stripe northern parking lot to meet compliance. Parking lot currently is usable but during the annual County Fair event, the parking lot is strictly used for accessible parking only. During this time the parking lot is not compliant and does not meet the 2010 ADA Standards. Due to estimated costs and time frame, parking lot will be earmarked for the upcoming year to be presented to the Board of County Commissioners for budget approval.

Corrective Action: Work order #463379 created on 5/22/19.

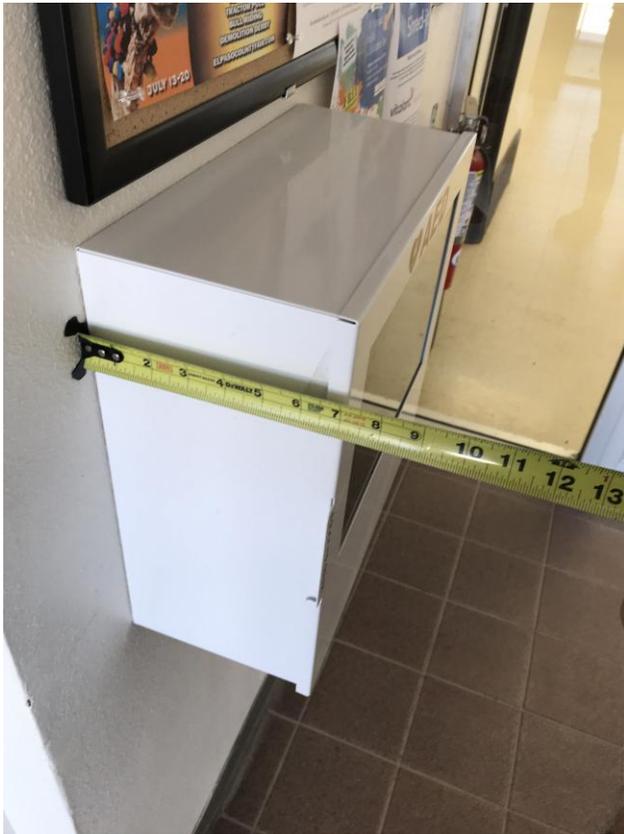
Finding 297876 Main Photo

Wall-mounted objects that have leading edges between 27 inches and 80 inches from the floor must not project more than 4 inches into the circulation path. Protruding objects that extend to the floor or within 27 inches of the floor are cane detectable and are therefore not hazardous. Where it is necessary or desirable to have objects protrude from the wall, a manner of cane detection must be provided.

If possible, replace AED housing with low profile housing or recess housing into wall to meet the 4 inch maximum protrusion or place AED away from circulation path.

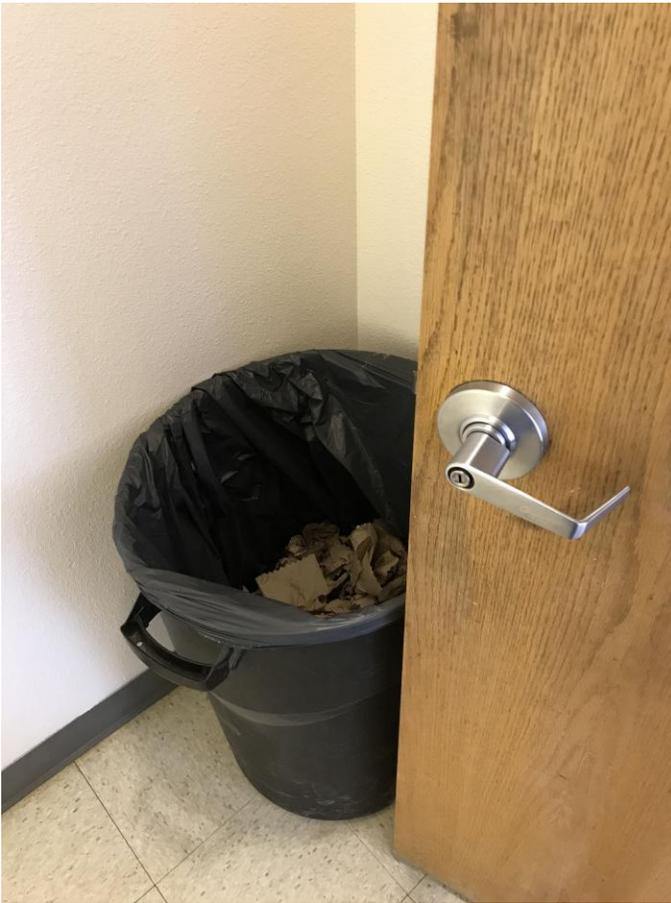
Finding 297881 Main Photo

Citation:	As Built:	Budgeting Range:
2010 ADAS Section: Recommended	Trash can obstructing circulation path into restroom	\$0 - \$0.00

Relocate trash can or replace with low profile trash can that does not obstruct door opening.

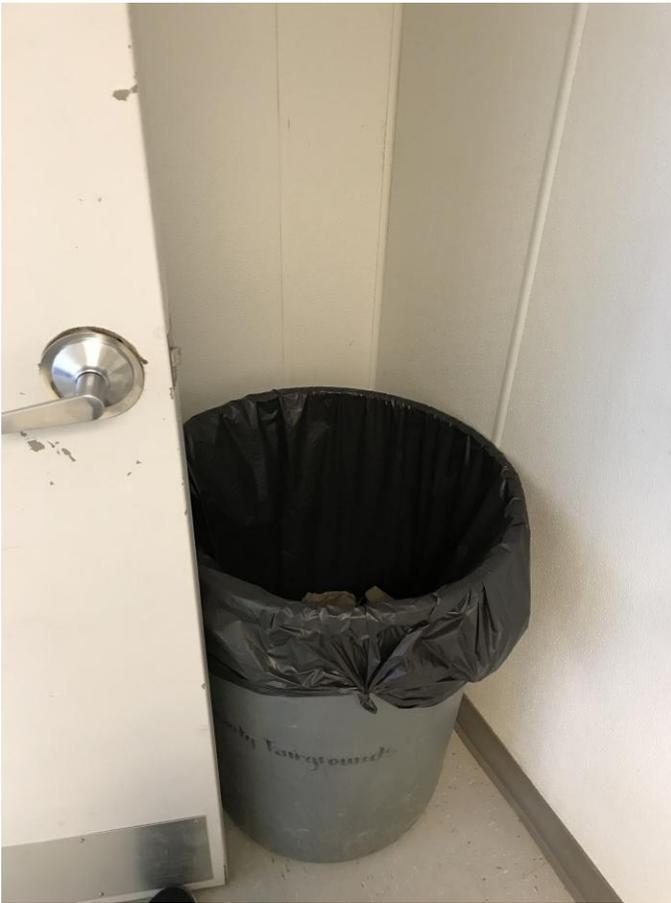
Finding 298010 Main Photo

Citation:	As Built:	Budgeting Range:
2010 ADAS Section: Recommended	Trash can obstructing circulation path into restroom	\$0 - \$0.00

Relocate trash can or replace with low profile trash can that does not obstruct door opening.

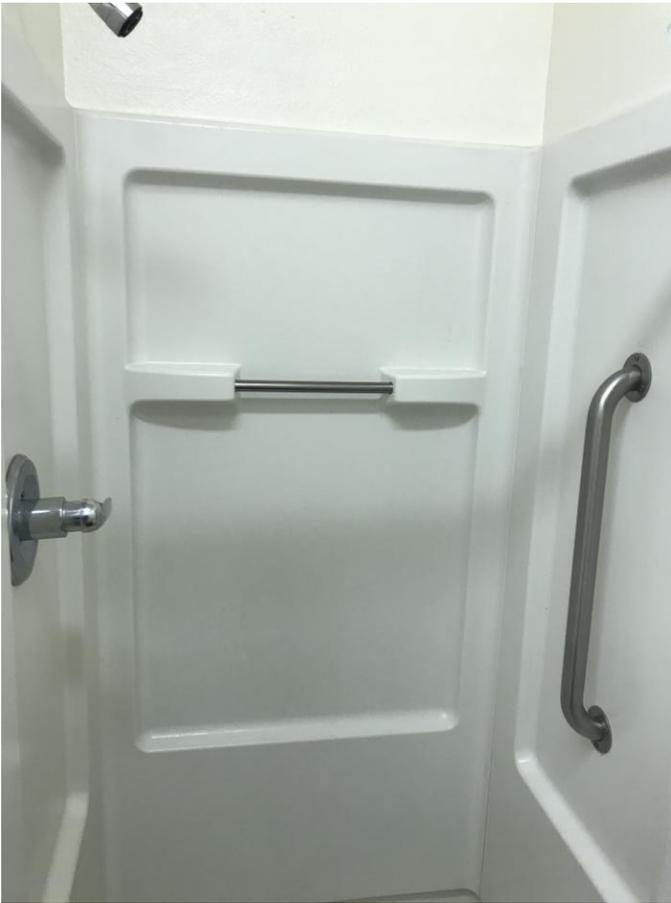
Finding 298073 Main Photo

Missing grab bars,  
shower seat and non  
accessible shower pan
