Site Accessibility Evaluation

Fountain Creek Nature Center

**320 Peppergrass Ln
Fountain, CO 80817**

Accessibility Evaluation

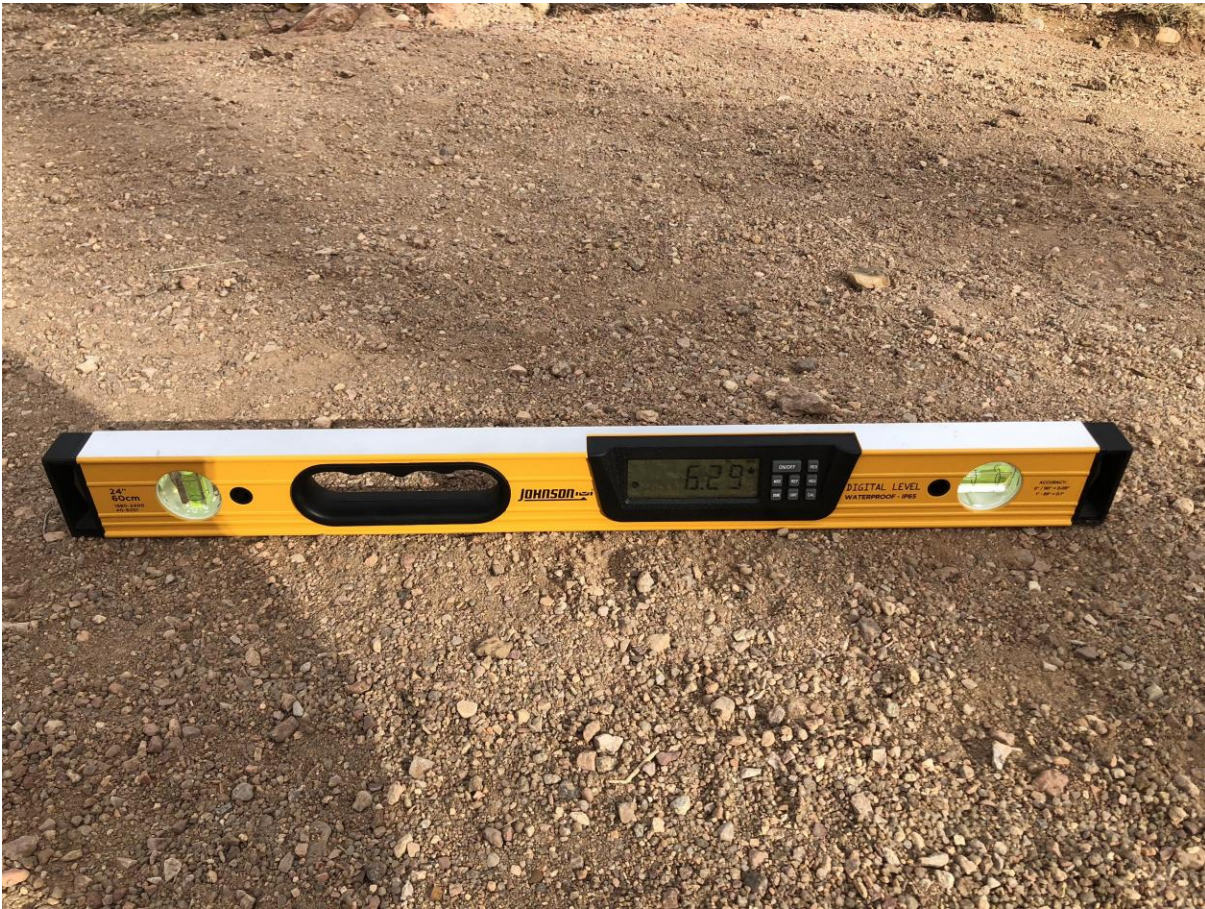
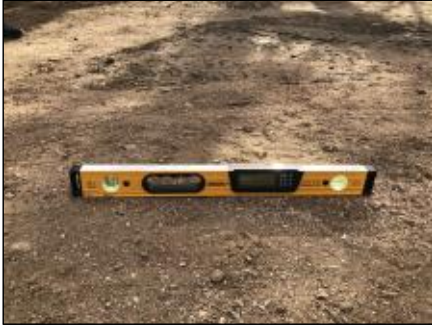
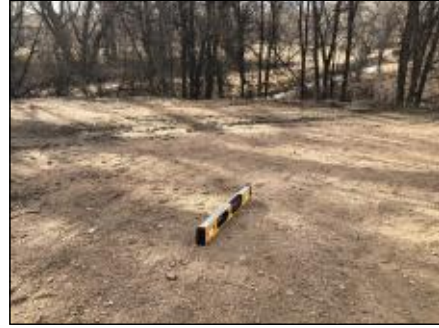
Finding #1 Additional Finding Photos

Finding: 1

The running slope of the surface of the trail is too steep and no resting intervals exist of at least 5ft x 5ft.

Trail running slope varies from 6.29% to 16.02%

Re-engineer southern trailhead to try and meet ABA standards to the extent feasible. Grading will be required but some portions of the southern trail will probably not be at 100% compliance.

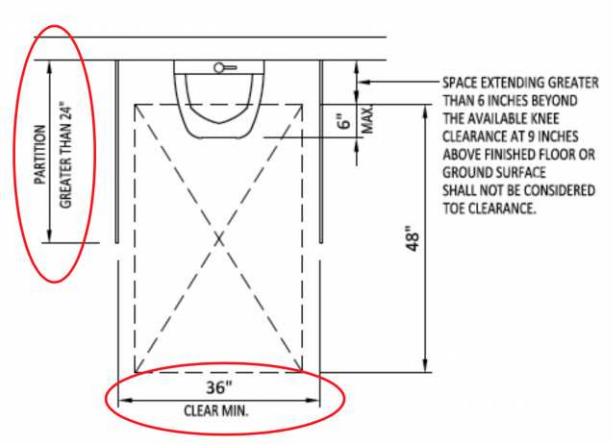
Finding #3 Continued

The urinal is confined on three sides (alcove).

Forward approach
measures 31 inches

Due to limited space and placement/protrusion of the changing table into the minimum required cleared floor space for a forward approach, the required 36 inches may not be met. Recommend reconfiguration if and when renovation/remodel is performed to meet compliance.

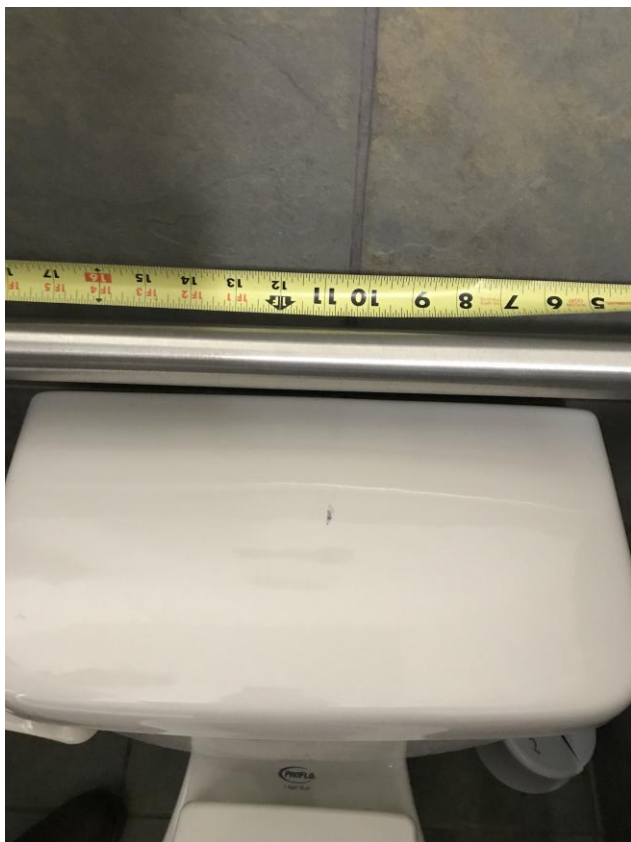
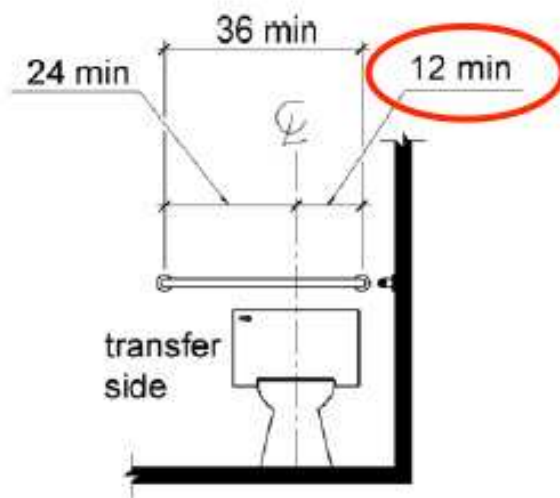
Finding #4 Continued

The rear grab bar does not extend adequately past the centerline of the toilet on the wall side.

10.5 inches from
centerline of toilet

Re-position rear grab bar to extend 12 inches minimum on wall side and 24 inches minimum on the transfer side measured from the centerline of the toilet.

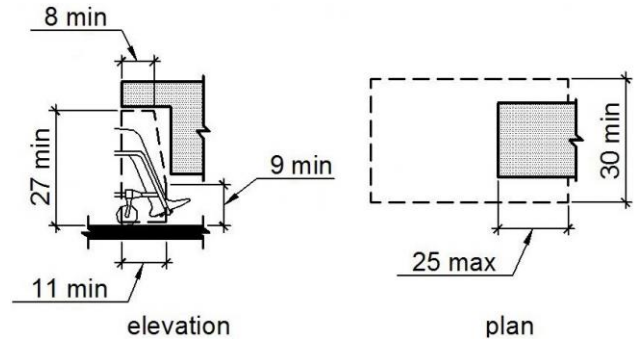
Finding #5 Continued

The knee clearance not compliant.

26.5 inches above
finished floor

Lower baby changing station to meet the 27 inches minimum required under an element for knee clearance, 28 inches minimum to 34 inches maximum to the top of the table surface and 48 inches maximum height to operable part measured from the finished floor.

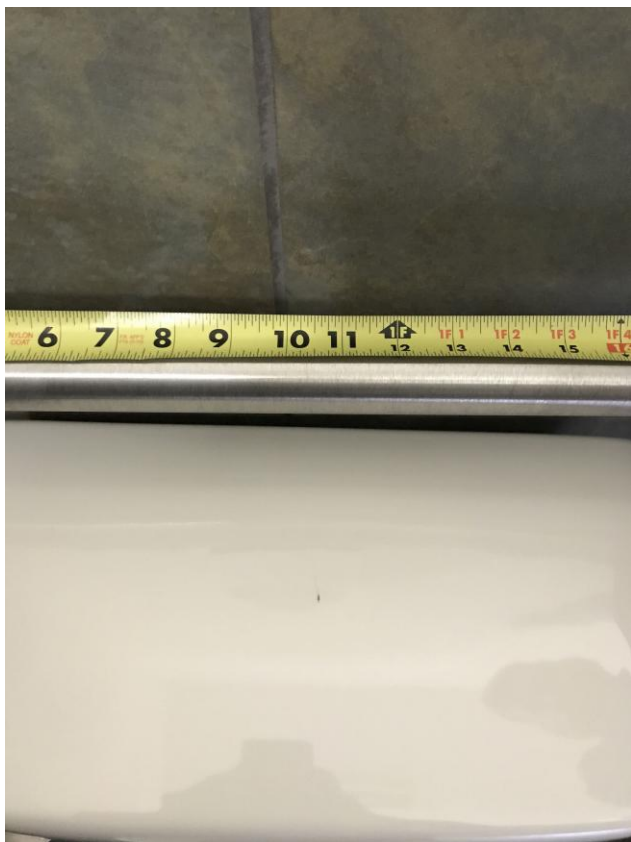
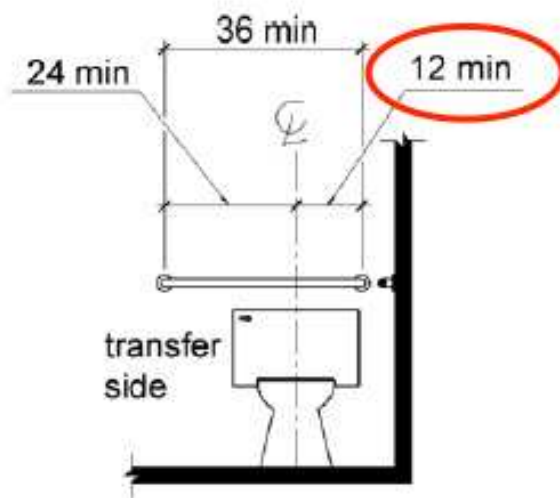
Finding #6 Continued

The rear grab bar does not extend adequately past the centerline of the toilet on the wall side.

10.5 inches from
centerline of toilet

Re-position rear grab bar to extend from the centerline of the toilet 12 inches minimum to the wall side and 24 inches minimum to the transfer/open side.

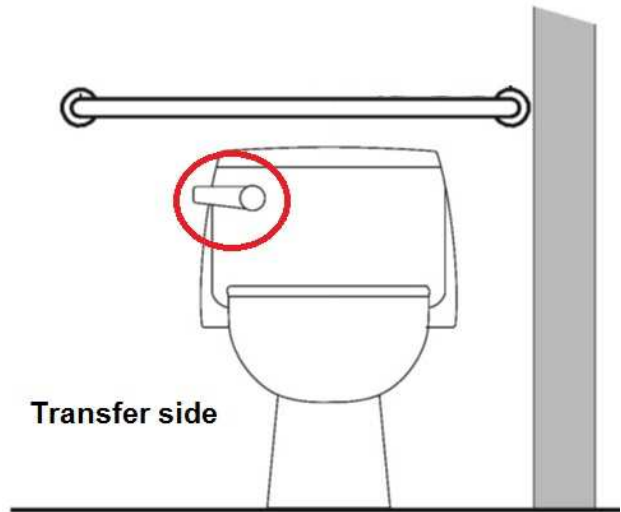
Finding #7 Continued

The flush handle is located on the wrong side of the toilet.

Flush handle located
on the closed side

Replace toilet water tank with one that has flush handle on the opposite side (open side of toilet area).
