Site Accessibility Evaluation

Americans with Disabilities Act Title II (Public Services: State and Local Government)

Sahwatch Parking Garage

Accessibility Evaluation

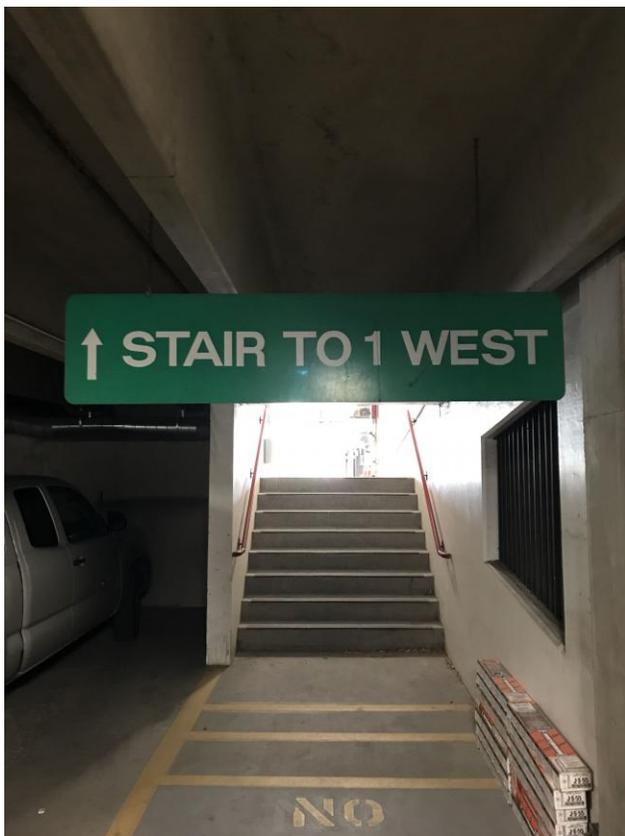
Finding 297987 Main Photo

The “Stair to 1 West” overhanging sign extends down too close to the route of travel.

75.5 inches above
finished floor

3 (Moderate): Should be completed as soon as possible, but there may be other items that will provide greater access to persons with disabilities. (Includes; Findings that have a high financial impact on the entity in relationship to the degree of access provided)

Adjust overhanging sign to provide a minimum of 80 inches above the walking surface measured from the bottom edge of the sign.

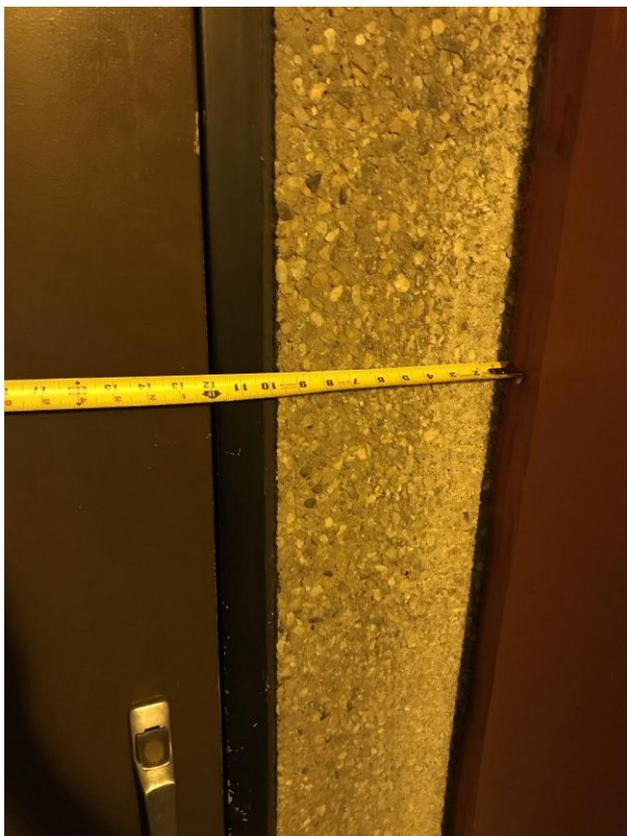
Finding 297988 Main Photo

The maneuvering space on the pull side of the door or gate does not adequately extend beyond the latch side of the door.

Citation:	As Built:	Budgeting Range:
2010 ADAS Section: 404.2.4.1	12 inches of maneuvering space on the pull side	\$2,500 - \$2,765.00

3 (Moderate): Should be completed as soon as possible, but there may be other items that will provide greater access to persons with disabilities. (Includes; Findings that have a high financial impact on the entity in relationship to the degree of access provided)

Providing the minimum required maneuvering space on the pull side of the door is technically infeasible at this time because existing structural conditions would require removing or altering a load-bearing member that is an essential part of the structural frame; or because other existing physical or site constraints prohibit modification or addition of elements, spaces, or features that are in full and strict compliance with the minimum requirements. Best practice measures are recommended to ensure parking garage is accessible to the maximum extent possible.

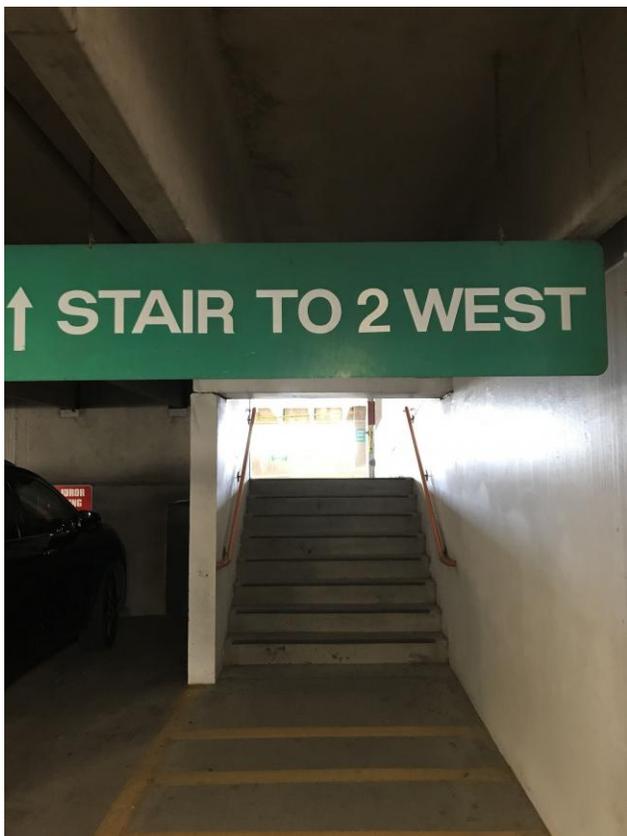
Finding 297996 Main Photo

The “Stair to 2 West” overhanging sign extends down too close to the route of travel.

77 inches above
finished floor

3 (Moderate): Should be completed as soon as possible, but there may be other items that will provide greater access to persons with disabilities. (Includes; Findings that have a high financial impact on the entity in relationship to the degree of access provided)

Adjust overhanging sign to provide a minimum of 80 inches above the walking surface measured from the bottom edge of the sign.

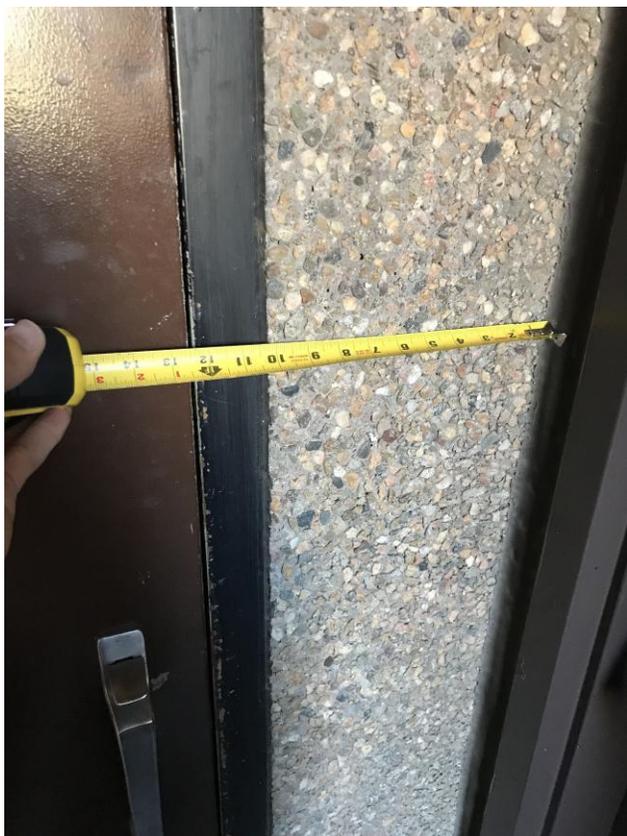
Finding 298015 Main Photo

The maneuvering space on the pull side of the door or gate does not adequately extend beyond the latch side of the door.

Citation:	As Built:	Budgeting Range:
2010 ADAS Section: 404.2.4.1	12 inches of maneuvering space on the pull side	\$2,500 - \$2,765.00

3 (Moderate): Should be completed as soon as possible, but there may be other items that will provide greater access to persons with disabilities. (Includes; Findings that have a high financial impact on the entity in relationship to the degree of access provided)

Providing the minimum required maneuvering space on the pull side of the door is technically infeasible at this time because existing structural conditions would require removing or altering a load-bearing member that is an essential part of the structural frame; or because other existing physical or site constraints prohibit modification or addition of elements, spaces, or features that are in full and strict compliance with the minimum requirements. Best practice measures are recommended to ensure parking garage is accessible to the maximum extent possible.

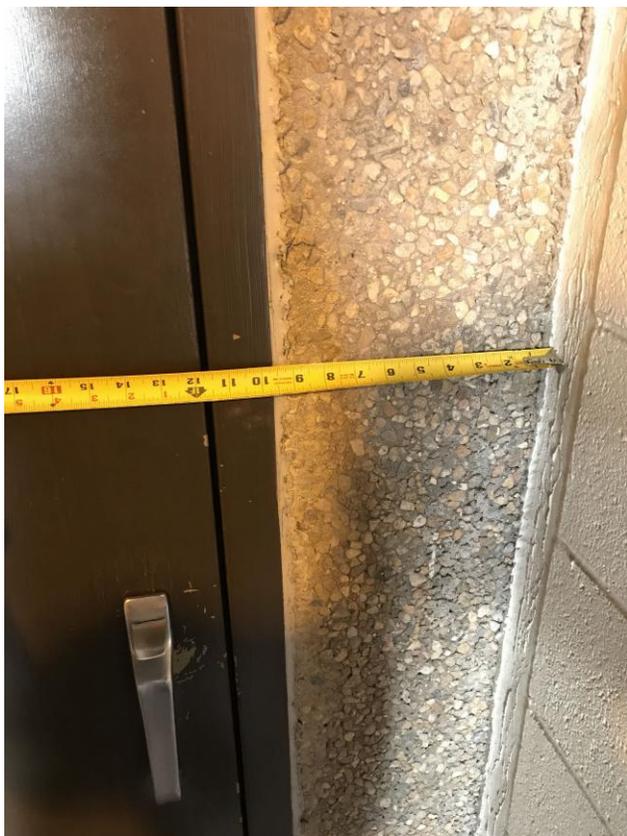
Finding 298020 Main Photo

The maneuvering space on the pull side of the door or gate does not adequately extend beyond the latch side of the door.

Citation:	As Built:	Budgeting Range:
2010 ADAS Section: 404.2.4.1	12 inches of maneuvering space on the pull side	\$2,500 - \$2,765.00

3 (Moderate): Should be completed as soon as possible, but there may be other items that will provide greater access to persons with disabilities. (Includes; Findings that have a high financial impact on the entity in relationship to the degree of access provided)

Providing the minimum required maneuvering space on the pull side of the door is technically infeasible at this time because existing structural conditions would require removing or altering a load-bearing member that is an essential part of the structural frame; or because other existing physical or site constraints prohibit modification or addition of elements, spaces, or features that are in full and strict compliance with the minimum requirements. Best practice measures are recommended to ensure parking garage is accessible to the maximum extent possible.

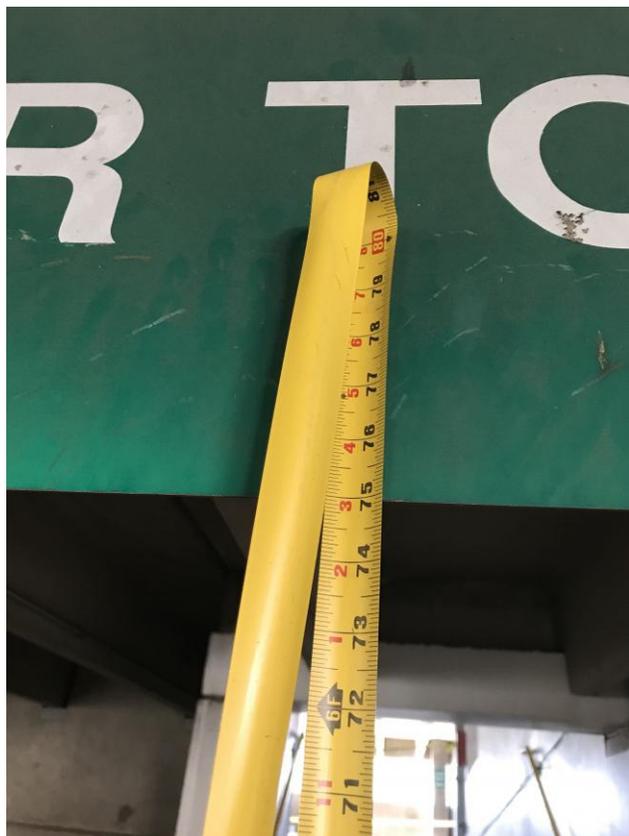
Finding 298025 Main Photo

The "Stair to 3 West" overhanging sign extends down too close to the route of travel.

76 inches above
finished floor

3 (Moderate): Should be completed as soon as possible, but there may be other items that will provide greater access to persons with disabilities. (Includes; Findings that have a high financial impact on the entity in relationship to the degree of access provided)

Adjust overhanging sign to provide a minimum of 80 inches above the walking surface measured from the bottom edge of the sign.

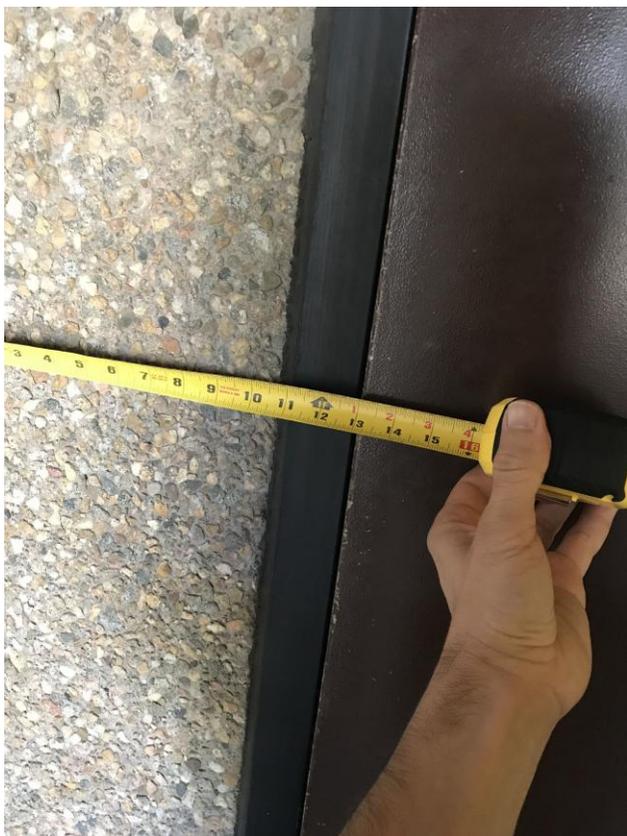
Finding 298026 Main Photo

The maneuvering space on the pull side of the door or gate does not adequately extend beyond the latch side of the door.

Citation:	As Built:	Budgeting Range:
2010 ADAS Section: 404.2.4.1	13 inches of maneuvering space on the pull side	\$2,500 - \$2,765.00

3 (Moderate): Should be completed as soon as possible, but there may be other items that will provide greater access to persons with disabilities. (Includes; Findings that have a high financial impact on the entity in relationship to the degree of access provided)

Providing the minimum required maneuvering space on the pull side of the door is technically infeasible at this time because existing structural conditions would require removing or altering a load-bearing member that is an essential part of the structural frame; or because other existing physical or site constraints prohibit modification or addition of elements, spaces, or features that are in full and strict compliance with the minimum requirements. Best practice measures are recommended to ensure parking garage is accessible to the maximum extent possible.

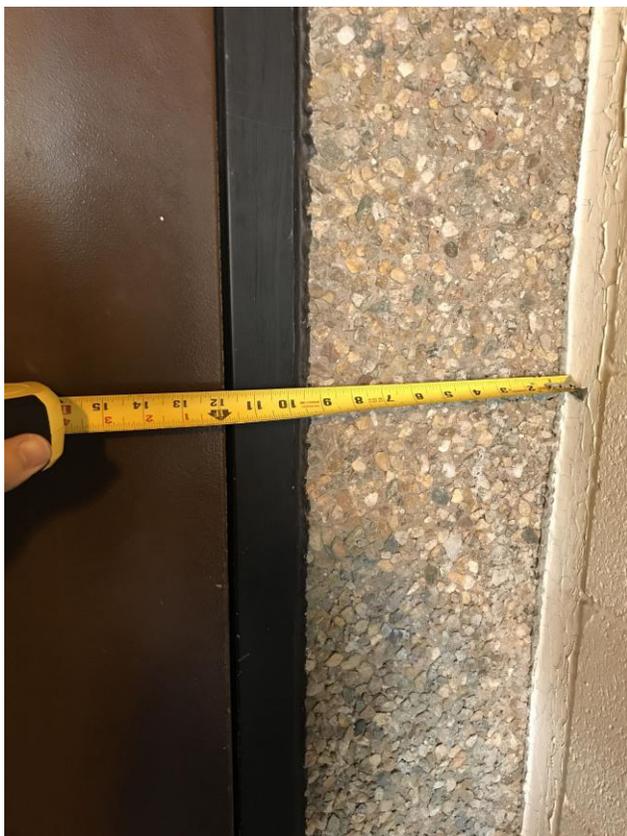
Finding 298030 Main Photo

The maneuvering space on the pull side of the door or gate does not adequately extend beyond the latch side of the door.

Citation:	As Built:	Budgeting Range:
2010 ADAS Section: 404.2.4.1	13 inches of maneuvering space on the pull side	\$2,500 - \$2,765.00

3 (Moderate): Should be completed as soon as possible, but there may be other items that will provide greater access to persons with disabilities. (Includes; Findings that have a high financial impact on the entity in relationship to the degree of access provided)

Providing the minimum required maneuvering space on the pull side of the door is technically infeasible at this time because existing structural conditions would require removing or altering a load-bearing member that is an essential part of the structural frame; or because other existing physical or site constraints prohibit modification or addition of elements, spaces, or features that are in full and strict compliance with the minimum requirements. Best practice measures are recommended to ensure parking garage is accessible to the maximum extent possible.

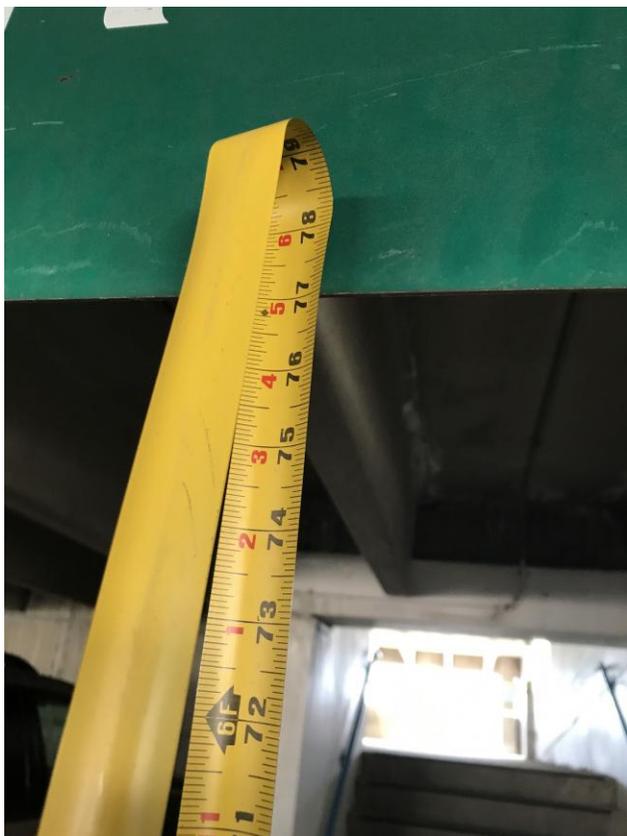
Finding 298035 Main Photo

The “Stair to 4 West” overhanging sign extends down too close to the route of travel.

76 inches above
finished floor

3 (Moderate): Should be completed as soon as possible, but there may be other items that will provide greater access to persons with disabilities. (Includes; Findings that have a high financial impact on the entity in relationship to the degree of access provided)

Adjust overhanging sign to provide a minimum of 80 inches above the walking surface measured from the bottom edge of the sign.

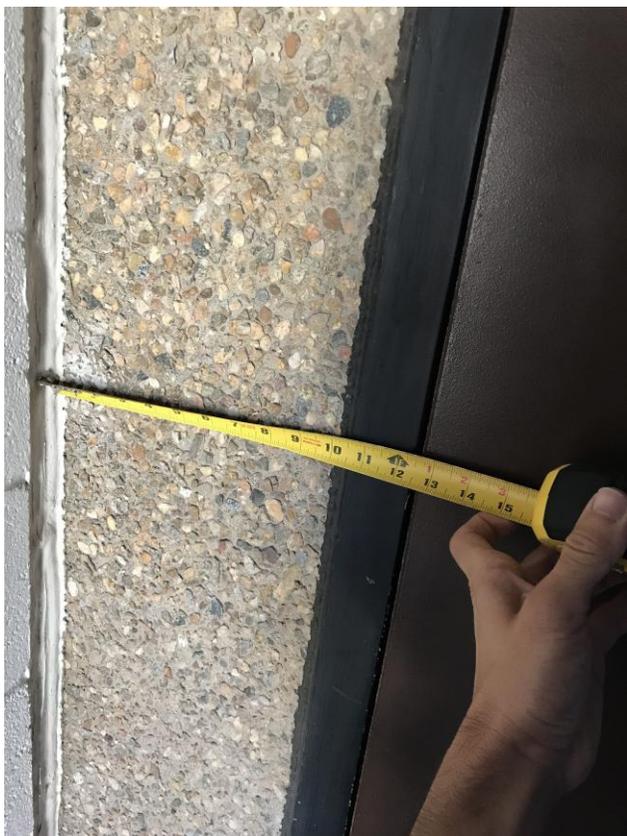
Finding 298036 Main Photo

The maneuvering space on the pull side of the door or gate does not adequately extend beyond the latch side of the door.

Citation:	As Built:	Budgeting Range:
2010 ADAS Section: 404.2.4.1	12.5 inches of maneuvering space on the pull side	\$2,500 - \$2,765.00

3 (Moderate): Should be completed as soon as possible, but there may be other items that will provide greater access to persons with disabilities. (Includes; Findings that have a high financial impact on the entity in relationship to the degree of access provided)

Providing the minimum required maneuvering space on the pull side of the door is technically infeasible at this time because existing structural conditions would require removing or altering a load-bearing member that is an essential part of the structural frame; or because other existing physical or site constraints prohibit modification or addition of elements, spaces, or features that are in full and strict compliance with the minimum requirements. Best practice measures are recommended to ensure parking garage is accessible to the maximum extent possible.

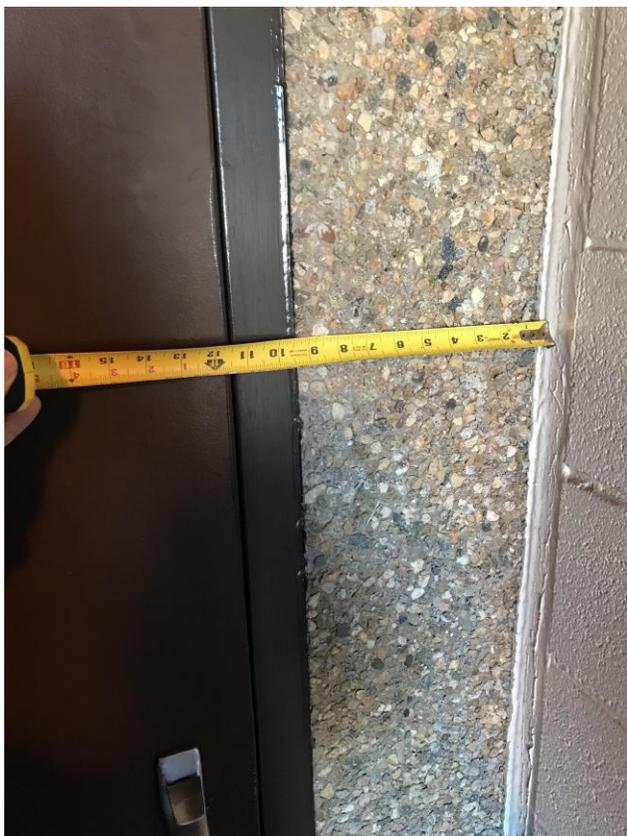
Finding 298041 Main Photo

The maneuvering space on the pull side of the door or gate does not adequately extend beyond the latch side of the door.

Citation:	As Built:	Budgeting Range:
2010 ADAS Section: 404.2.4.1	11.5 inches of maneuvering space on the pull side	\$2,500 - \$2,765.00

3 (Moderate): Should be completed as soon as possible, but there may be other items that will provide greater access to persons with disabilities. (Includes; Findings that have a high financial impact on the entity in relationship to the degree of access provided)

Providing the minimum required maneuvering space on the pull side of the door is technically infeasible at this time because existing structural conditions would require removing or altering a load-bearing member that is an essential part of the structural frame; or because other existing physical or site constraints prohibit modification or addition of elements, spaces, or features that are in full and strict compliance with the minimum requirements. Best practice measures are recommended to ensure parking garage is accessible to the maximum extent possible.

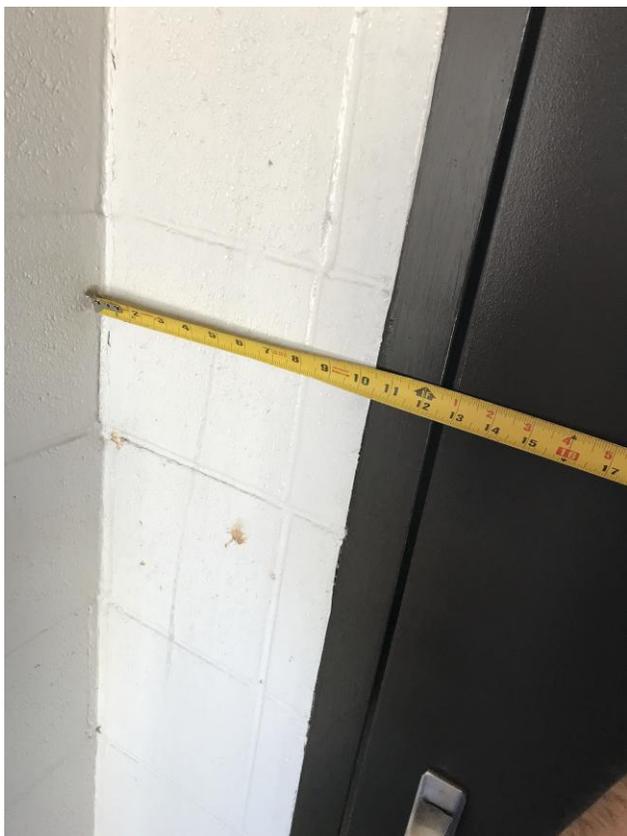
Finding 298046 Main Photo

The maneuvering space on the pull side of the door or gate does not adequately extend beyond the latch side of the door.

Citation:	As Built:	Budgeting Range:
2010 ADAS Section: 404.2.4.1	12.5 inches of maneuvering space on the pull side	\$2,500 - \$2,765.00

3 (Moderate): Should be completed as soon as possible, but there may be other items that will provide greater access to persons with disabilities. (Includes; Findings that have a high financial impact on the entity in relationship to the degree of access provided)

Providing the minimum required maneuvering space on the pull side of the door is technically infeasible at this time because existing structural conditions would require removing or altering a load-bearing member that is an essential part of the structural frame; or because other existing physical or site constraints prohibit modification or addition of elements, spaces, or features that are in full and strict compliance with the minimum requirements. Best practice measures are recommended to ensure parking garage is accessible to the maximum extent possible.

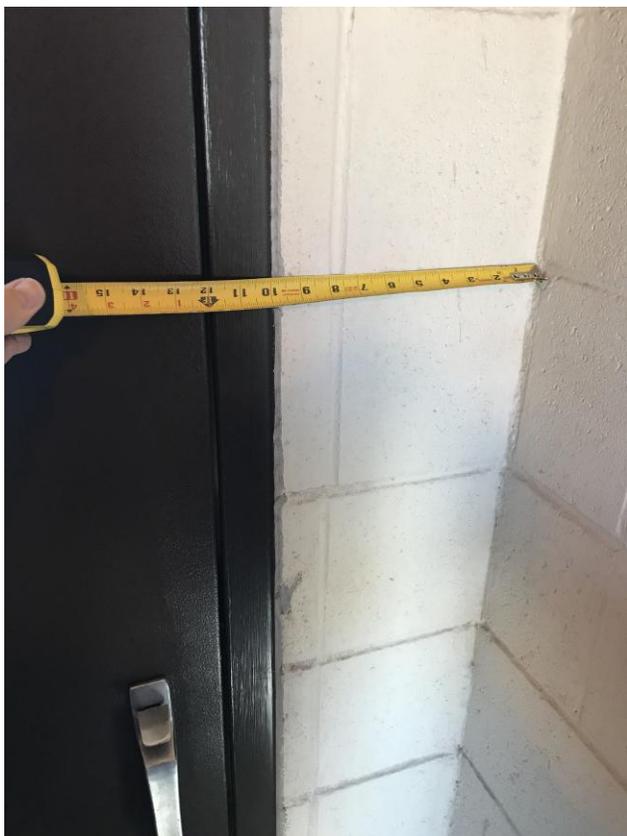
Finding 298053 Main Photo

The maneuvering space on the pull side of the door or gate does not adequately extend beyond the latch side of the door.

Citation:	As Built:	Budgeting Range:
2010 ADAS Section: 404.2.4.1	12 inches of maneuvering space on the pull side	\$2,500 - \$2,765.00

3 (Moderate): Should be completed as soon as possible, but there may be other items that will provide greater access to persons with disabilities. (Includes; Findings that have a high financial impact on the entity in relationship to the degree of access provided)

Providing the minimum required maneuvering space on the pull side of the door is technically infeasible at this time because existing structural conditions would require removing or altering a load-bearing member that is an essential part of the structural frame; or because other existing physical or site constraints prohibit modification or addition of elements, spaces, or features that are in full and strict compliance with the minimum requirements. Best practice measures are recommended to ensure parking garage is accessible to the maximum extent possible.
