# Site Accessibility Evaluation

## Americans with Disabilities Act Title II (Public Services: State and Local Government)

### **Bear Creek Nature Center**

**Accessibility Evaluation**

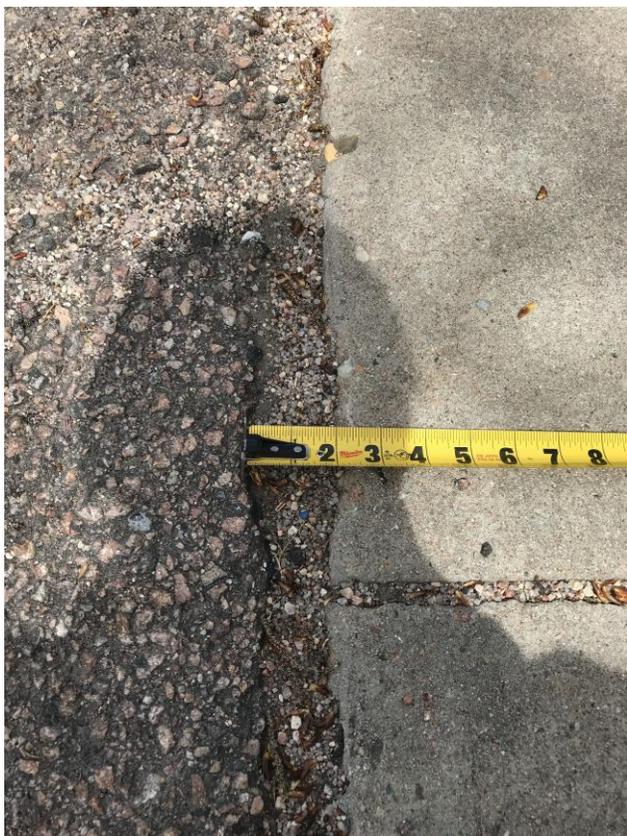
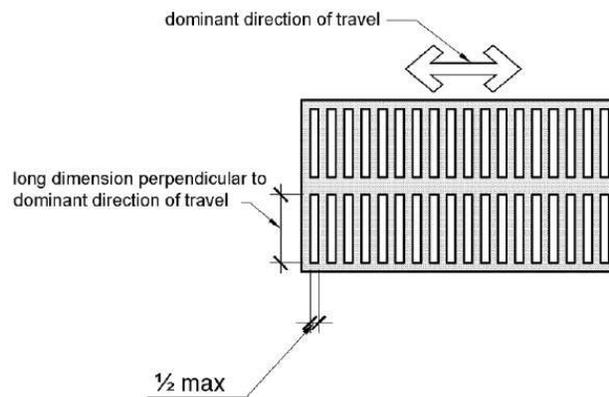
Finding 299242 Main Photo

The concrete expansion joint is spaced greater than 1/2 inch.

Citation:	As Built:	Budgeting Range:
2010 ADAS Section: 302.3	Expansion joint 2 inches in width	\$1,500 - \$4,500.00

Crack fill expansion joints to ensure an opening no more than 1/2 inch in diameter.

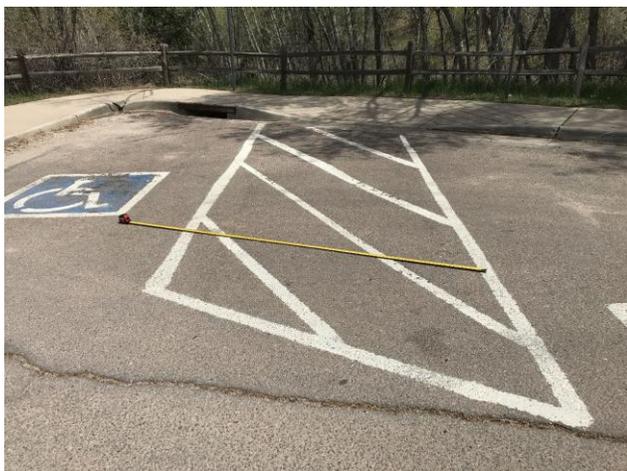
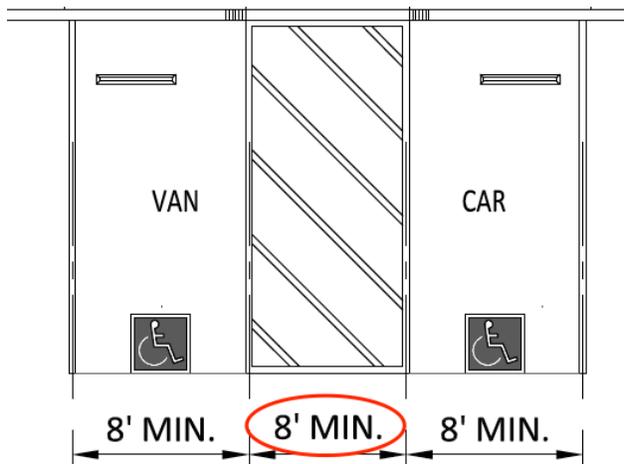
Finding 299243 Main Photo

The access aisle is not a minimum 8 feet to the centerline of the stripe.

7ft 2 inches in width

Re-stripe access aisle and ensure a minimum width of 8 feet measured to the center of the paint stripe.

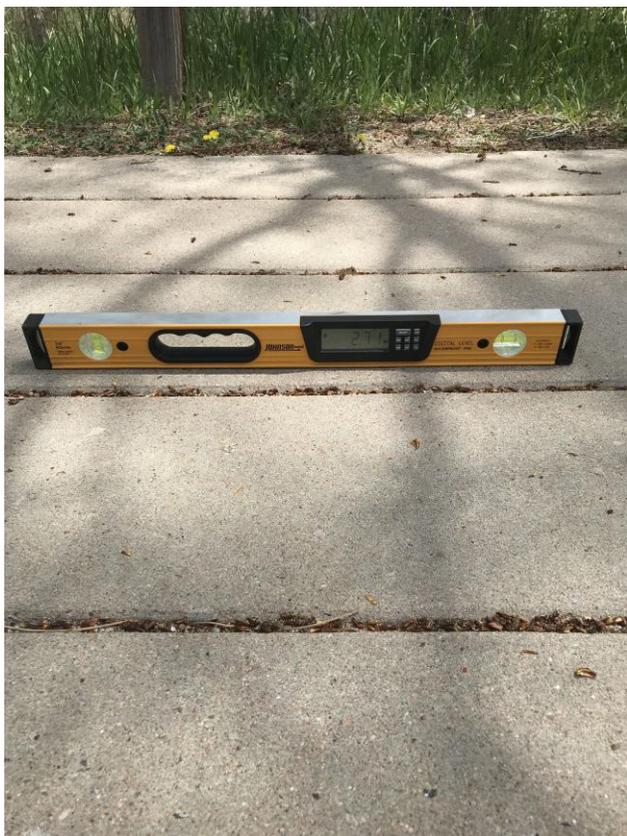
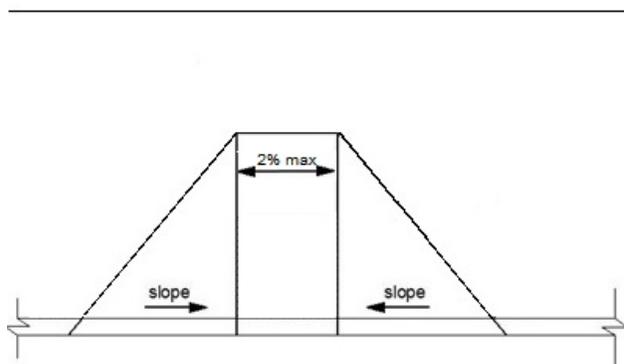
Finding 299244 Main Photo

The curb ramp on the accessible route contains cross slopes greater than 2%.

Curb ramp has 2.71%  
cross slope

During re-construction/remodel, replace existing pedestrian ramp and construct a parallel curb ramp to meet current ADA standards.

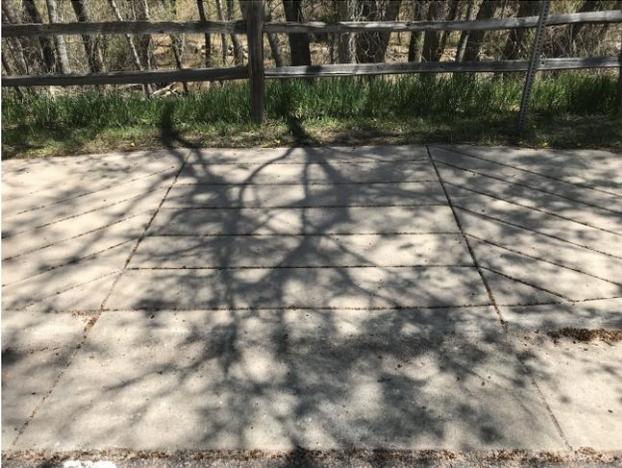
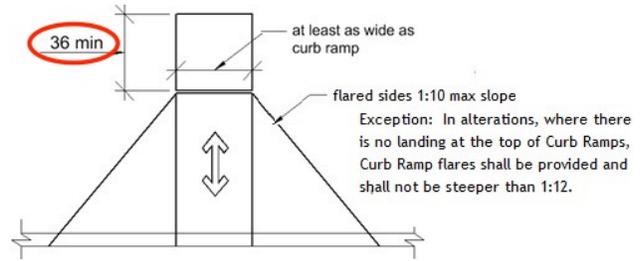
Finding 299245 Main Photo

The top of the curb ramp does not have a level landing.

No level landing exists  
on top of curb ramp

During re-construction/remodel, replace existing pedestrian ramp and construct a parallel curb ramp to meet current ADA standards.

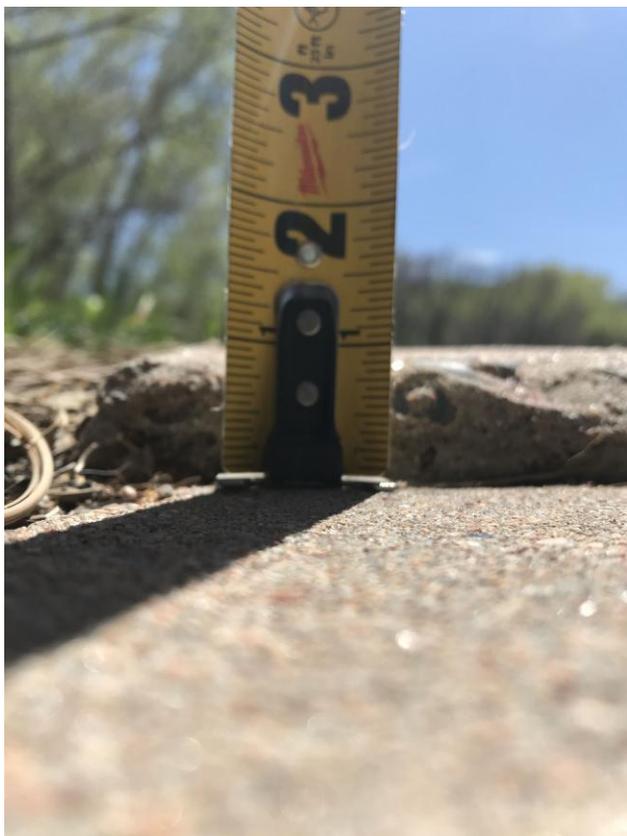
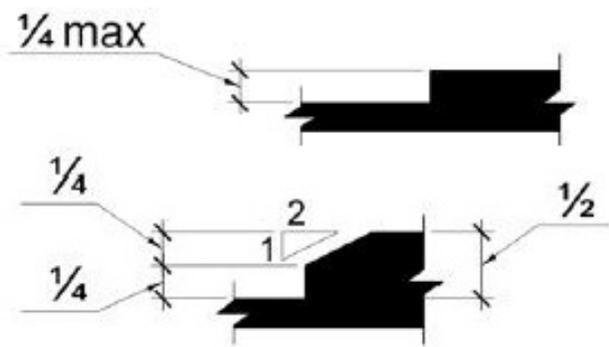
Finding 299246 Main Photo

The walkway contains abrupt vertical edges and/or variations over a 1/4 inch.

Path of travel contains a couple of abrupt vertical changes greater than 1/4 inch

Shave abrupt vertical changes along the walkway/path of travel.

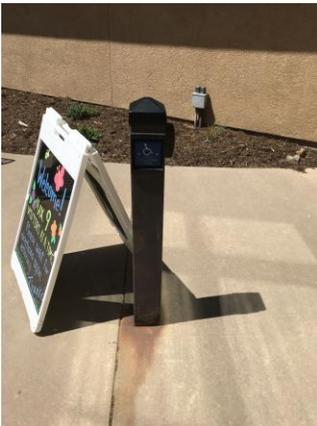
Finding 299247 Main Photo

Push button to main entrance automatic door not operational.

Push button non operational

Replace batteries or replace push button.

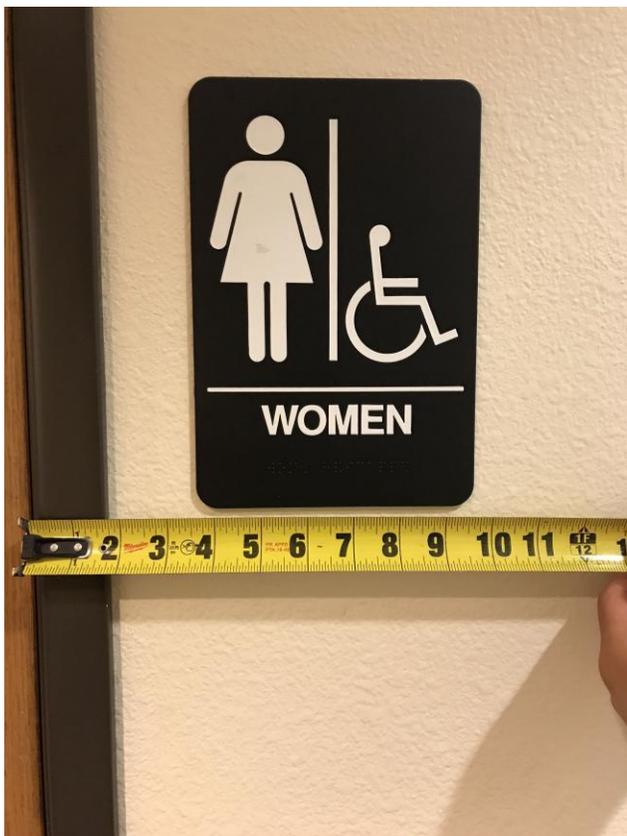
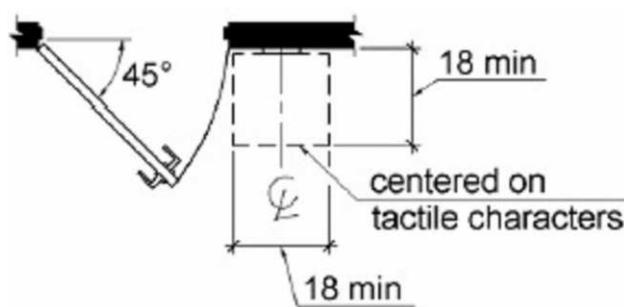
Finding 299248 Main Photo

Clear floor space is not provide at the tactile door sign.

6.5 inches to  
centerline of sign

Reposition restroom sign to 9 inches minimum centerline of tactile sign measured from the edge of door frame opening.

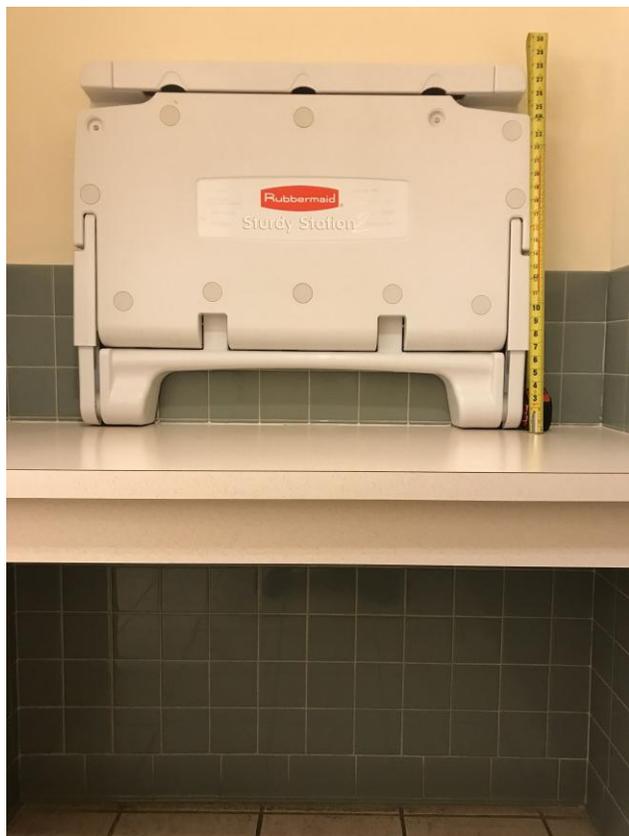
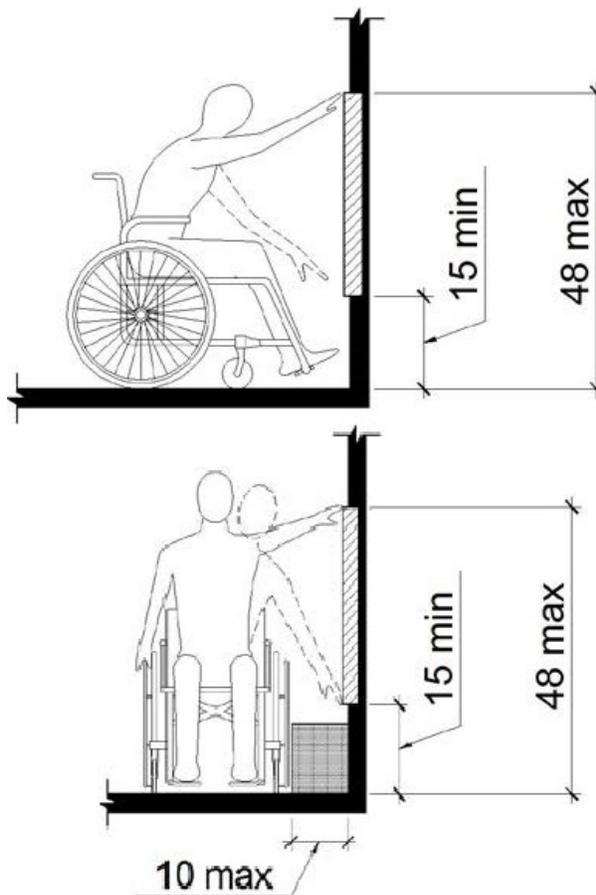
Finding 299249 Main Photo

The baby changing table operating mechanism is outside reach range.

58 inches above finished floor to operable part

If possible, relocate baby changing station to another section/wall and ensure it meets ADA standards. If baby changing station cannot be relocated, remove and use existing table/counter as baby changing station. Existing table/counter meets ADA compliance for knee, toe, height and forward approach clearance.

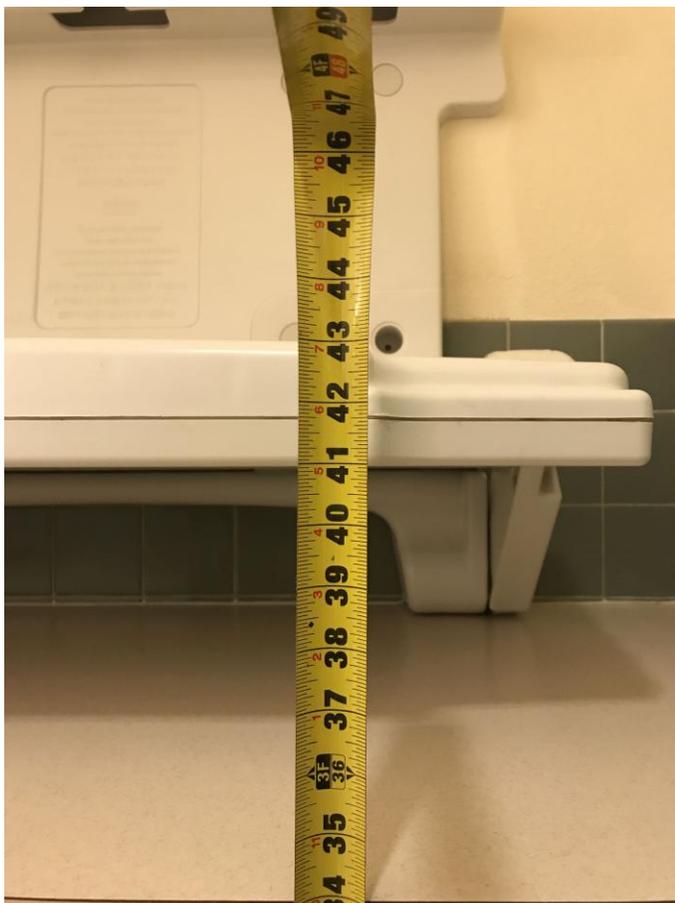
Finding 299250 Main Photo

The baby changing table is too high when folded down.

43 inches above  
finished floor

If possible, relocate baby changing station to another section/wall and ensure it meets ADA standards. If baby changing station cannot be relocated, remove and use existing table/counter as baby changing station. Existing table/counter meets ADA compliance for knee, toe, height and forward approach clearance.

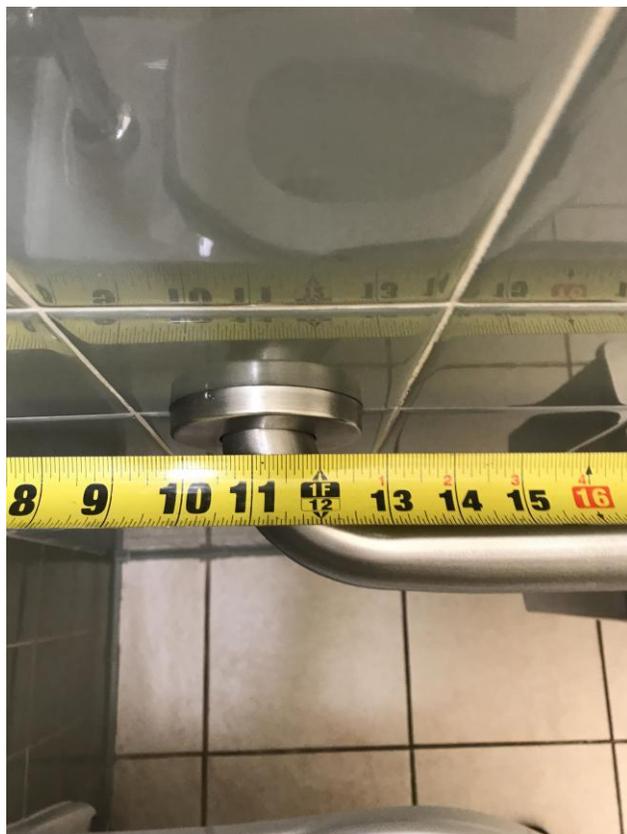
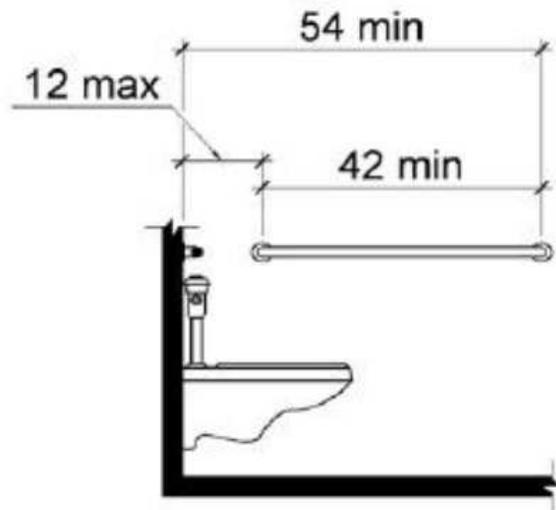
Finding 299251 Main Photo

The side grab bar is located greater than 12 inches from the rear wall.

11.25 inches from rear wall

Adjust side grab bar not to exceed 12 inches from rear wall measured to the centerline of the grab bar. Side grab bar must be 42 inches minimum in length and extend at least 54 inches minimum beyond the rear wall measured to the centerline of the grab bar.

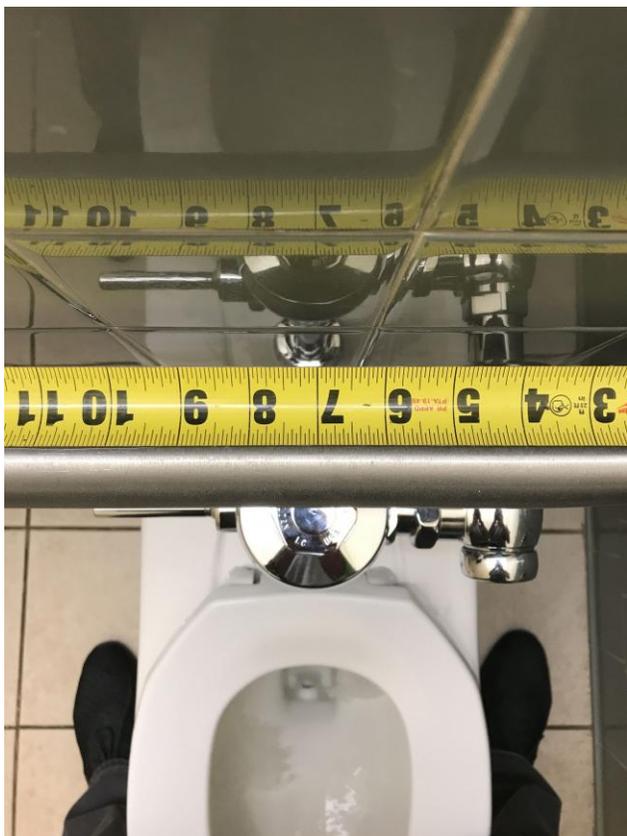
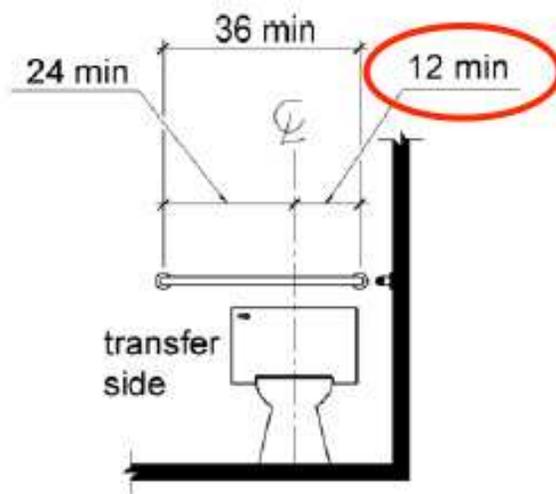
Finding 299252 Main Photo

The rear grab bar does not extend adequately past the centerline of the toilet on the wall side.

7 inches past  
centerline of toilet to  
wall side

Re-position rear grab bar to extend from the centerline of the toilet 12 inches minimum to the wall side and 24 inches minimum to the transfer/open side.

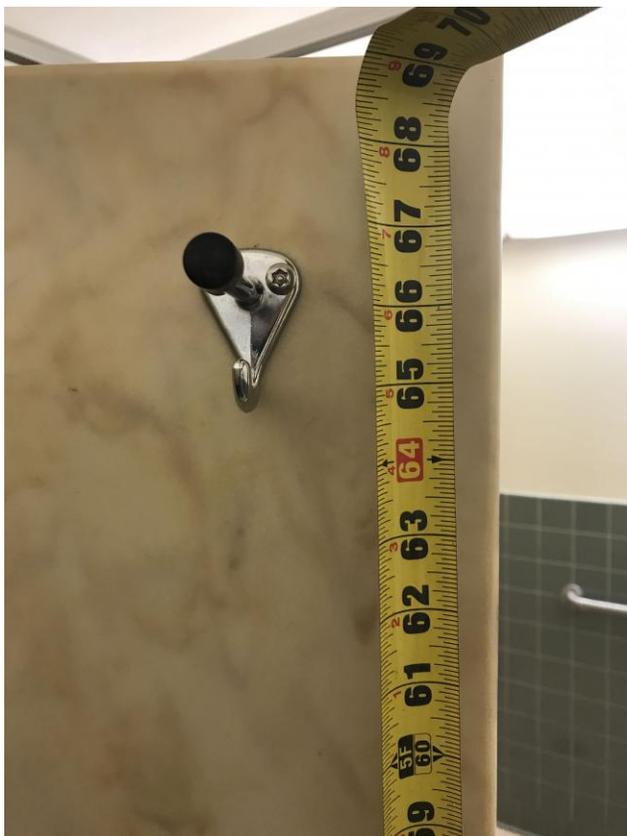
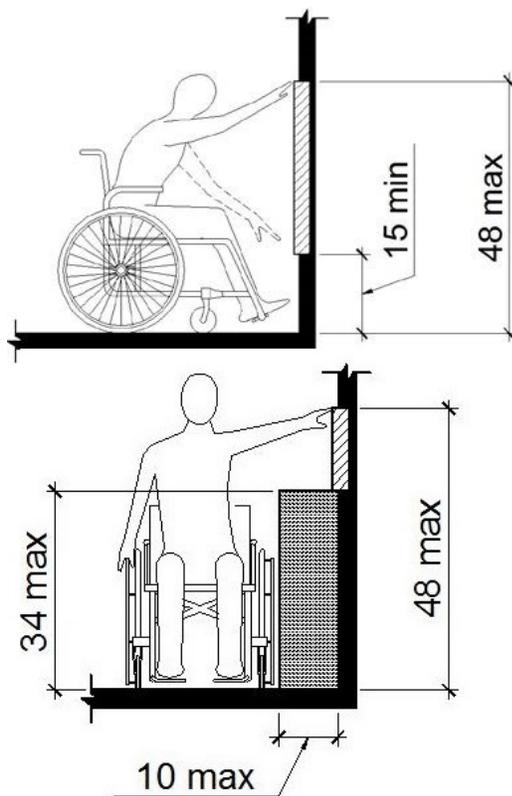
Finding 299253 Main Photo

The coat hook is installed greater than 48 inches above the finished floor.

Coat hook 66.25  
inches above finished  
floor

Lower coat hook 19 inches minimum or install another coat hook not to exceed a maximum height of 48 inches above finished floor.

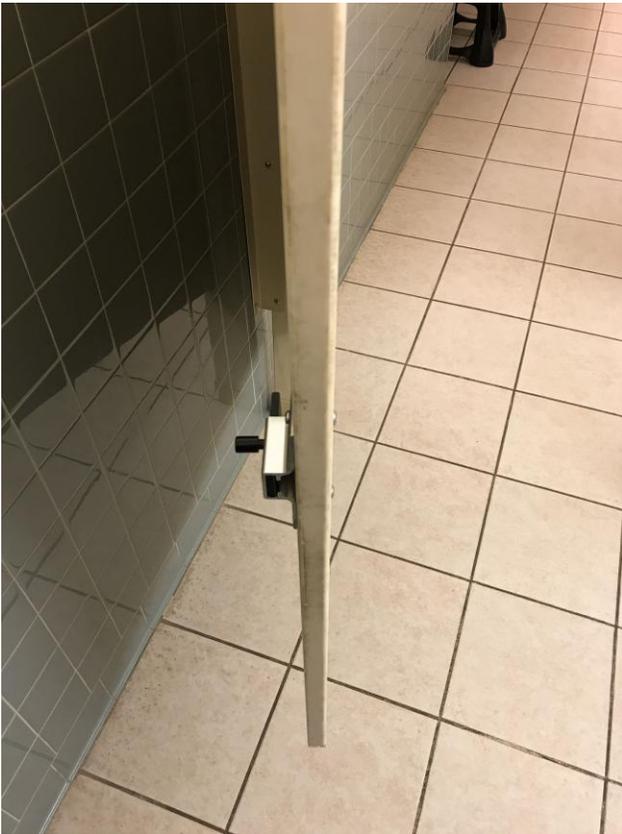
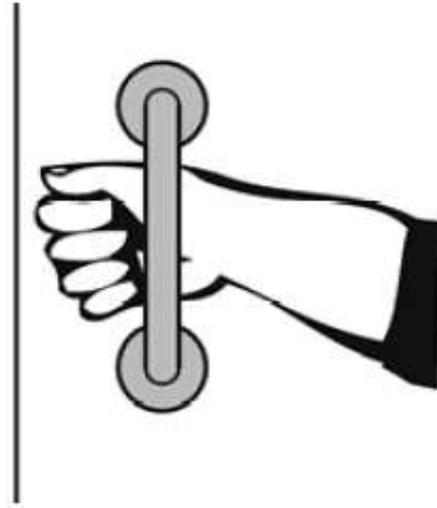
Finding 299254 Main Photo

The water closet compartment door is missing a loop handle.

Compartment door  
missing loop handles

Install loop or U-shape handles on the inside and outside of the compartment door. Between 36 - 40 inches preferred.

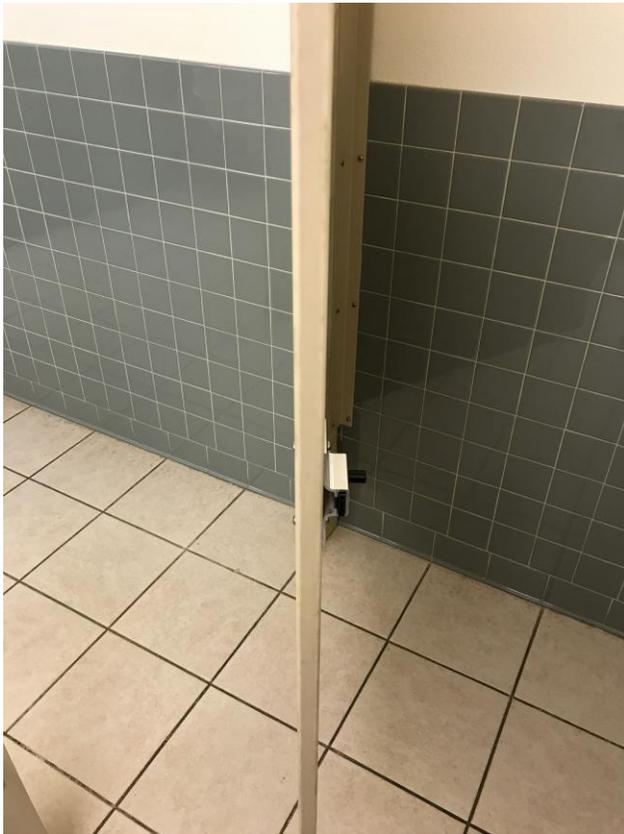
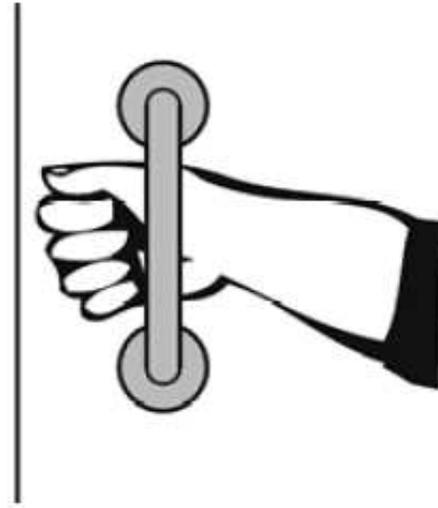
Finding 299262 Main Photo

The water closet compartment door is missing a loop handle.

Compartment door  
missing loop handles
