Site Accessibility Evaluation

Americans with Disabilities Act Title II (Public Services: State and Local Government)

Black Forest Regional Park

Accessibility Evaluation

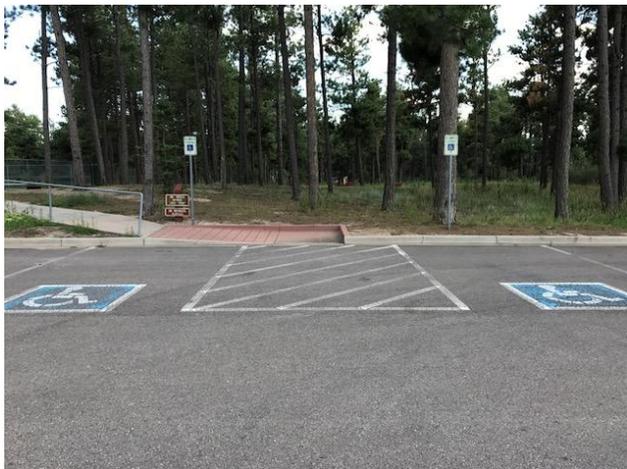
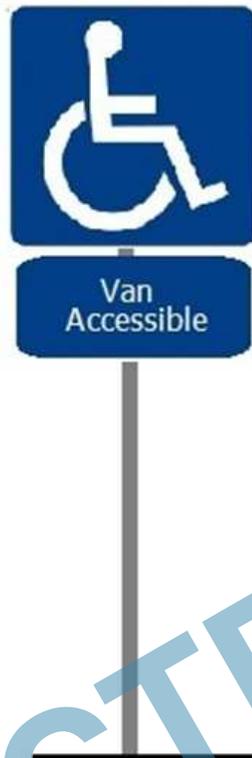
Finding #1 Continued

The van stall is missing a sign identifying it as a van accessible stall.

Van accessible sign
not installed

Add Van Accessible signs (X2) below International Symbol of Accessibility 60 inches minimum above the finish or ground surface measured to the bottom of the sign.

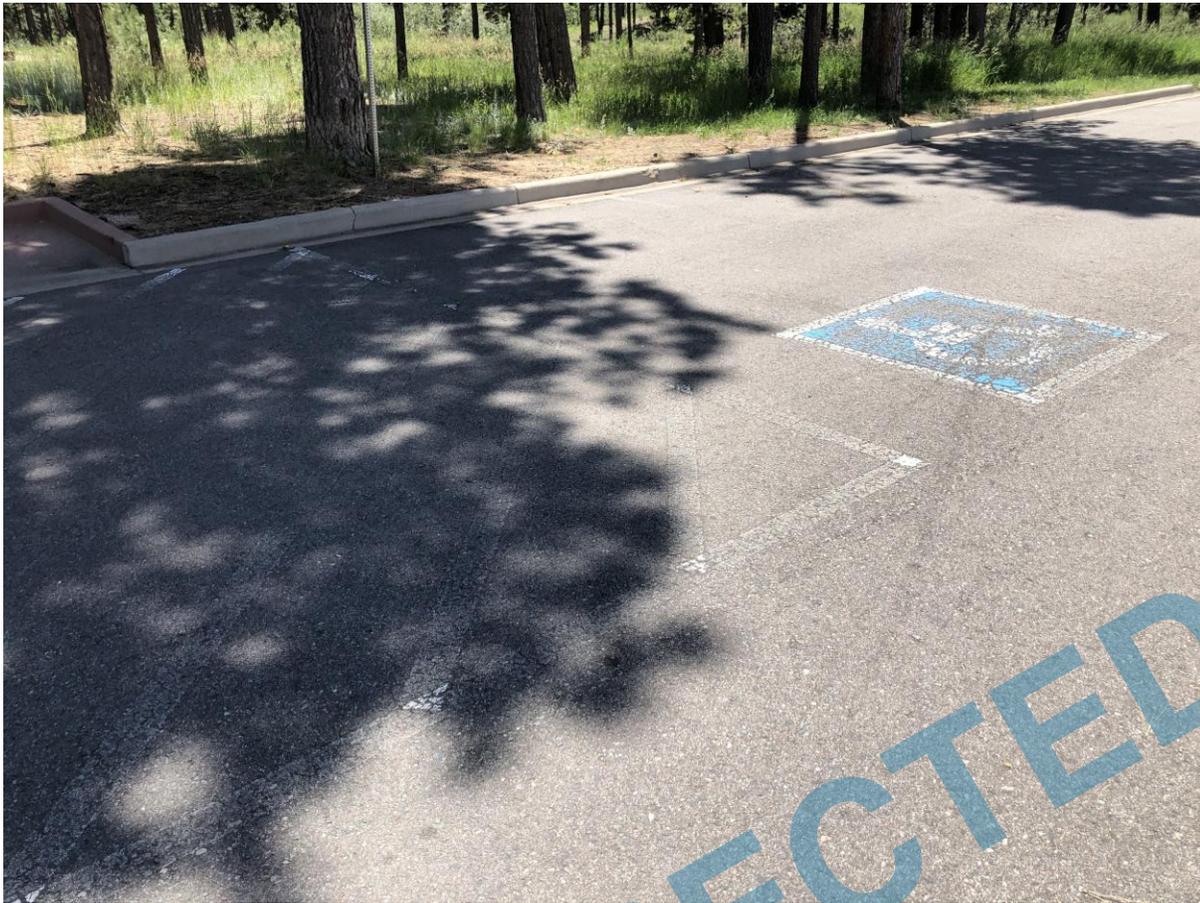
Finding #2 Continued

The striping and markings for the accessible parking stall, access aisle are dilapidated and in need of repair and/or maintenance.

Citation:	As Built:	Budgeting Range:
2010 ADAS Section: 502.3.3	Accessible parking stalls and access aisle striping barely visible	\$300 - \$500.00

Re-stripe 2 van accessible stalls, access aisle and single accessible parking stall. Add International Symbol of Accessibility to single accessible parking stall.

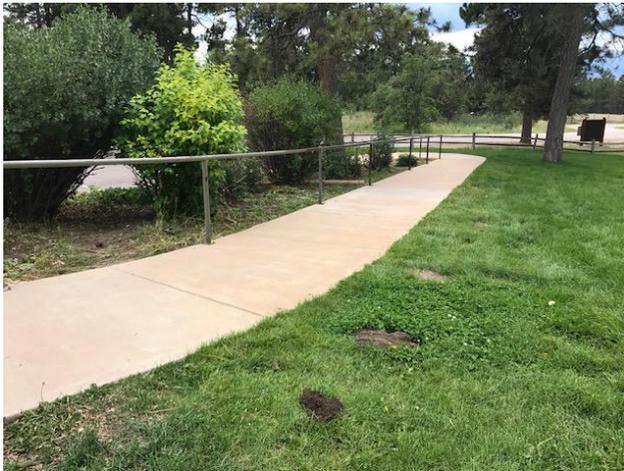
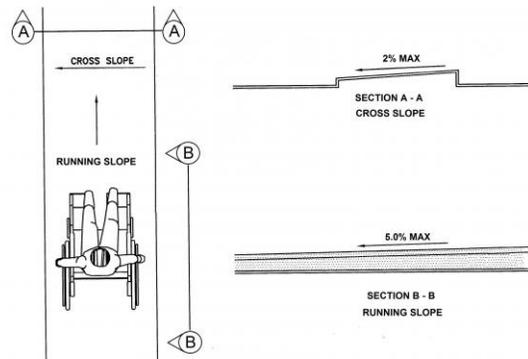
Finding #3 Continued

The accessible route contains running slopes greater than 5 percent and cross slopes greater than 2 percent across the width of the walk and has not been constructed as a ramp (i.e. handrails, wheel guides, etc.).

Running slope ranged from 6.6% to 7.3% //
Cross slope ranged from 2.1% 3.0%

Install handrails on both sides that comply with 505 due to the running slope exceeding the maximum slope allowed (1:20 or 5.0%).

Add level landings at the top and bottom of the ramp run and every 30 feet in between complying with 405.6

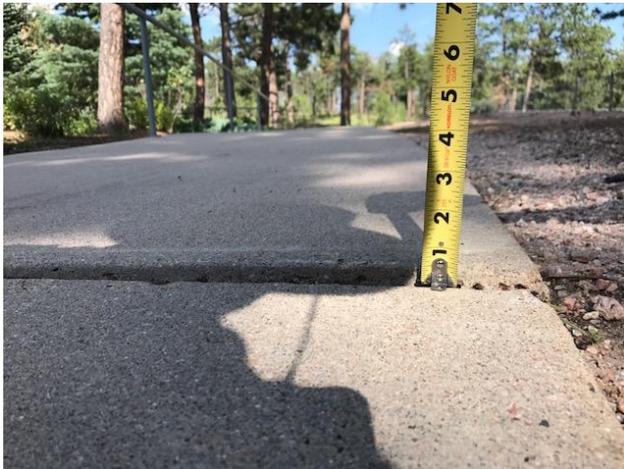
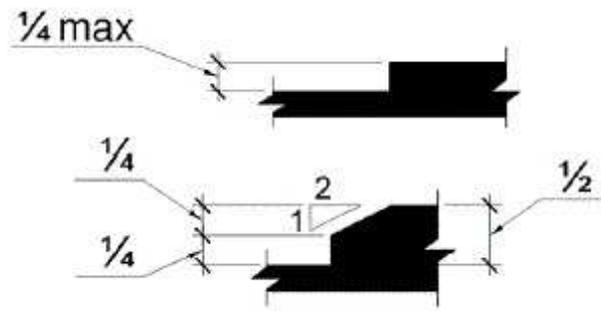
Finding #4 Continued

There is a change in level greater than 1/4 inch.

3/4 inch upheaval

Edge/bevel treatment on access route throughout due to changes in level exceeding the 1/4 in vertical maximum and 1/2 in horizontal separation maximum.

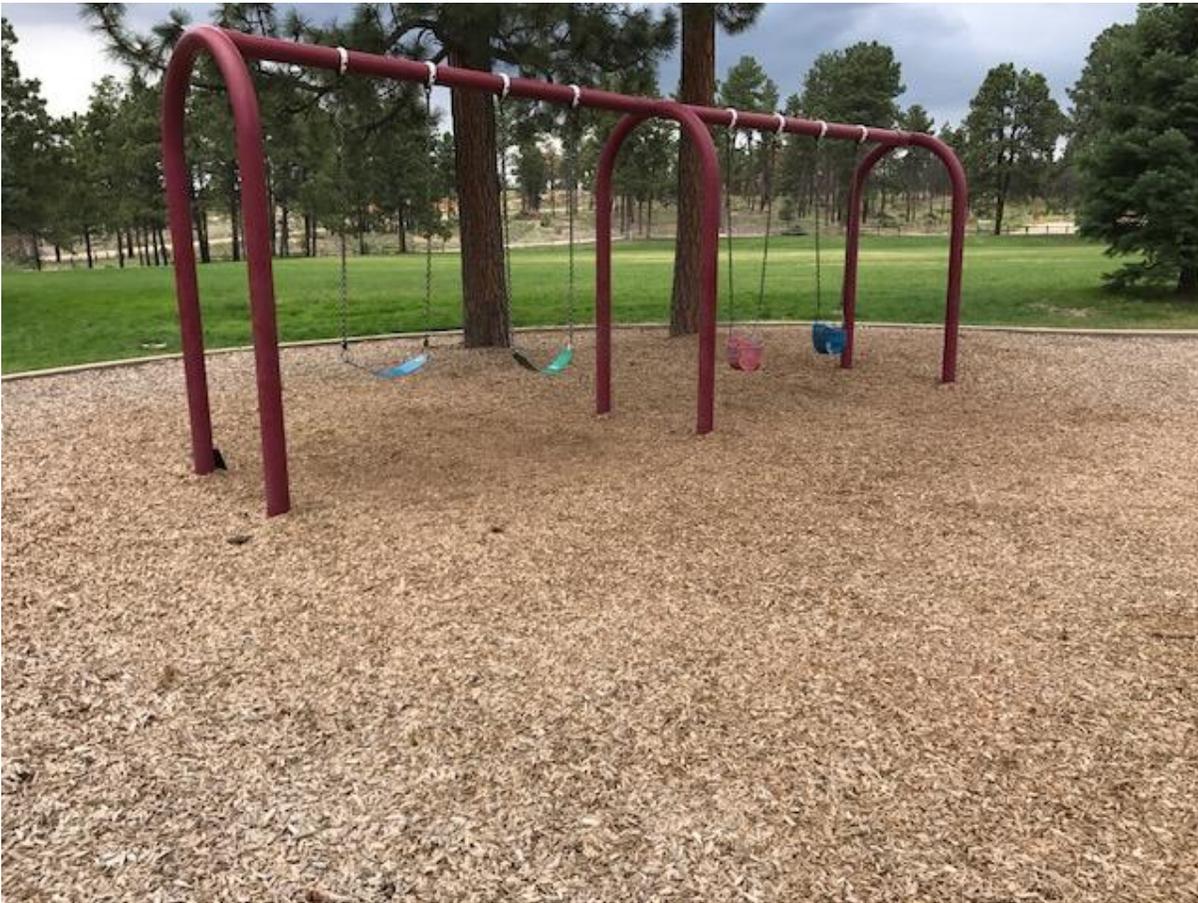
Finding #5 Continued

A minimum of one of each type of ground level play components is not on an accessible route.

Inaccessible ground play component

Make ground level and elevated play components accessible including the entry and exit points of those components by installation of a compliant playground surface.

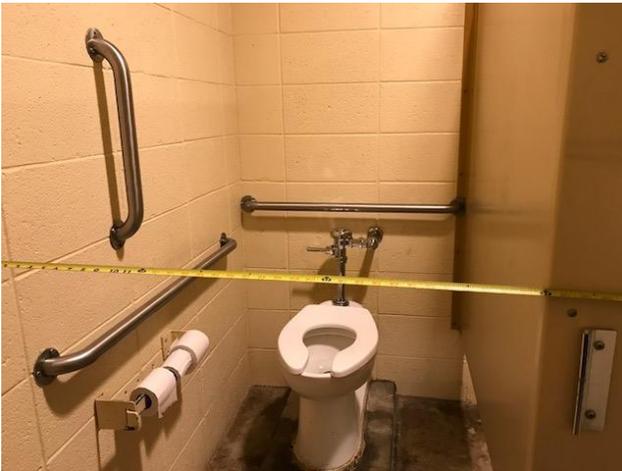
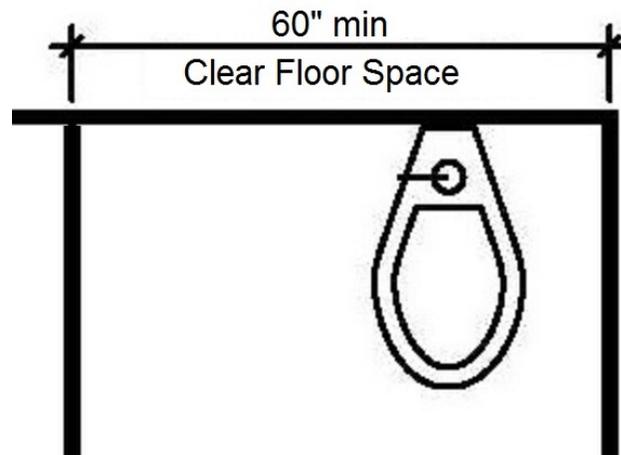
Finding #6 Continued

The toilet compartment is not wide enough.

**Toilet closet measured
36 inches wide.**

Major remodel/construction will be required to meet current ADA Standards.

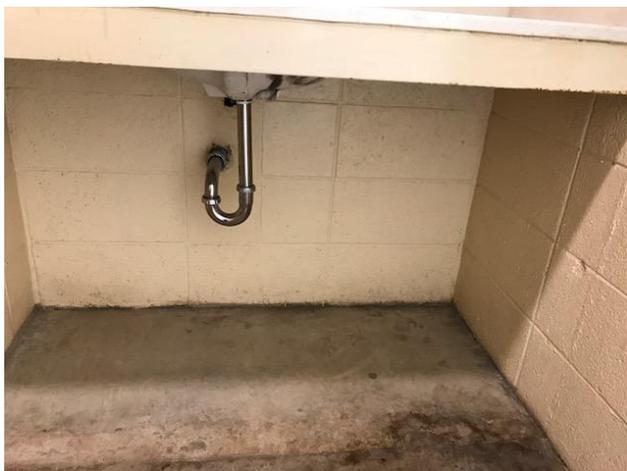
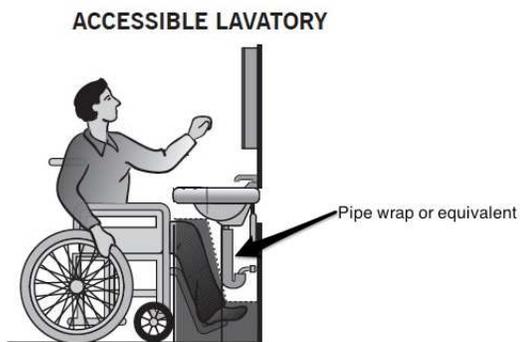
Finding #7 Continued

The water and drain pipes under the lavatory are not adequately insulated.

Drain pipes not insulated

Insulate drain pipes underneath lavatory.

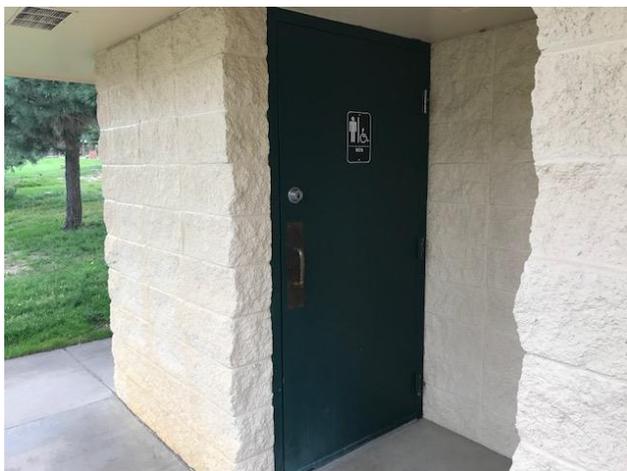
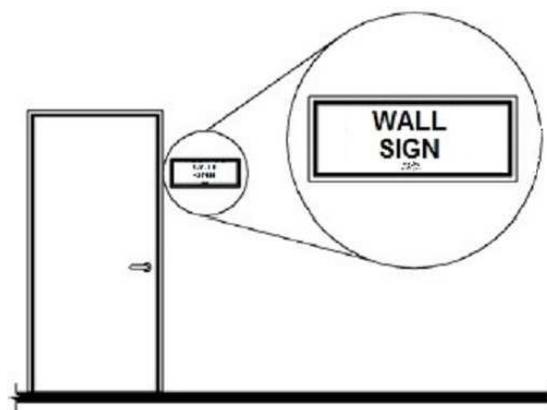
Finding #8 Continued

The tactile sign is incorrectly located.

Tactile sign mounted directly on door.

Move sign to left/latch side of door 48 inches minimum above finish floor or ground surface measured from the lowest tactile character or 60 inches maximum from the highest tactile character.

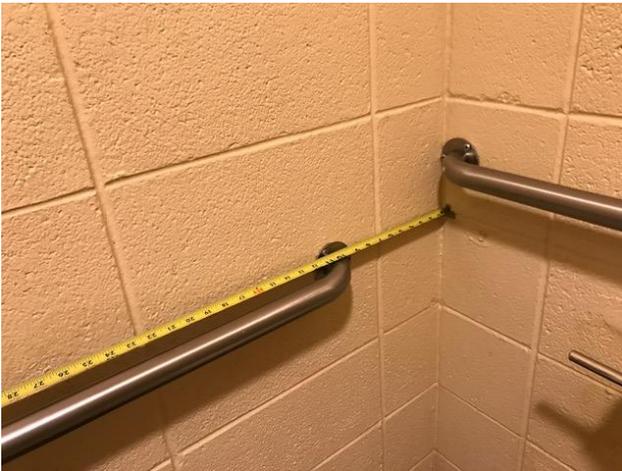
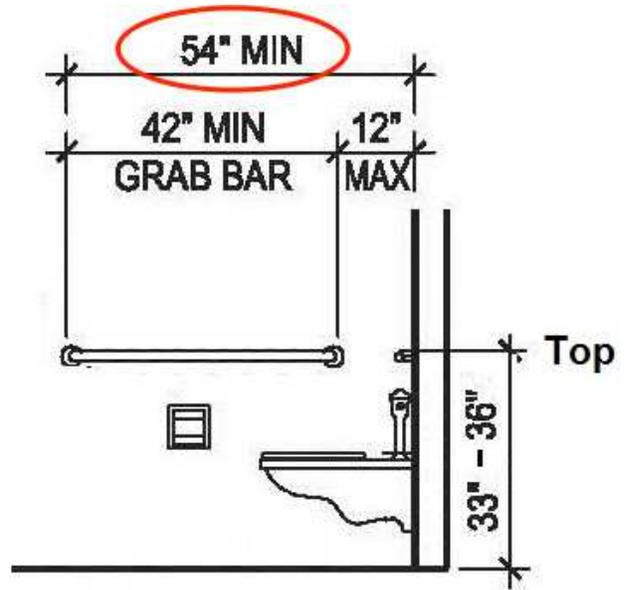
Finding #9 Continued

The side grab bar does not extend far enough from the rear wall.

Side grab bar does not extend the 54 inches required per ADA.

Re-position side grab bar an additional 1.75 inches away from rear wall to meet the 54 inch minimum required per ADAS.

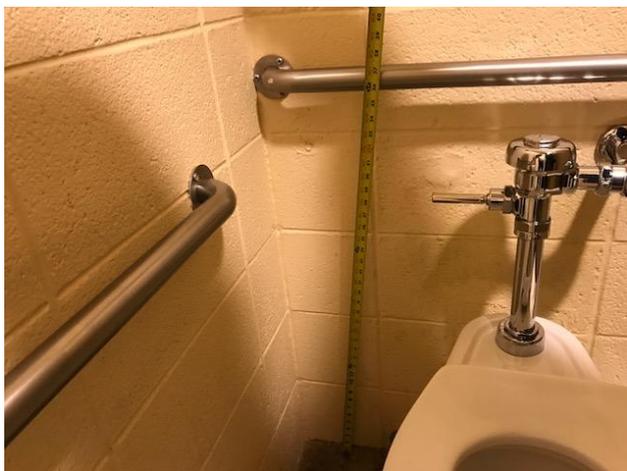
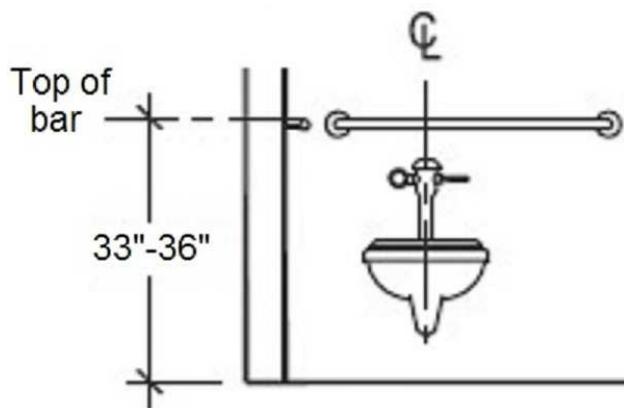
Finding #10 Continued

The rear grab bar is too high.

Measures 37 inches to the top of the gripping surface.

Remove and re-position 1 inch lower to comply with ADAS.

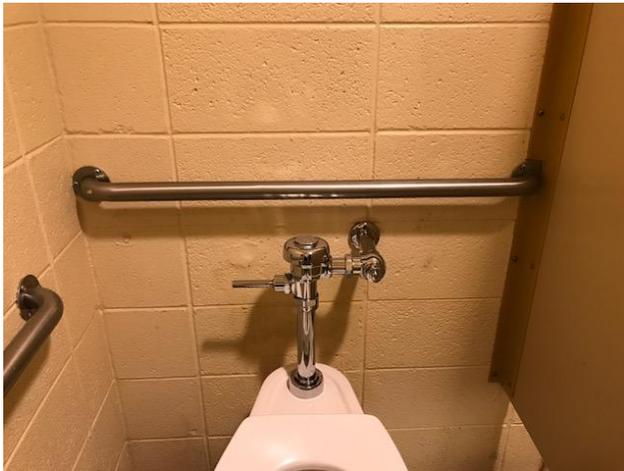
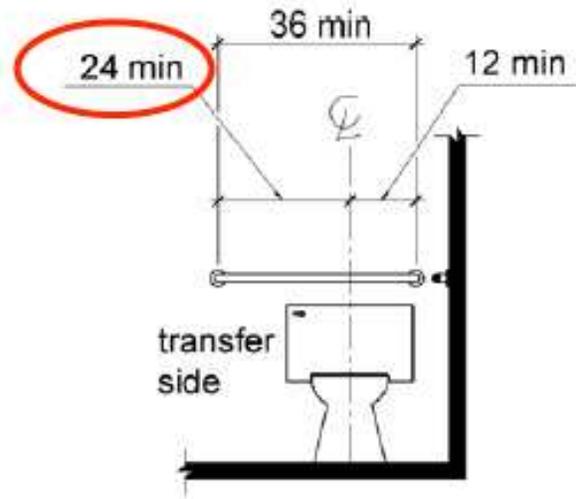
Finding #11 Continued

The rear grab bar does not extend adequately past the toilet on the wide side.

Width of toilet compartment does not allow for compliance

Extend width of toilet compartment and re-position rear grab bar to meet ADAS.

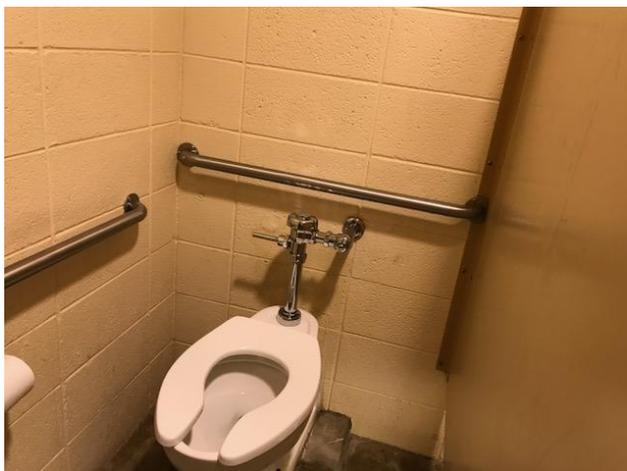
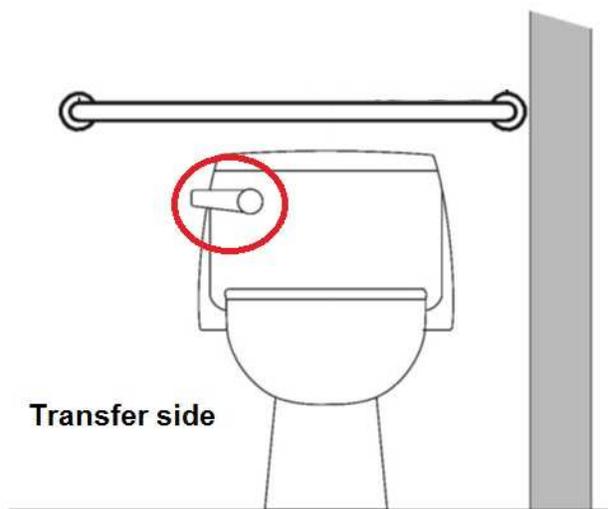
Finding #12 Continued

The flush handle is located on the wrong side of the toilet.

Flush handle not on transfer side of water closet

Extend width of toilet compartment and ensure flush handle is on the open side of the water close.

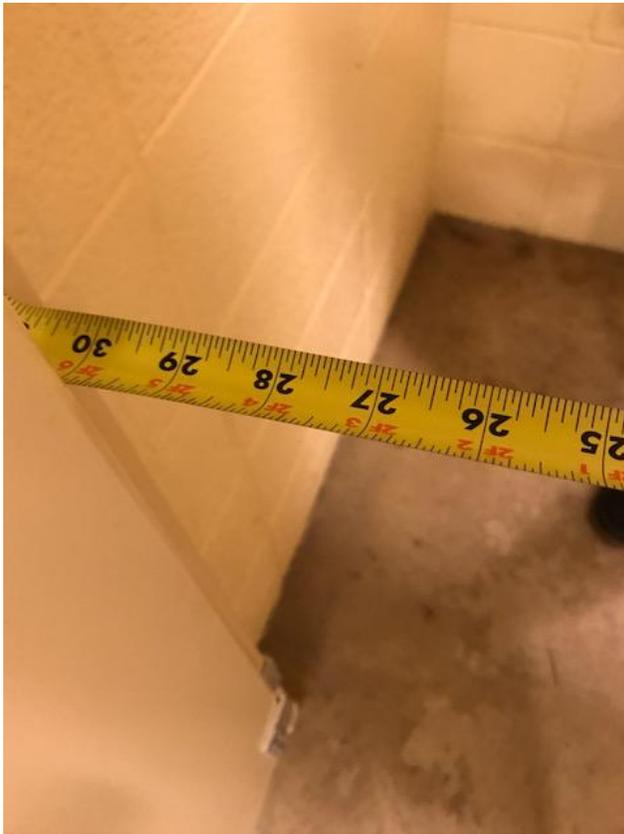
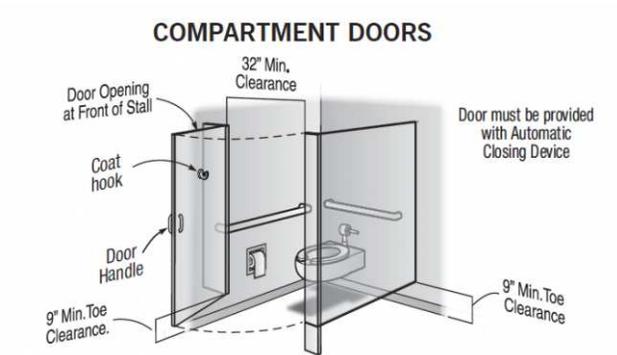
Finding #13 Continued

The compartment door does not have an unobstructed clear opening width of 32 inches.

Door opening width is
29 1/2 inches.

Upon reconstruction and/or alteration extend water closet door width to 32 inches minimum per 2010 ADAS.

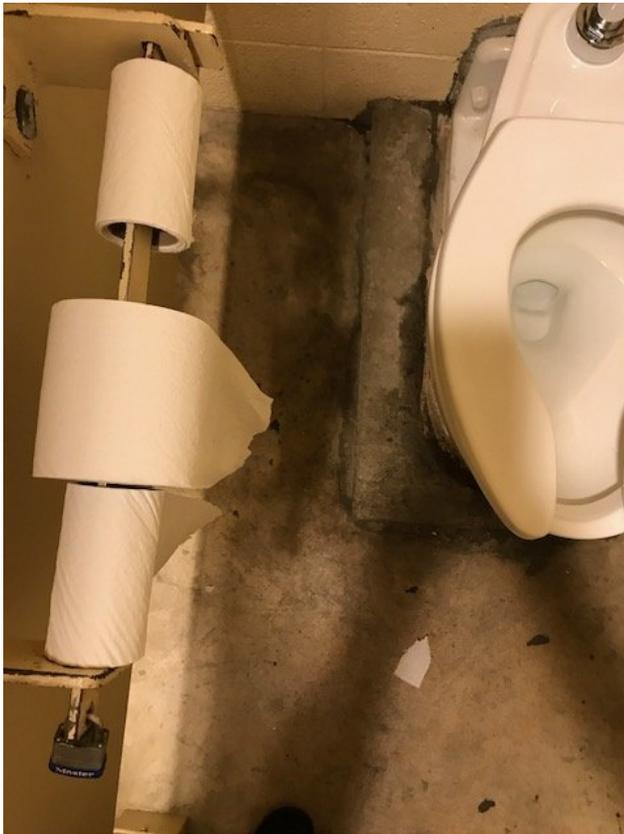
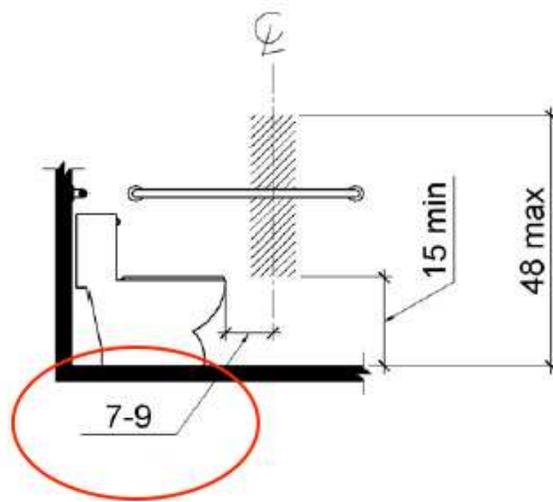
Finding #14 Continued

The toilet paper dispenser does not allow a continuous flow.

Does not allow continuous flow of toilet paper.

Replace dispenser with one that will allow continuous flow.

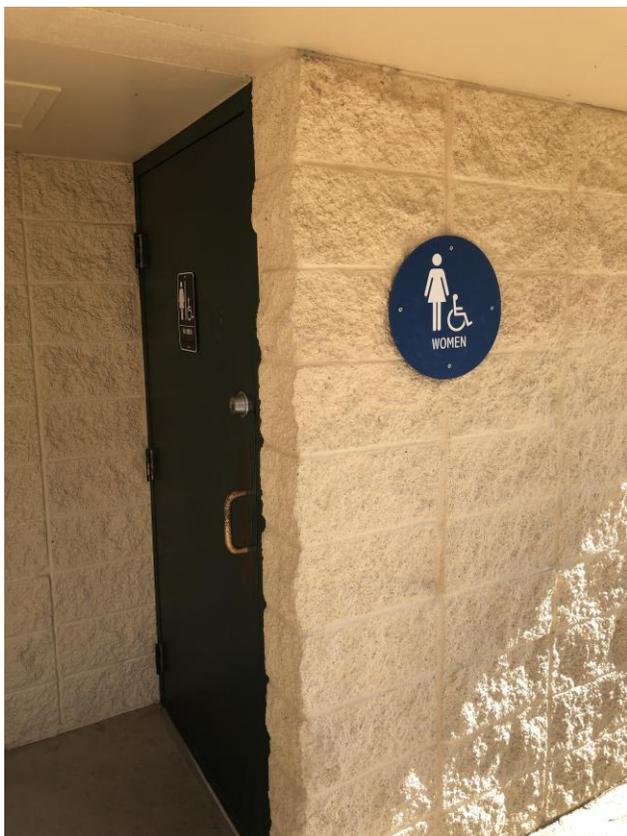
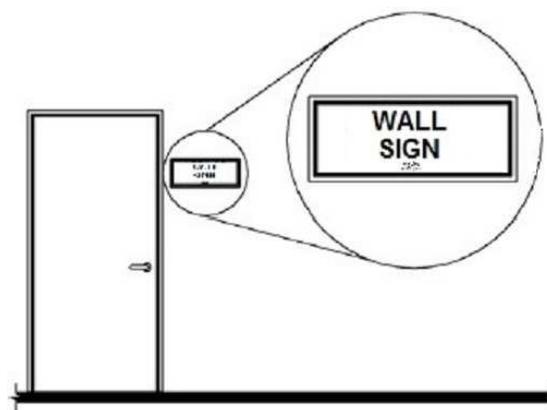
Finding #15 Continued

The tactile sign is incorrectly located.

Tactile sign mounted directly on door.

Move sign to left/latch side of door 48 inches minimum above finish floor or ground surface measured from the lowest tactile character or 60 inches maximum from the highest tactile character.

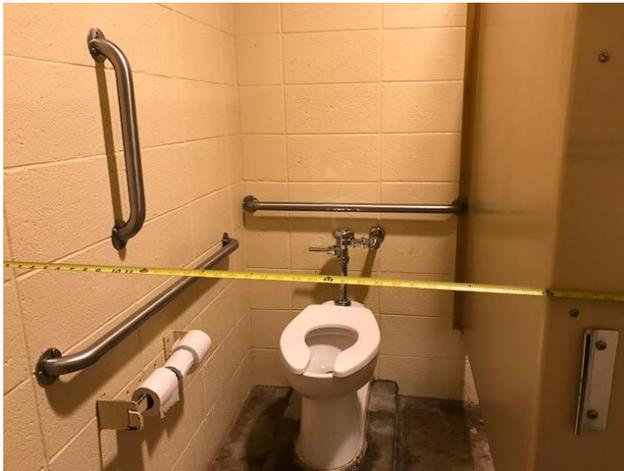
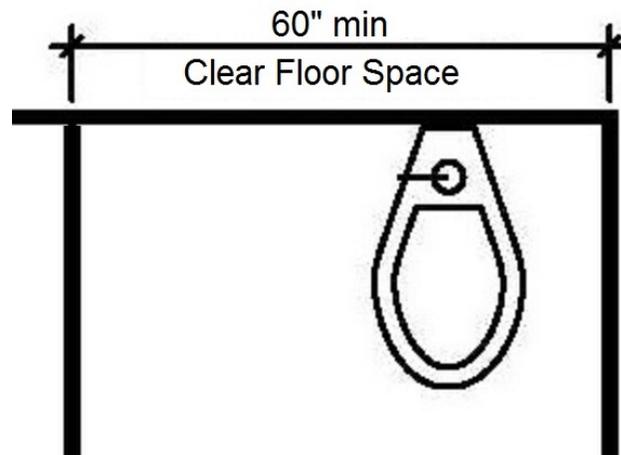
Finding #16 Continued

The toilet compartment is not wide enough.

Toilet closet measured
37 inches wide.

Major remodel/construction will be required to meet current ADA Standards.
