# Site Accessibility Evaluation

## Americans with Disabilities Act Title II (Public Services: State and Local Government)

**Motor Vehicle Union**

***Inspection Date: 07/01/2019***

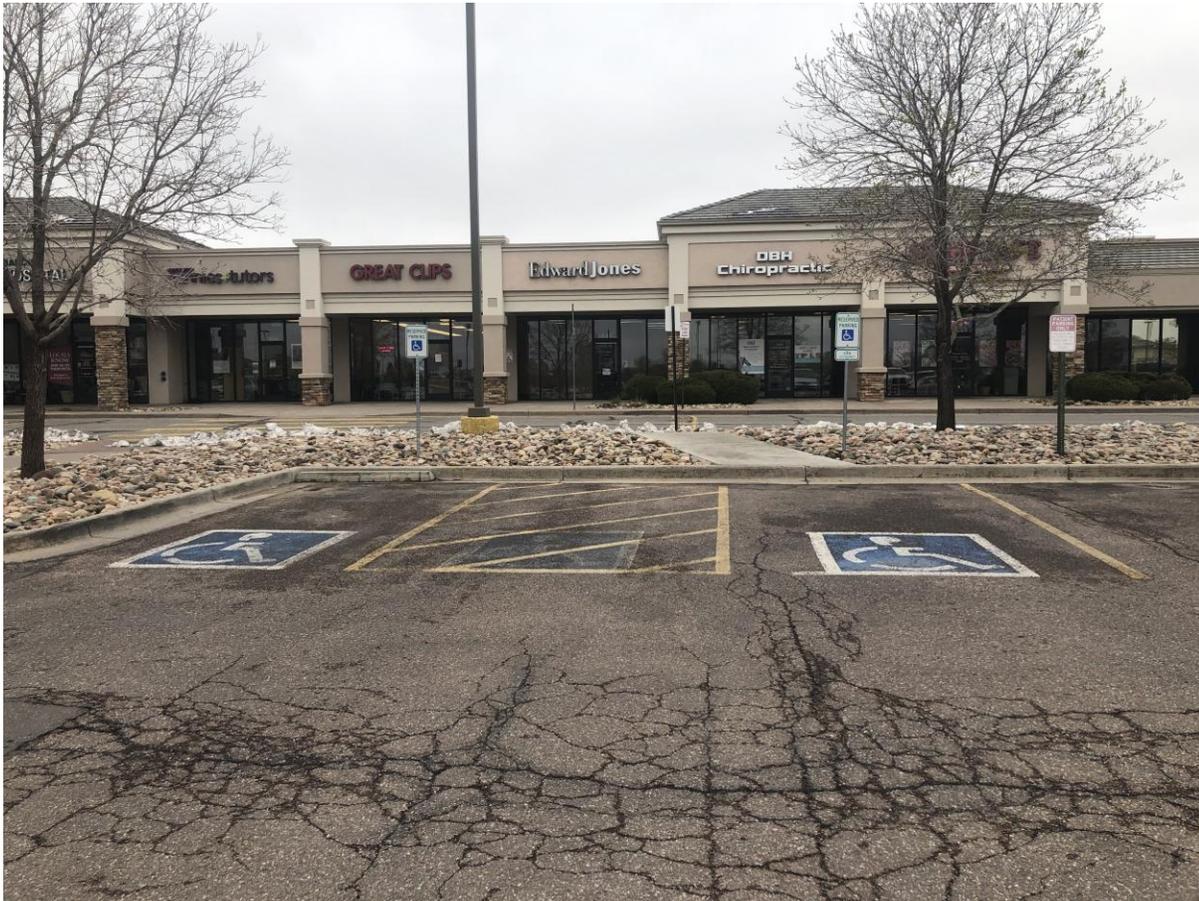
Finding 297089 Main Photo

The striping and markings for the accessible parking stalls, loading/unloading access aisles are dilapidated and in need of repair and/or maintenance.

*2010 ADAS Section 502.3.3*

Existing striping  
dilapidated

Reconfigure and re-stripe accessible parking stalls with international symbol of accessibility and access aisles.

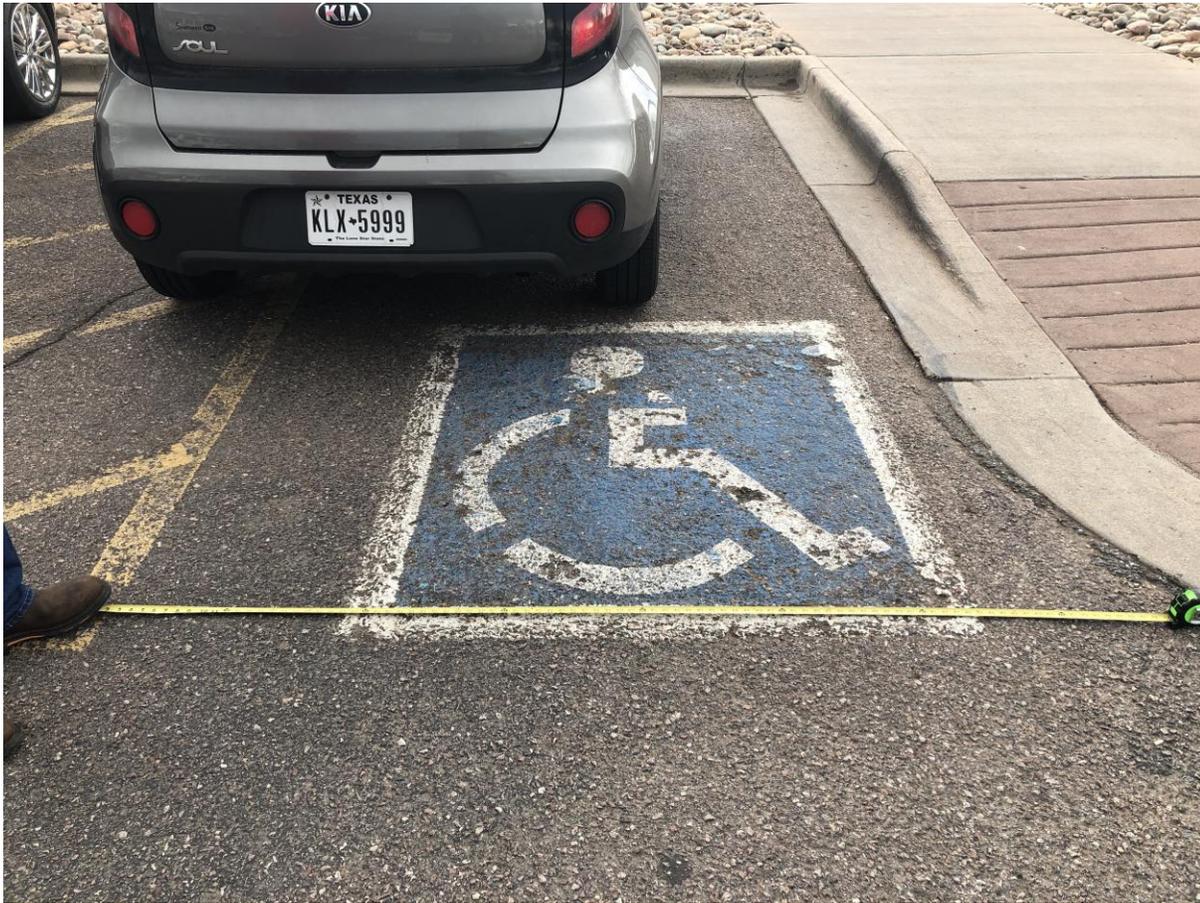
Finding 297099 Main Photo

Curb ramp leading to path of travel next to accessible parking stall not compliant due to side approach entrance and adjacent to accessible parking stall.

Citation:	As Built:	Budgeting Range:
2010 ADAS Section: Recommended	Existing curb ramp non-compliant	\$300 - \$2,000.00

Recommend re-striping adjacent parking stall to a no parking stall or reconfigure curb ramp with a forward approach entrance.

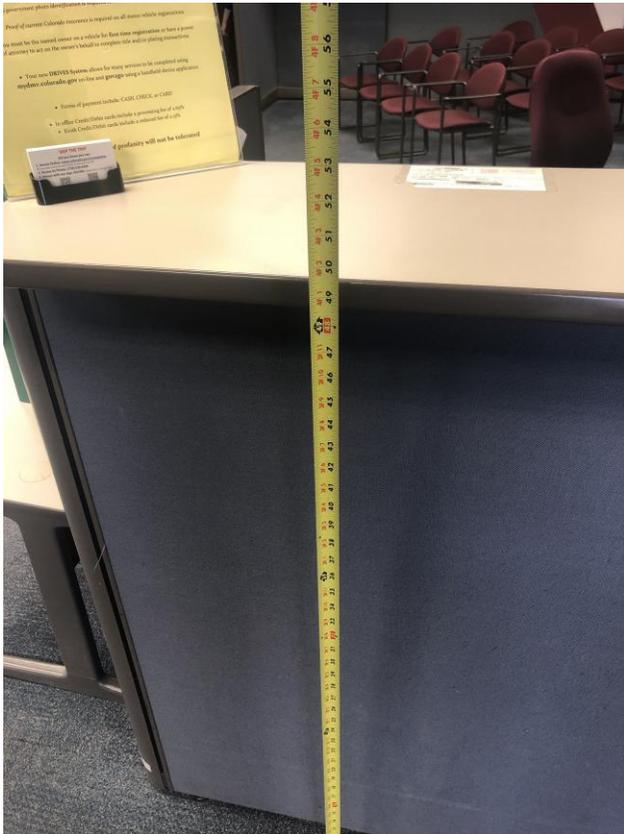
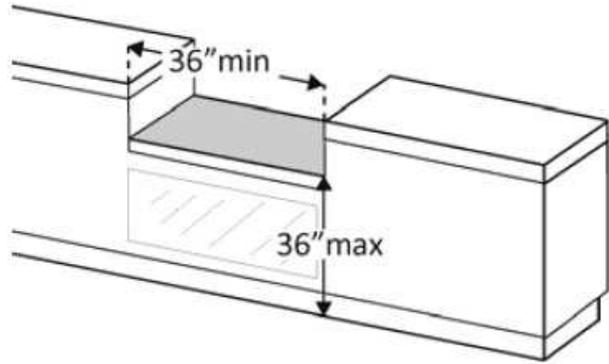
The transaction counter is too high.

*2010 ADAS Section 904.4.2*

49.5 inches in height

Install new counter section that measures 36 inches maximum in height from the finish floor and lengthen that section of the counter to 36 inches minimum. A clear floor or ground space shall be provided for either a parallel or forward approach complying with section 305 and/or 306 respectively. If forward approach is provided, please ensure knee clearance is also provided.

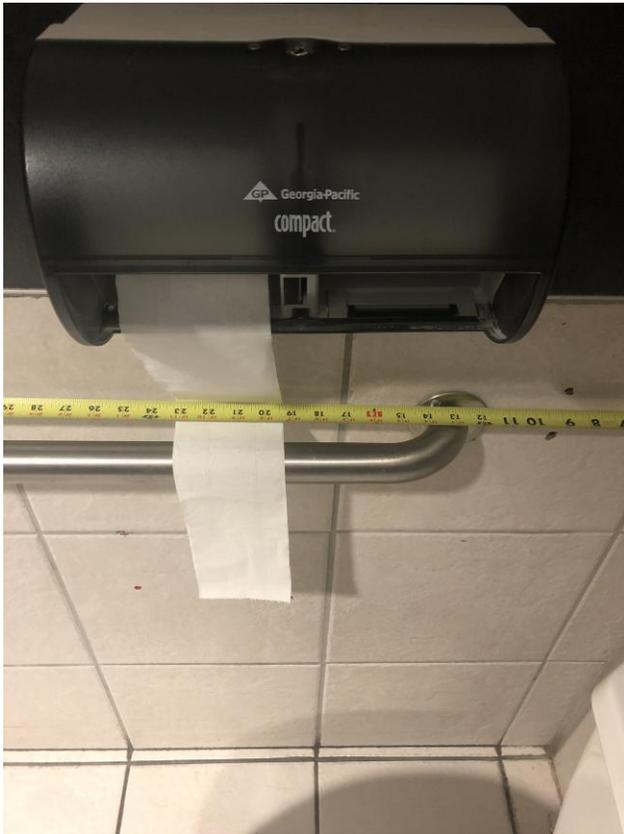
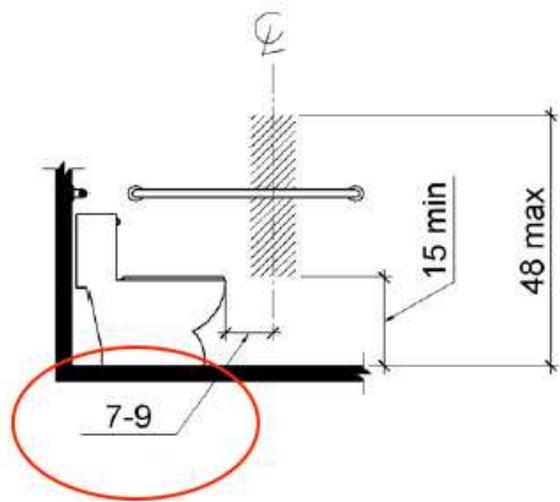
Finding 297079 Main Photo

The toilet paper is not installed within the compliant range in front of the toilet.

2010 ADAS Section 604.7

18 inches from rear wall

Relocate and ensure toilet paper dispenser is between 7 inches minimum to 9 inches maximum in front of water closet measured to centerline of the dispenser. If toilet paper dispenser is installed above side grab bar please ensure there is 12 inches of clearance minimum above side grab bar but no more than 48 inches in height measured from the floor to the center of the paper roll. If installed below grab bar ensure there is 1.5 inches clearance minimum but no less than 15 inches in height measured from the floor to the center of the paper roll.

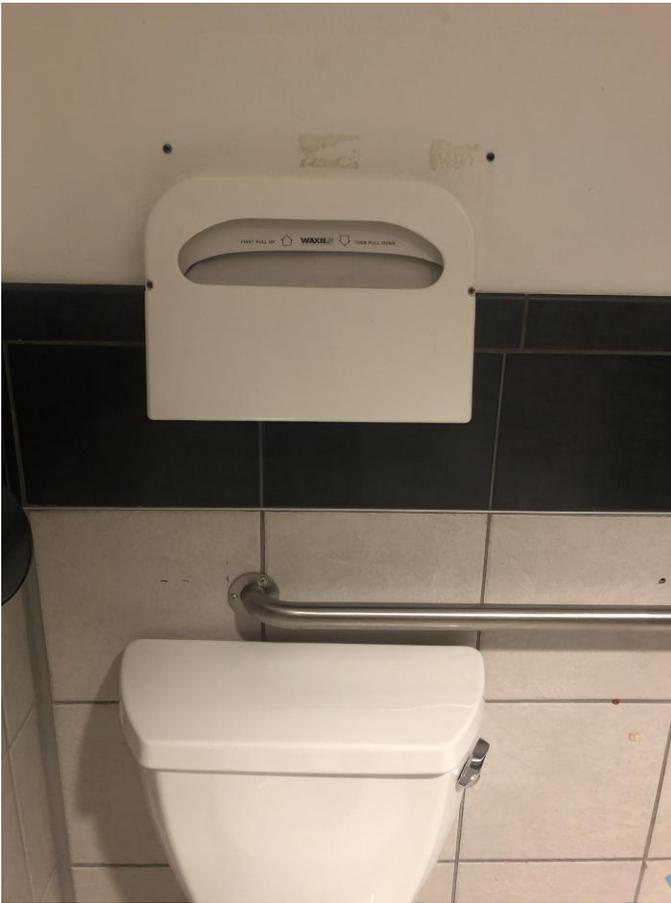
Finding 297080 Main Photo

The toilet seat cover dispenser is mounted too high and are not located in an accessible location.

*2010 ADAS Section 205.1*

53 inches above  
finished floor in rear  
wall

Relocate paper towel dispenser to have operable part between 15 inches minimum and 48 inches maximum above floor. May require relocation below grab bar at 1.5 inches minimum clearance below grab bar to meet compliance.

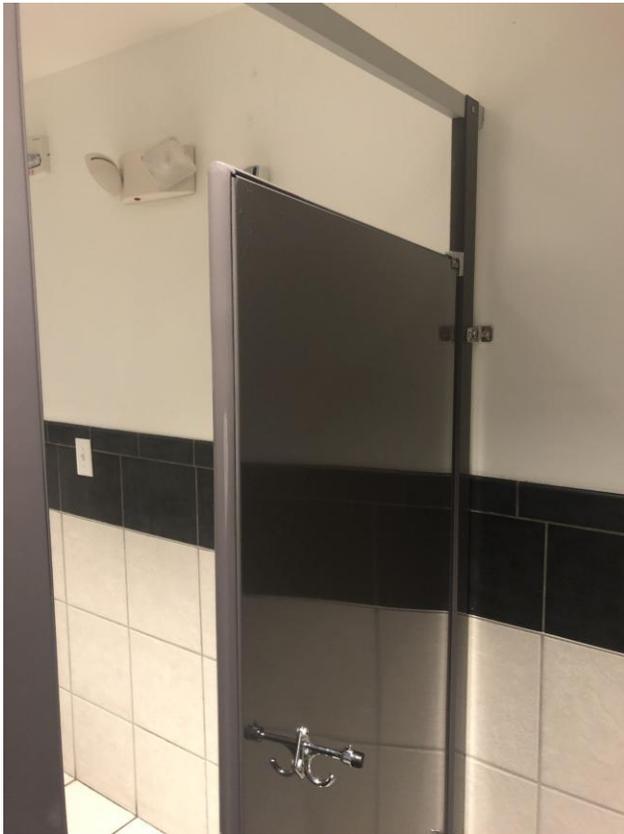
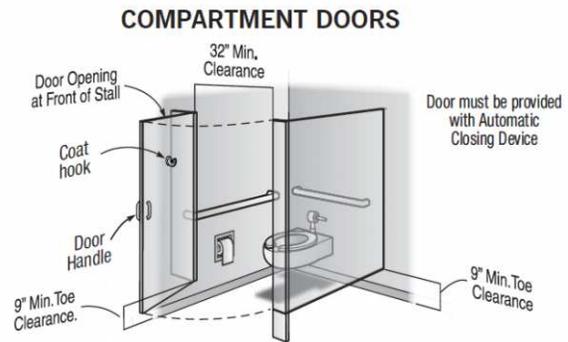
Finding 297081 Main Photo

The compartment door is not self closing.

2010 ADAS Section 604.8.1.2

Does not self close completely

Adjust or replace existing door hinges.

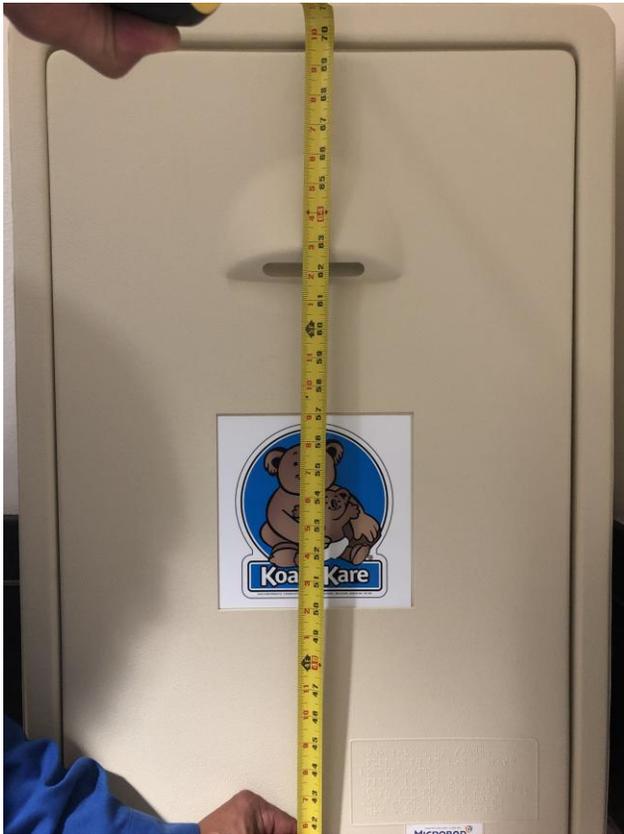
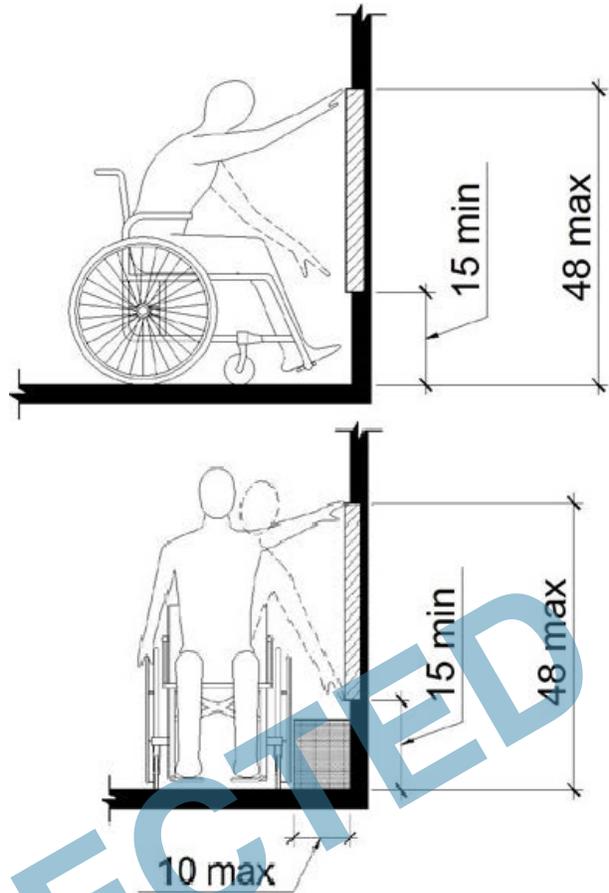
Finding 297097 Main Photo

The baby changing table operating mechanism is outside reach range.

*2010 ADAS Section 308.3.1*

Baby changing table at 62.5 inches above finished floor

Remove and replace existing baby changing station with a horizontal station. Ensure there is a 27 inch minimum knee clearance measured from the finished floor to the bottom edge of the baby changing station, 28 inches minimum to 34 inches maximum to the top of the table surface and the operable part at a maximum of 48 inches measured from the finished floor.

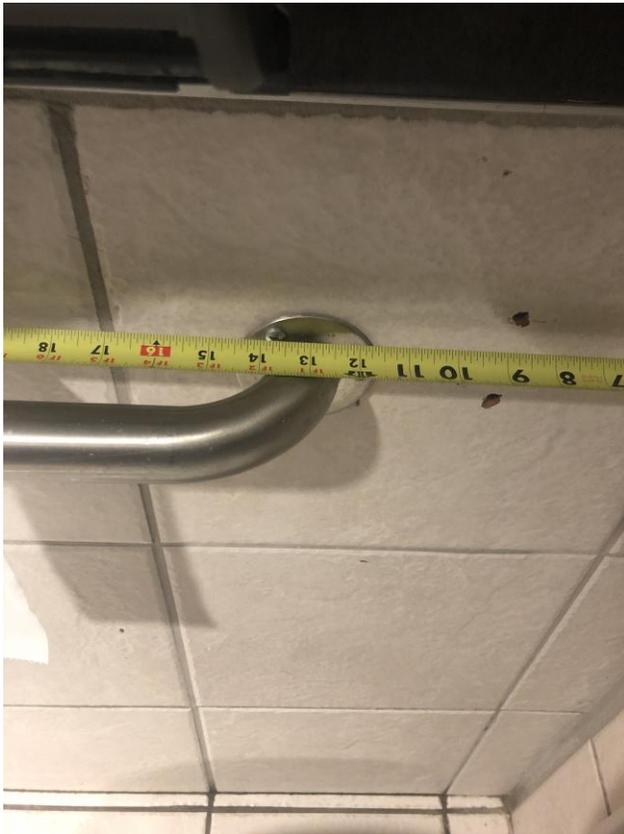
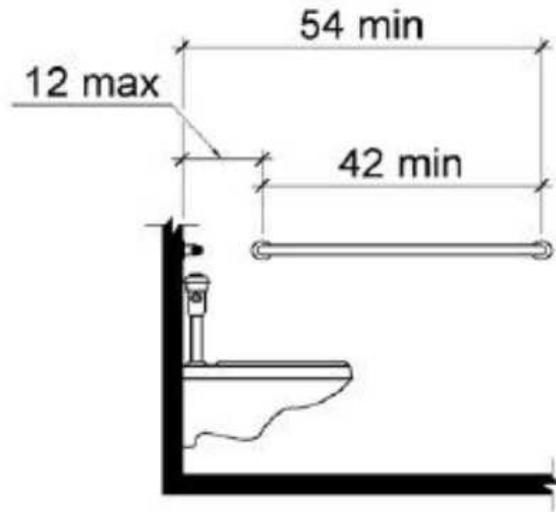
Finding 297078 Main Photo

The side grab bar is located greater than 12 inches from the rear wall.

*2010 ADAS Section 604.5.1*

13 inches from rear wall

Adjust side grab bar not to exceed 12 inches from rear wall. The side grab bar must be 42 inches minimum in length and extend at least 54 inches minimum beyond the rear wall.

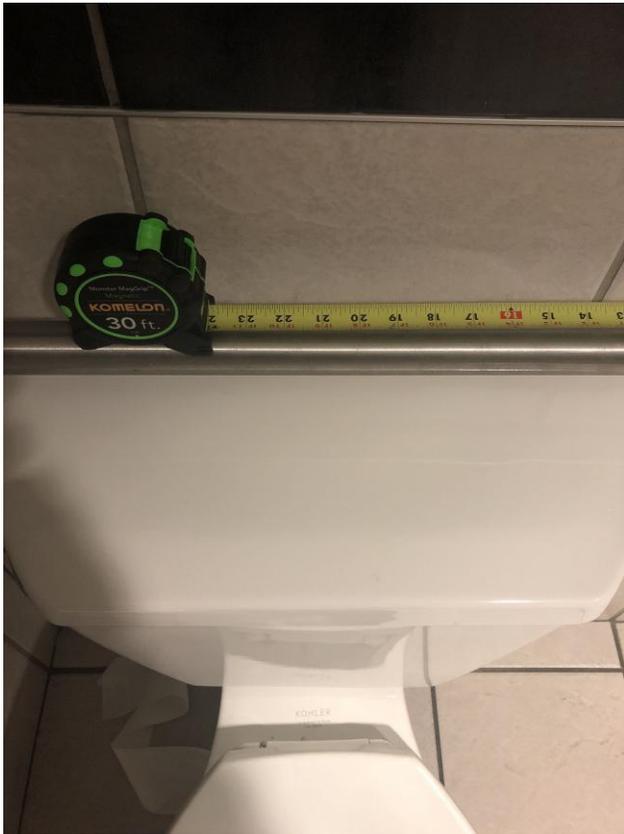
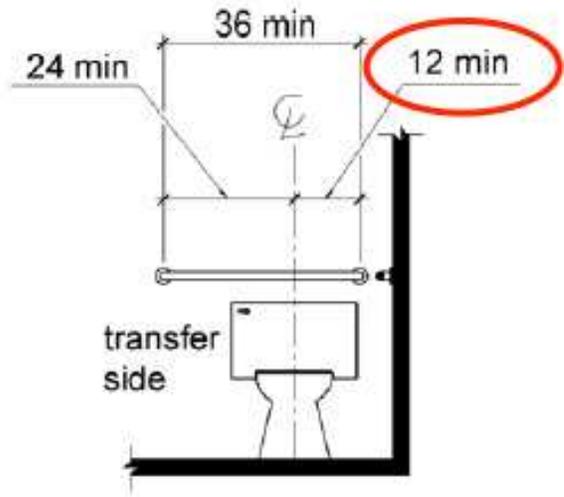
Finding 297082 Main Photo

The rear grab bar does not extend adequately past the centerline of the toilet on the wall side.

*2010 ADAS Section 604.5.2*

13 inches from side wall

Re-position rear grab bar to extend 12 inches minimum on wall side and 24 inches minimum on the transfer side measured from the centerline of the toilet.

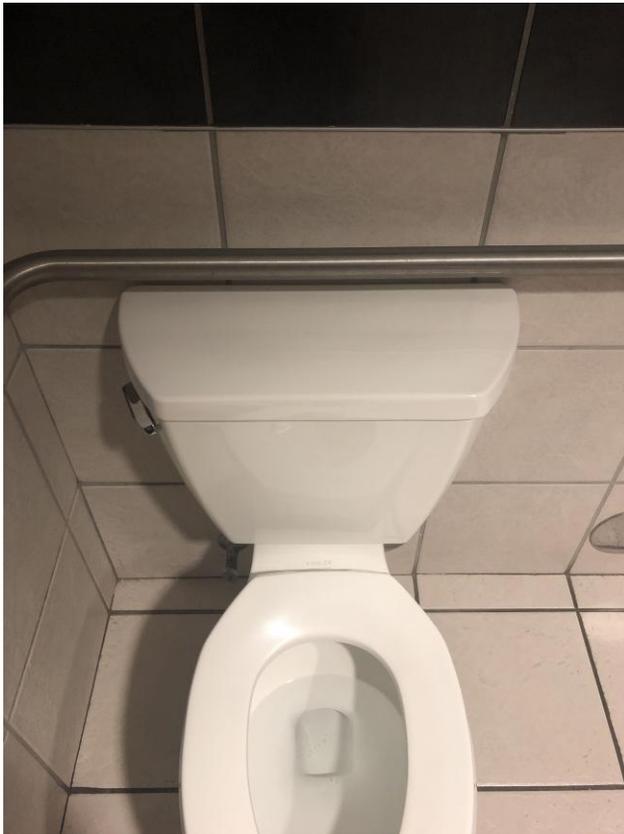
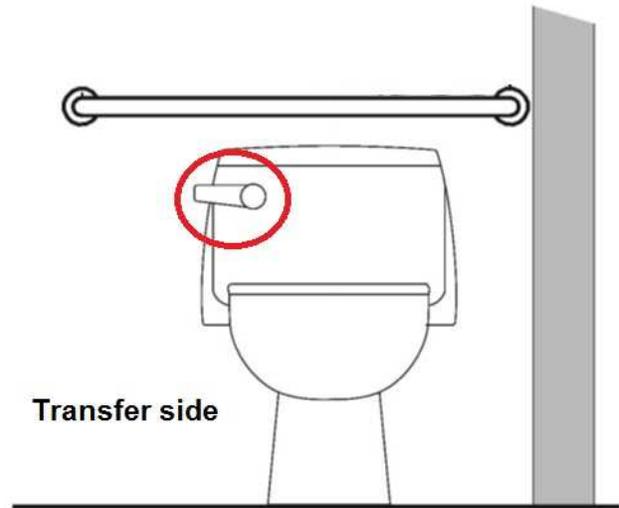
Finding 297083 Main Photo

The flush handle is located on the wrong side of the toilet.

*2010 ADAS Section 604.6*

Flush handle on wall side

Replace toilet water tank with one that has flush handle on the opposite side (open side of toilet area).

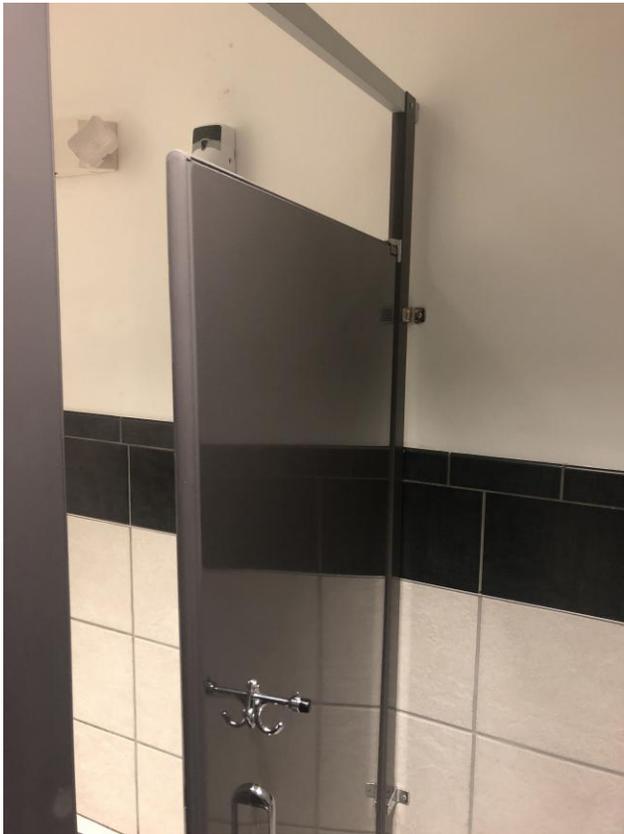
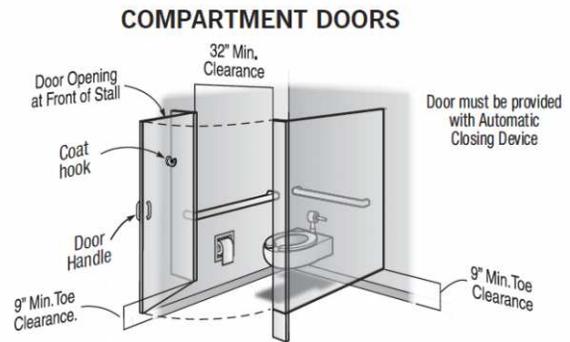
Finding 297086 Main Photo

The compartment door is not self closing.

2010 ADAS Section 604.8.1.2

Compartment door not self closing

Adjust or install automatic closing hinges.

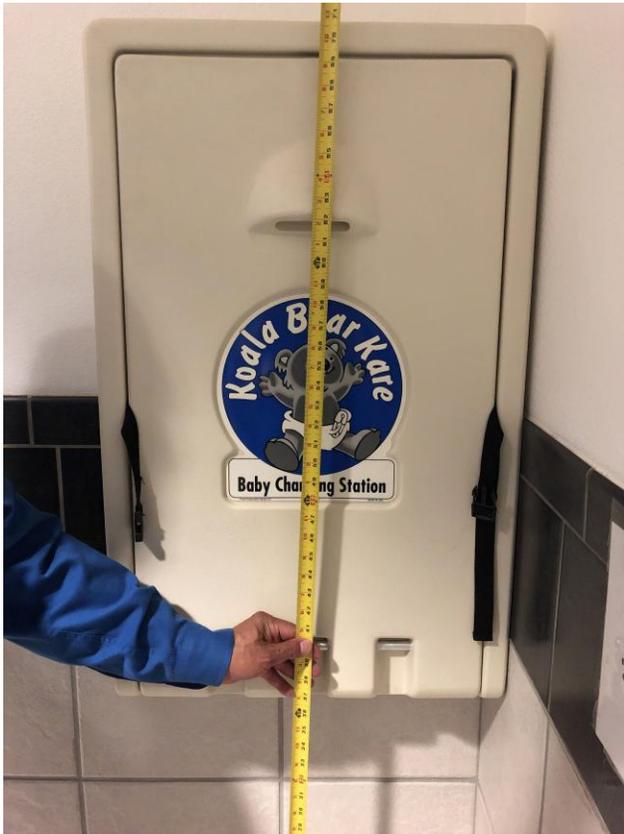
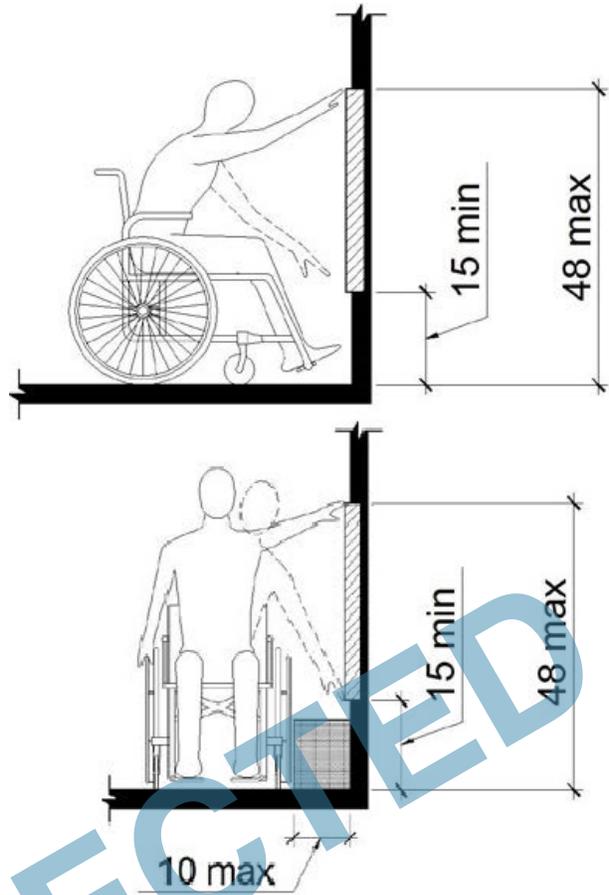
Finding 297098 Main Photo

The baby changing table operating mechanism is outside reach range.

*2010 ADAS Section 308.3.1*

62 inches above  
finished floor

Remove and replace existing baby changing station with a horizontal station. Ensure there is a 27 inch minimum knee clearance measured from the finished floor to the bottom edge of the baby changing station, 28 inches minimum to 34 inches maximum to the top of the table surface and the operable part at a maximum of 48 inches measured from the finished floor. Also, reverse opening of stall door to meet required clear floor space for the baby changing station.

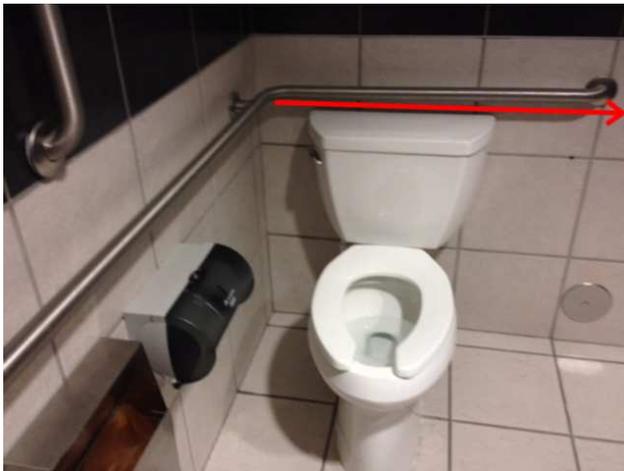
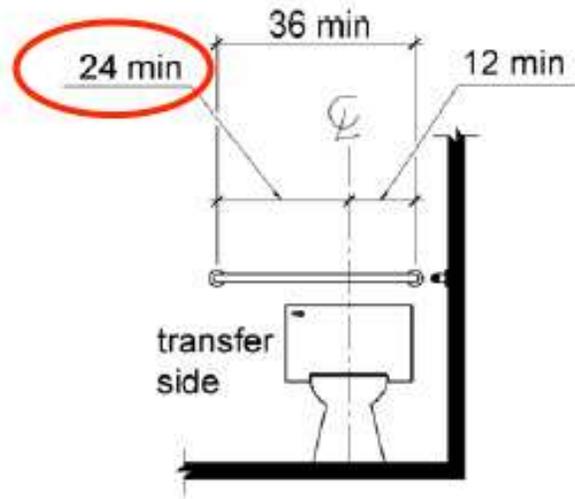
Finding 18928 Main Photo

The rear grab bar does not extend adequately past the toilet on the wide side.

*2010 ADAS Section 604.5.2*

Rear grab bar extends 21 inches.

Existing grab bar will not meet compliance due to one piece continuous grab bar. Install separate rear and side grab bars. Side grab bar shall be 42 inches in length and shall measure 54 inches minimum from rear wall when installed. Rear grab bar shall extend 12 inches minimum on wall side and 24 inches minimum on the transfer side measured from the centerline of the toilet.

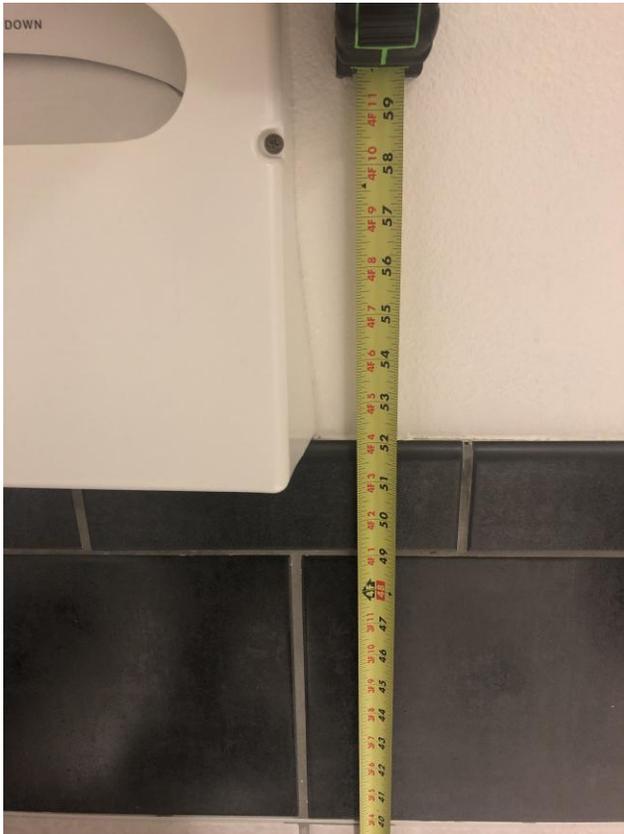
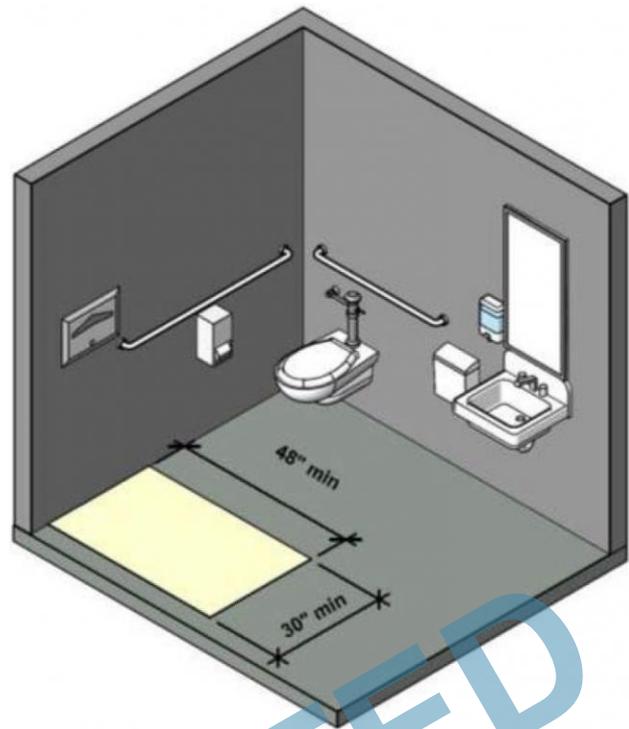
Finding 297084 Main Photo

The toilet seat cover dispenser is not on an accessible route.

*2010 ADAS Section 309.2*

59 inches above rear  
grab bar

Relocate seat cover dispenser to have operable part between 15 inches minimum and 48 inches maximum above floor. May require relocation below rear or side grab bar at 1.5 inches minimum clearance below grab bar to meet compliance.

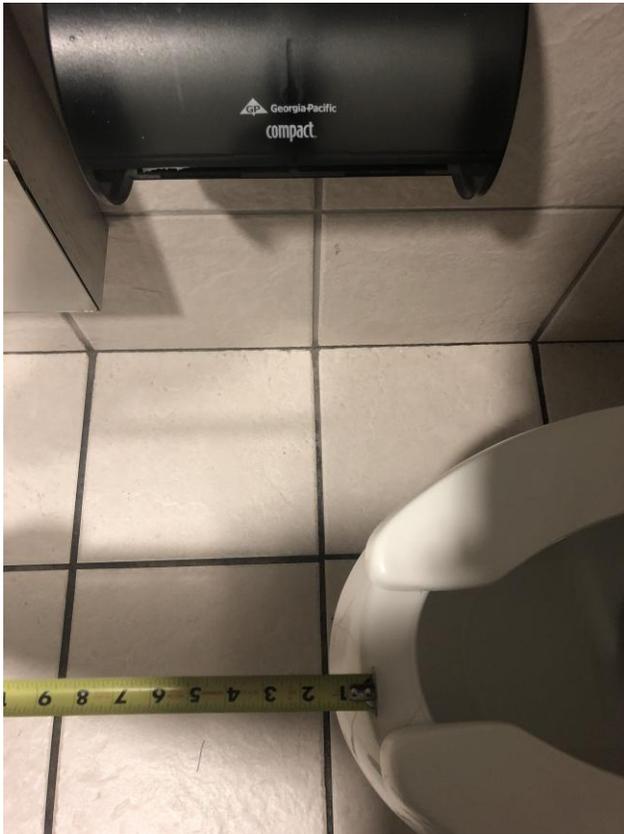
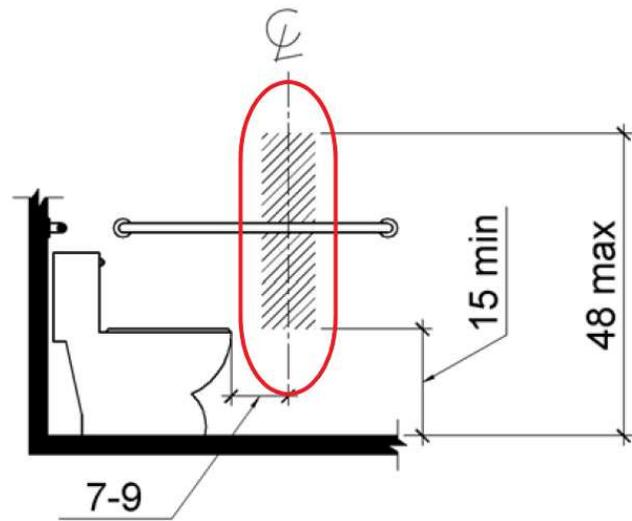
Finding 297085 Main Photo

The toilet paper is not installed within the compliant height range.

*2010 ADAS Section 604.7*

1 inch in front of toilet

Relocate sanitary paper dispenser or interchange sanitary paper dispenser with toilet paper dispenser and ensure toilet paper dispenser is between 7 inches minimum to 9 inches maximum in front of water closet measured to centerline of the dispenser.

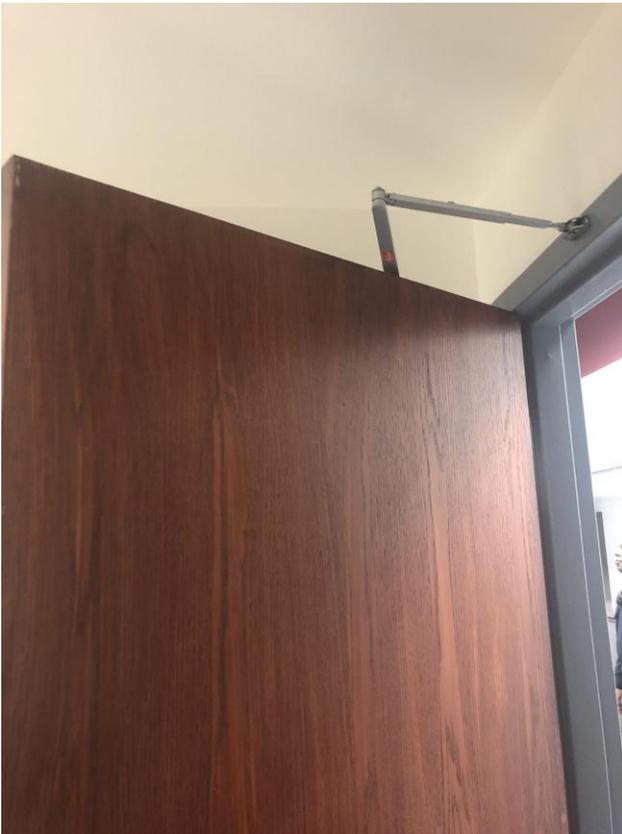
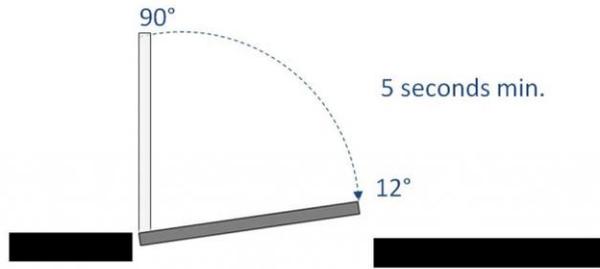
Finding 297088 Main Photo

The door is equipped with a door closer and returns to a closed position too quickly.

*2010 ADAS Section 404.2.8.1*

2 seconds to closed position
