# Site Accessibility Evaluation

### Widefield Park

**Accessibility Evaluation**

***Inspection Date: 06/26/2018***

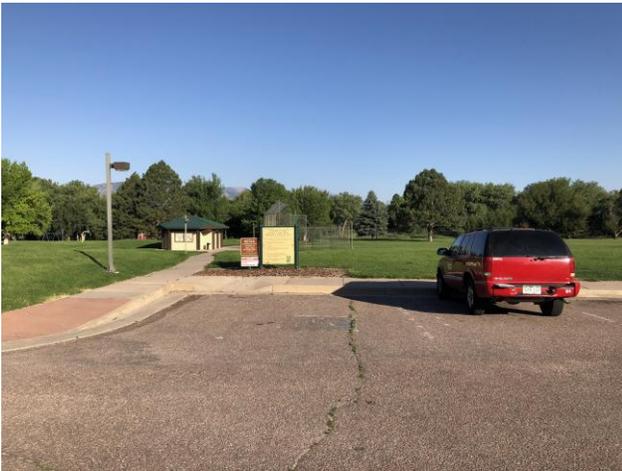
Finding 174004 Main Photo

There are not enough accessible stalls

There are 0 accessible parking stalls including 0 designated for a van.

There should be a minimum of 2 accessible parking stalls including a minimum of 1 van accessible stalls.

No accessible parking stalls

Repave and re-stripe parking lot to provide accessible parking stalls, access aisle connecting to main path of travel and install parking signs with the international symbol of accessibility.

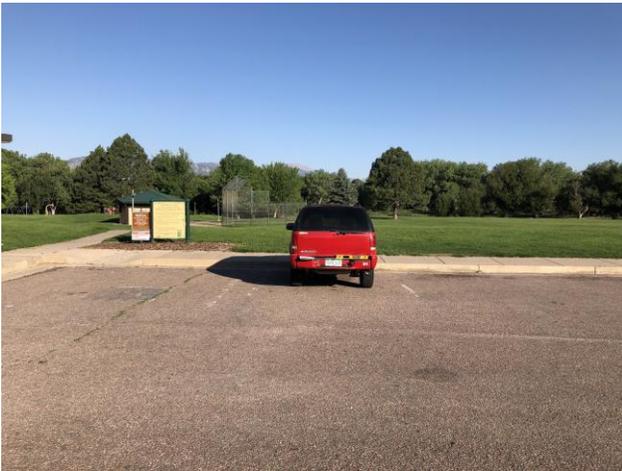
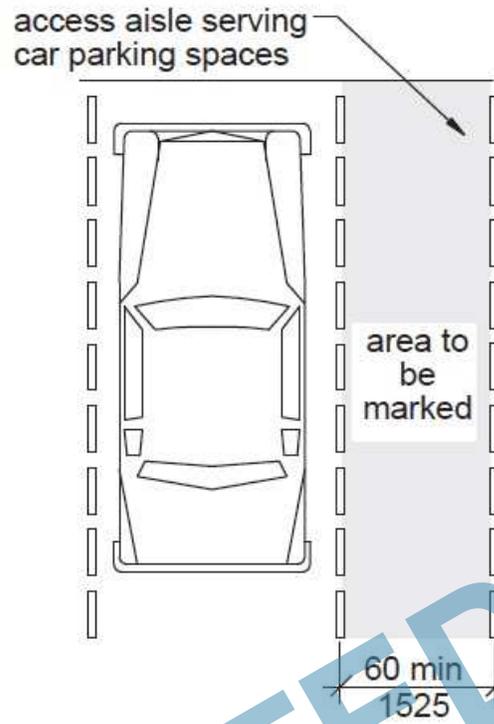
Finding 174005 Main Photo

The access aisle is missing at the accessible parking stall.

No accessible aisle

Stripe access aisle in between 2 accessible parking stalls.

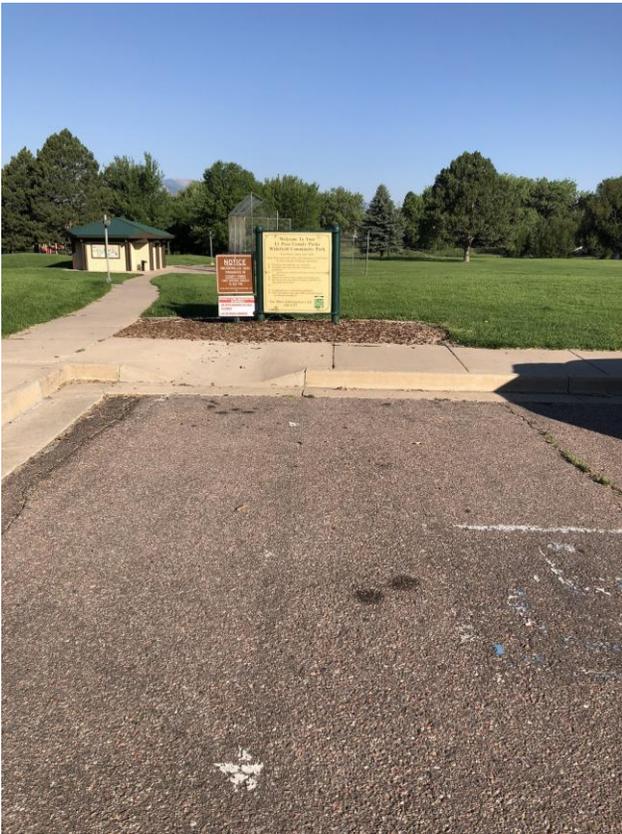
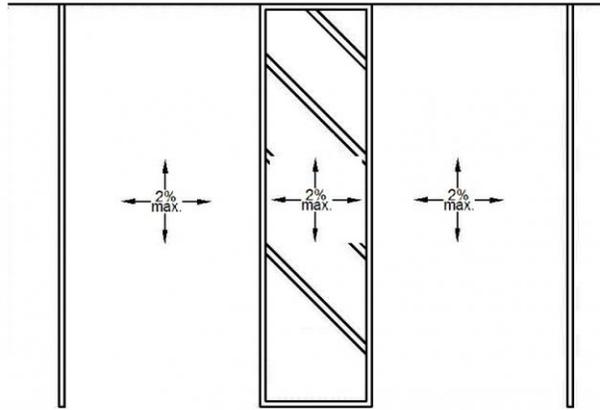
Finding 174006 Main Photo

The access aisle for the accessible parking stall contains a built up curb ramp which results in significant slopes greater than 2 percent.

No curb ramp into accessible route

Remove existing curb ramp and build new curb ramp in line with new access aisle to meet 2010 ADA standards.

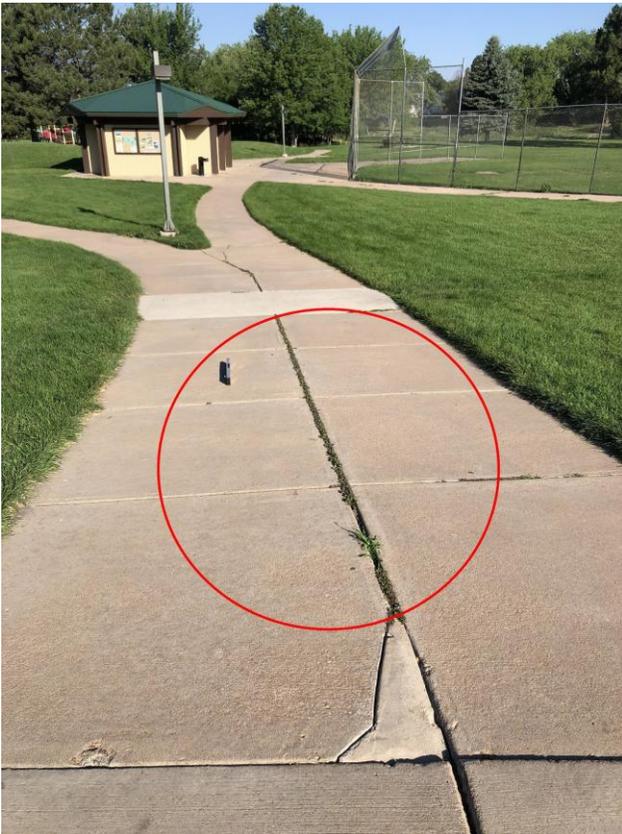
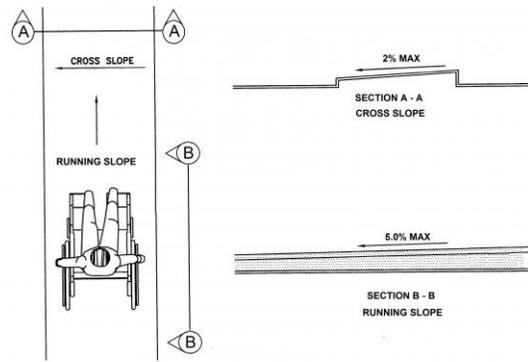
Finding 174007 Main Photo

The accessible route between the public bathrooms entrances and the accessible parking on the site contains running slopes greater than 5% and has not been constructed as a ramp (i.e. handrails, wheel guides, etc.).

Certain sections of circulation path up to 8.66% running slope 50ft from parking lot sidewalk

Level path of travel to 5% maximum to meet current ADA standards.

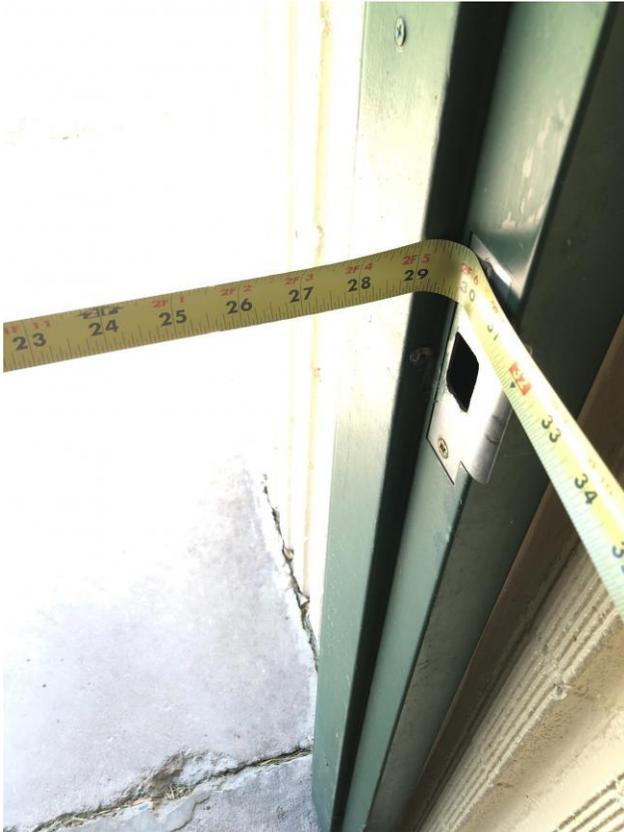
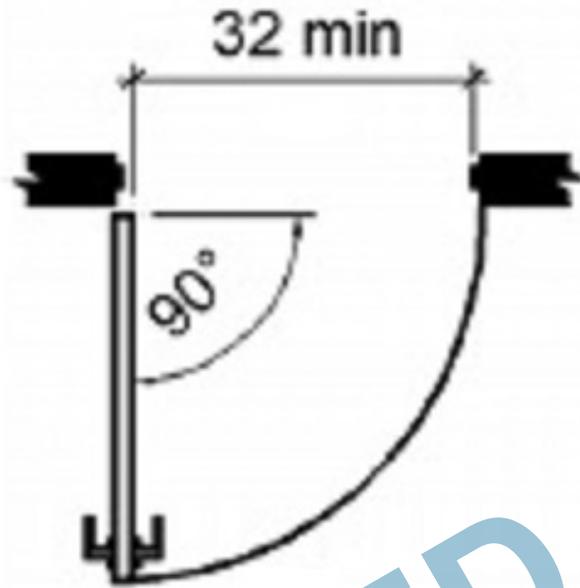
Finding 174008 Main Photo

The door opening does not provide at least 32 inches between the face of the door and the opposite stop.

29 inches opening width

Reconfigure door opening to meet compliance. Due to the existing and type of structure, it may be structurally infeasible.

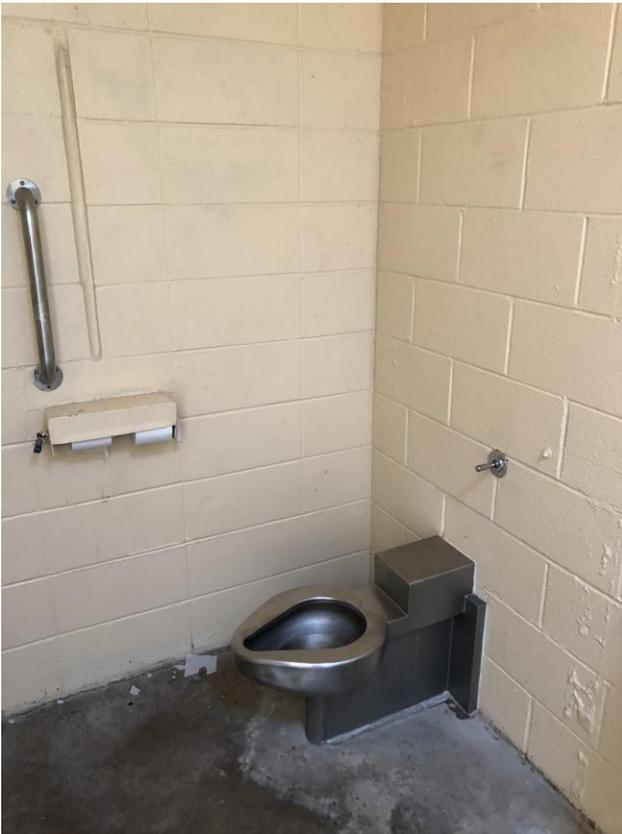
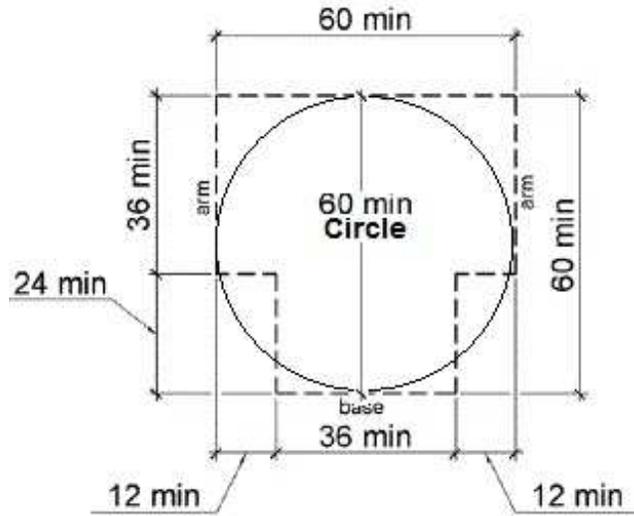
Finding 174086 Main Photo

Compliant turning space has not been provided.

54 inches in diameter

Alter toilet, urinal and lavatory to ensure a 60 inch radius is provided.

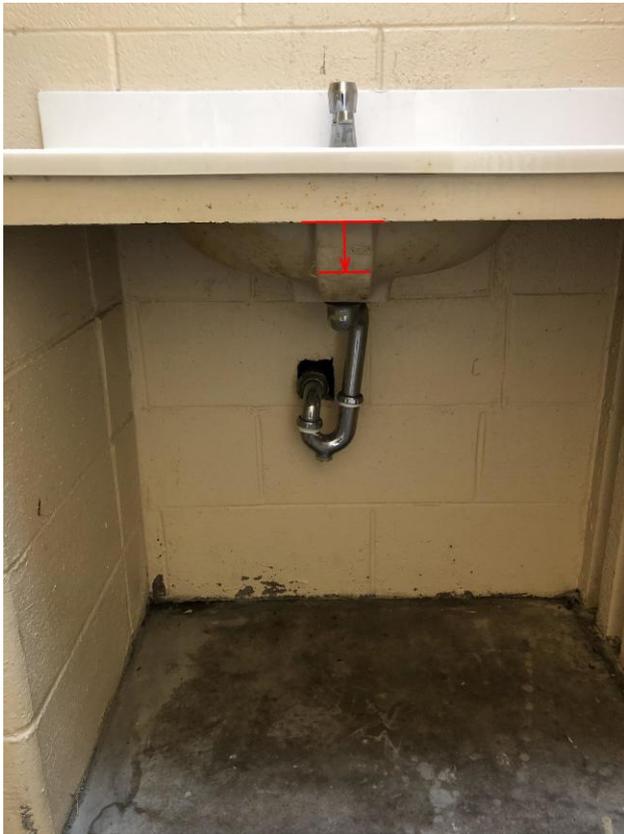
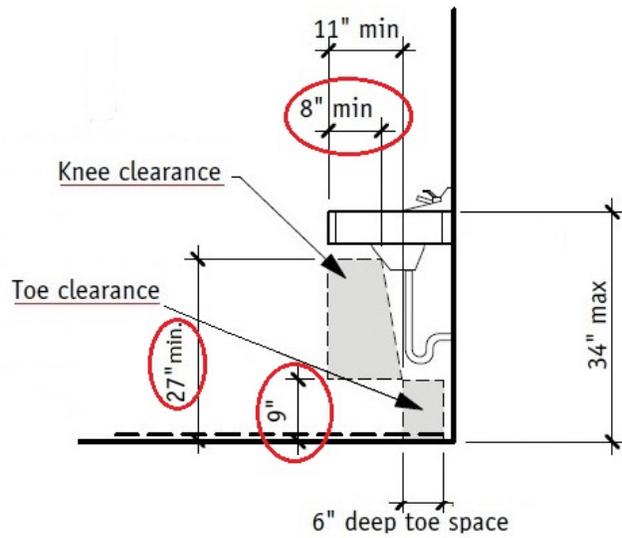
Finding 174144 Main Photo

The apron at the sink projects too low to the floor.

Measures only 4 inches back from the front edge

Replace lavatory with one that provides a minimum height from the bottom edge of no less than 27 inches above finished floor and 8 inches minimum in depth for knee clearance.

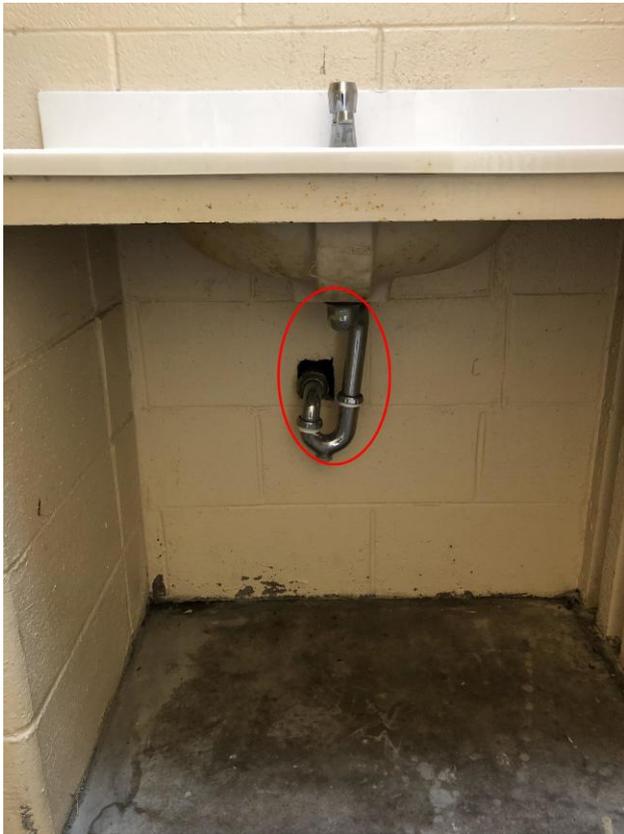
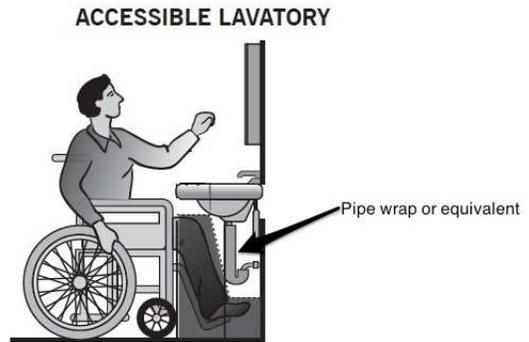
Finding 174163 Main Photo

The water and drain pipes under the lavatory are not adequately insulated.

Drain pipes not insulated

Insulate drain pipes underneath lavatory.

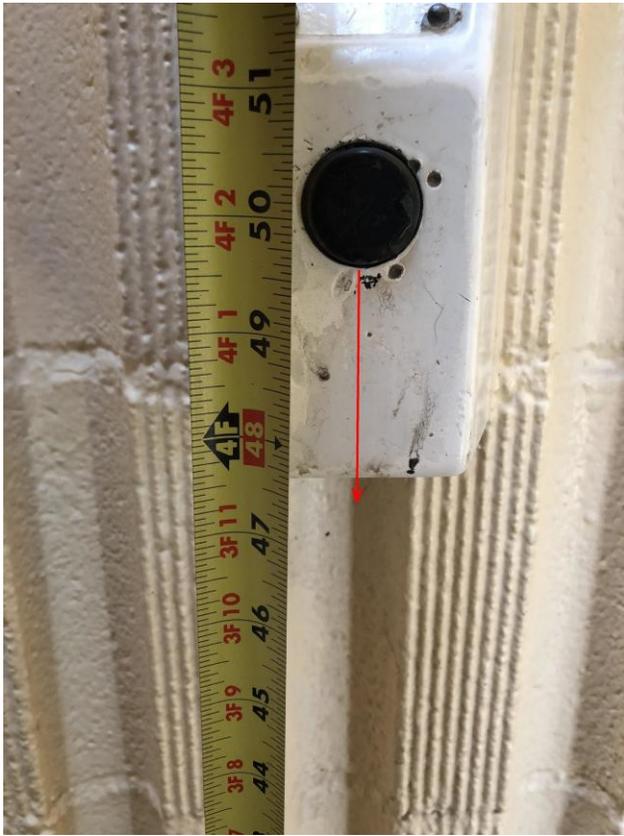
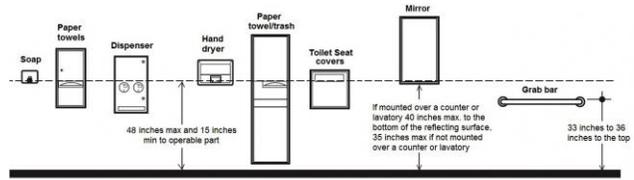
Finding 174549 Main Photo

The hand dryer dispenser's operation mechanism is too high off the floor.

50.5 inches from the ground

Lower hand dryer 3 to 4 inches to meet compliance. 48 inches maximum height above finished floor for operable parts (sensor).

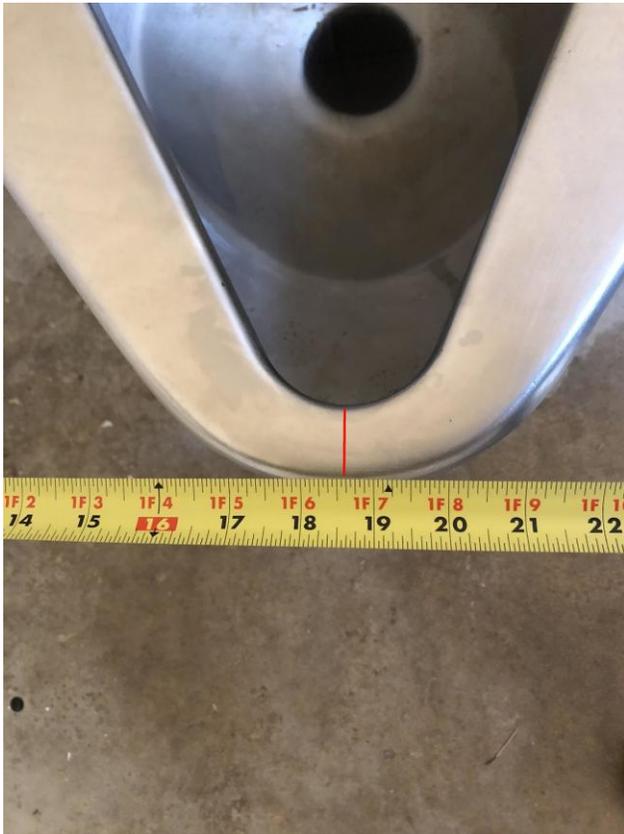
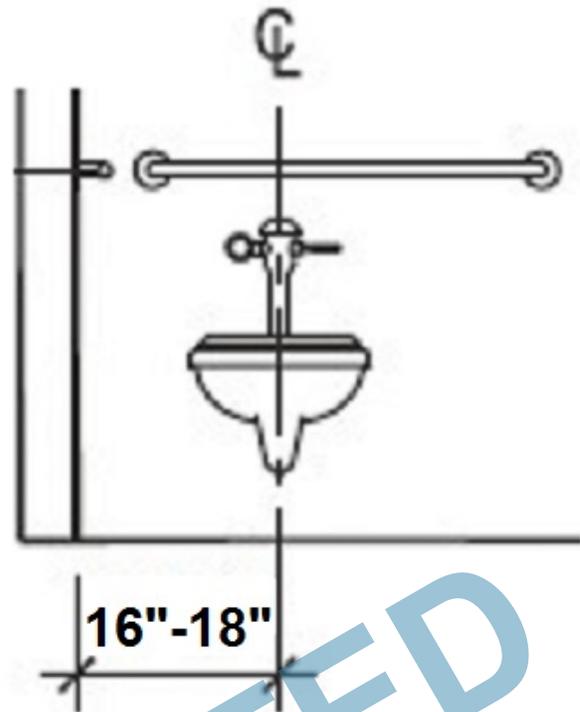
Finding 174559 Main Photo

The toilet is not located within the range allowed from the side wall or partition.

18.5 inches from side wall

Re-position toilet between 16 inches minimum and 18 inches maximum from centerline of toilet to side wall. May require plumbing alteration.

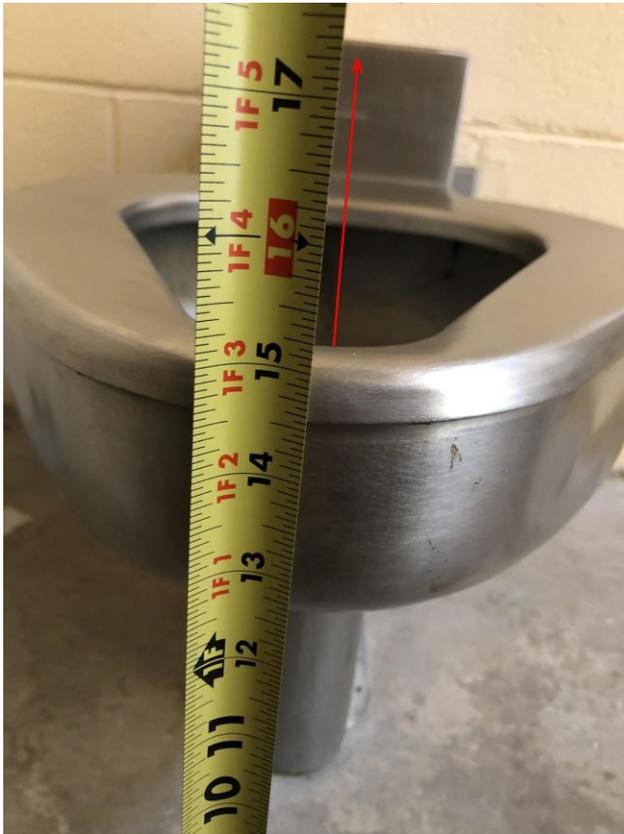
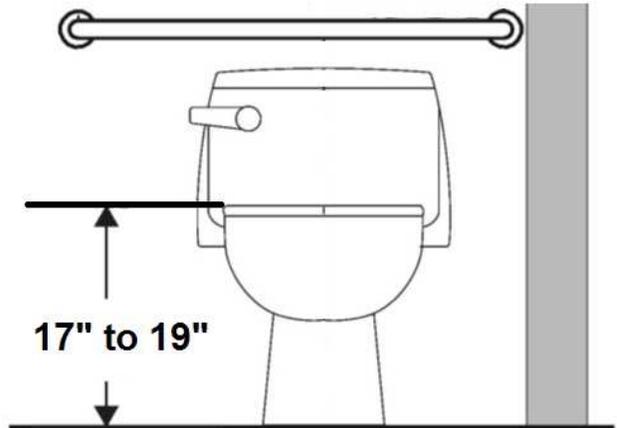
Finding 174571 Main Photo

The toilet seat is not located within the range allowed off the floor.

Citation:	As Built:	Budgeting Range:
2010 ADAS Section: 604.4	15 inches	\$150 - \$1,500.00

Adjust toilet height, replace toilet or replace toilet seat with one that will meet the minimum height of 17 inches but no more than maximum height of 19 inches.

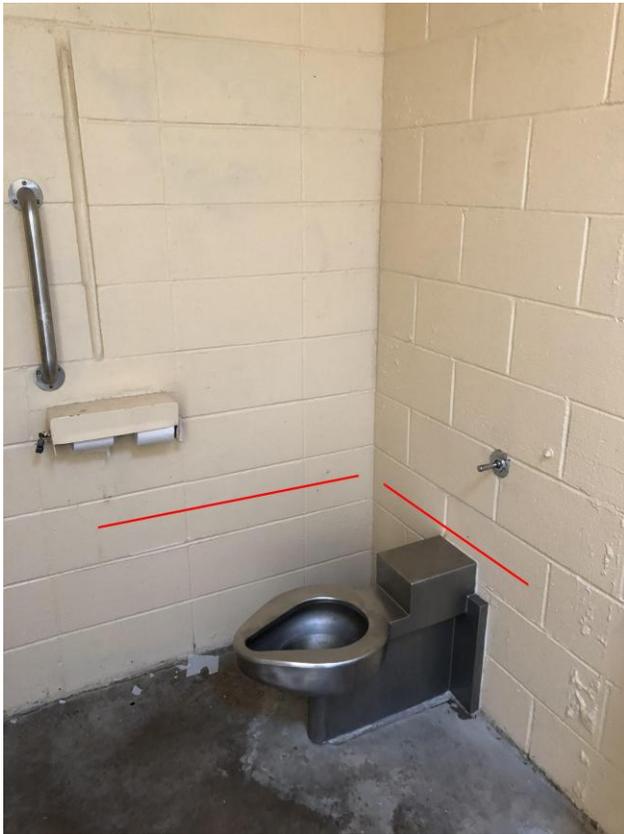
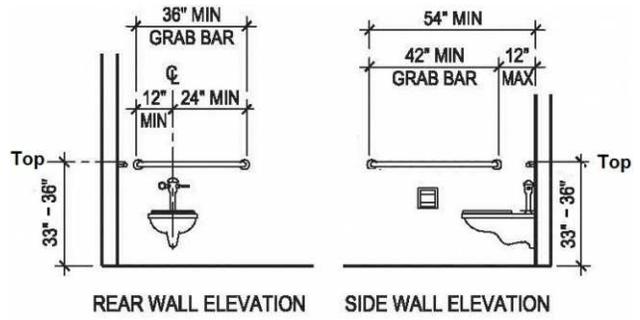
Finding 174578 Main Photo

Accessible toilets must have grab bars installed.

Missing grab bars

Install 1 side and 1 rear grab bar at 36 inches maximum above finished floor measured to the top of the gripping surface. Please see finding details for compliant measurements.

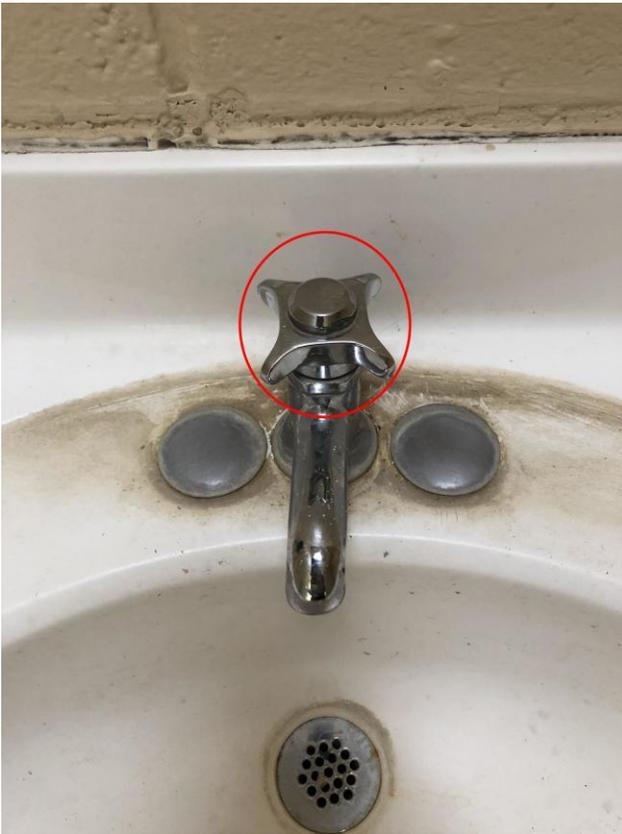
Finding 174236 Main Photo

The faucet controls require twisting of the wrist.

Faucet controls  
require tight grasping  
and twisting of the  
wrist

Install lever type faucet controls that do not require tight grasping, pinching or twisting of the wrist.

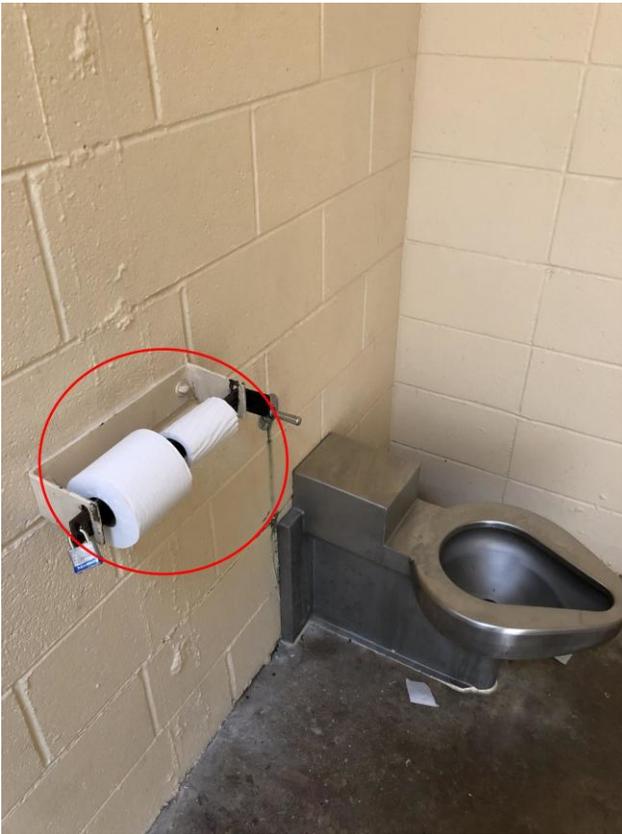
Finding 174582 Main Photo

The toilet paper is not installed within the compliant range.

Rear wall

Relocate and ensure toilet paper dispenser is between 7 inches minimum to 9 inches maximum in front of water closet measured to centerline of the dispenser. If toilet paper dispenser is installed above side grab bar ensure there is 12 inches of clearance minimum above side grab bar but no more than 48 inches in height measured from the floor to the center of the paper roll. If installed below grab bar ensure there is 1.5 inches clearance minimum but no less than 15 inches in height measured from the floor to the center of the paper roll.

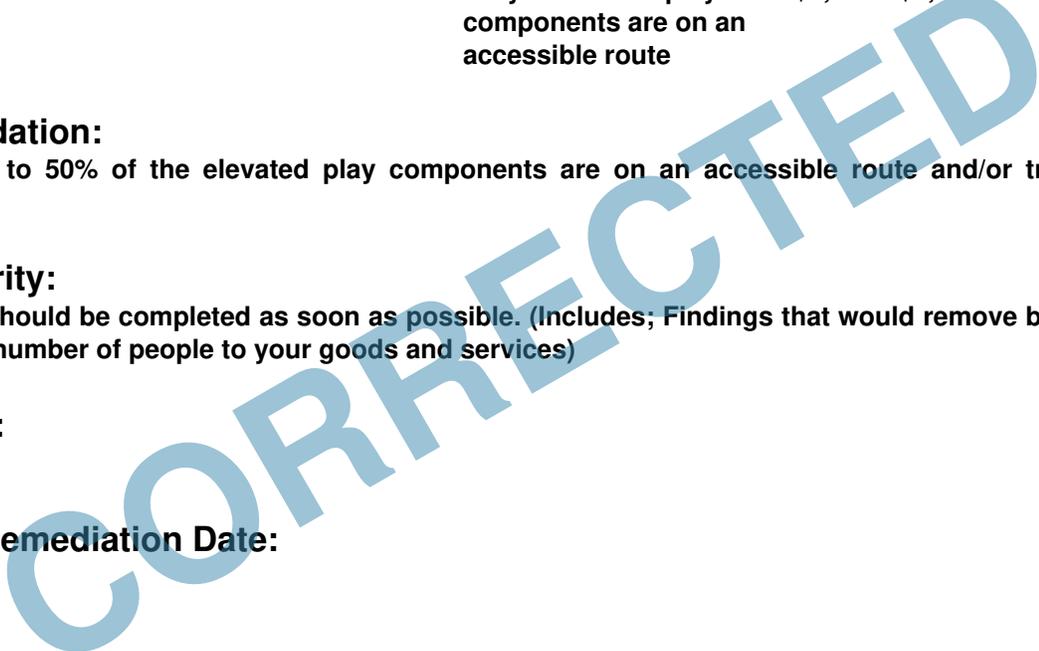
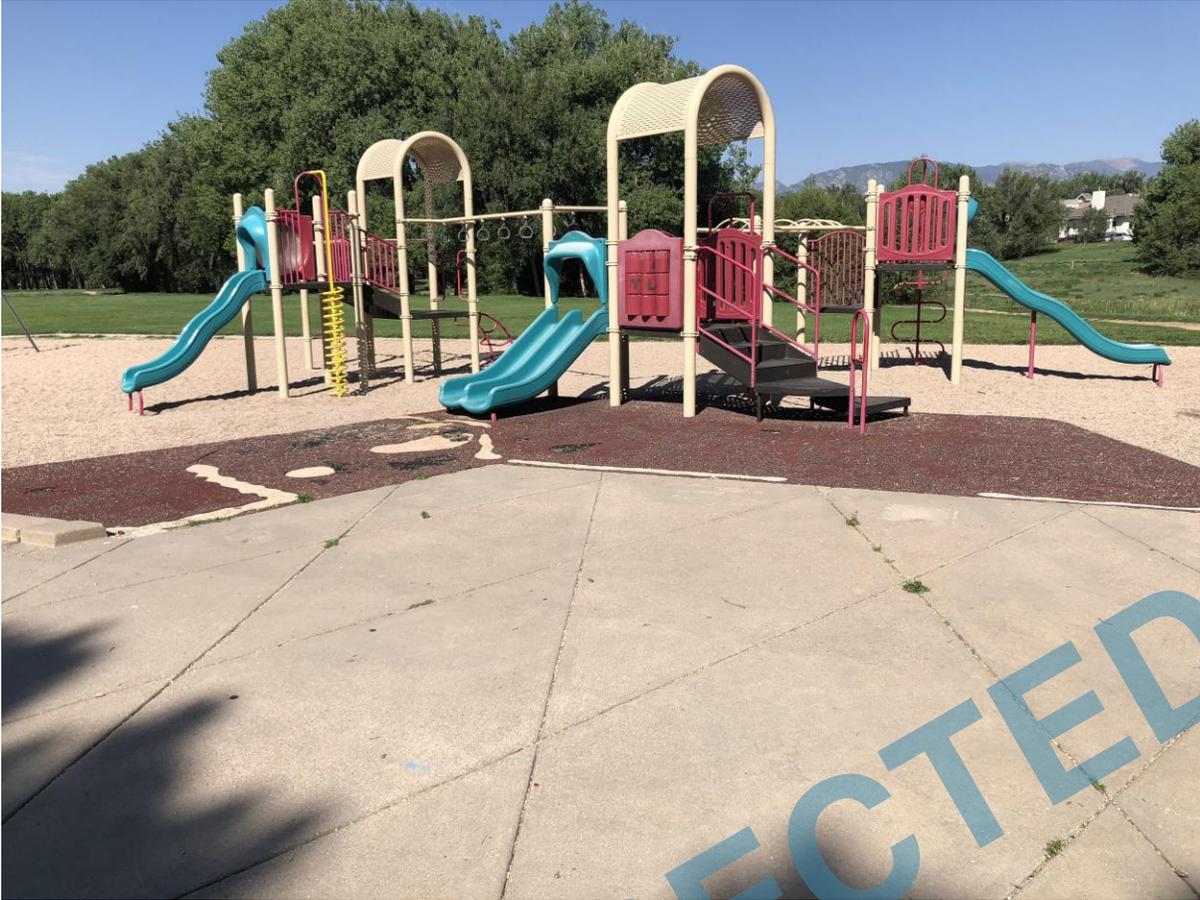
Finding 174688 Main Photo

There are not enough accessible elevated play components.

Only 2 elevated play components are on an accessible route

Ensure access to 50% of the elevated play components are on an accessible route and/or transfer system.
