Site Accessibility Evaluation

Centennial Hall

**200 S Cascade Ave
Downtown, CO 80903**

*Inspection Date: 05/14/2019
Inspector: David Mejia*

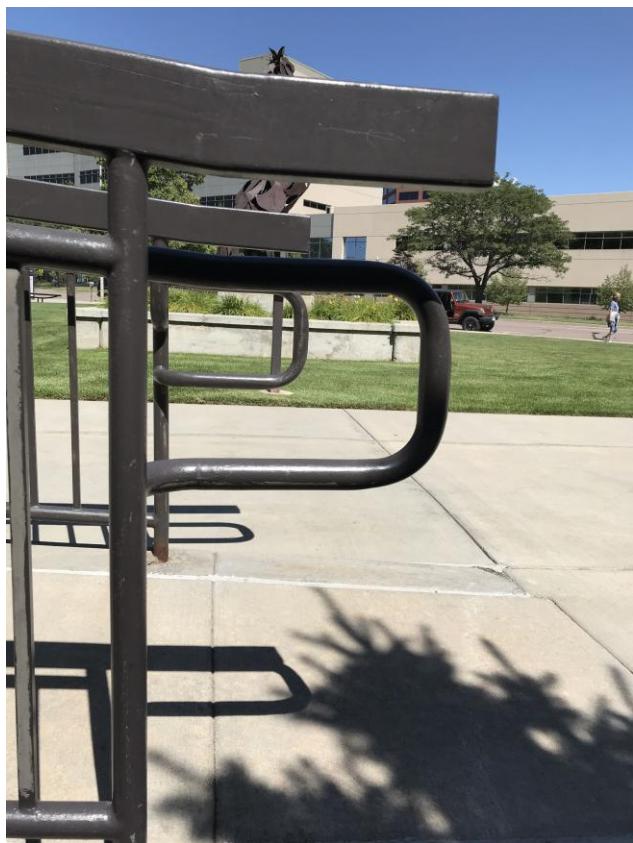
Finding 297822 Main Photo

The handrail does not extend horizontally.

2010 ADAS Section 505.10.1

Handrail does not extend full length of ramp

Modify existing handrails to extend the full length of the ramp.

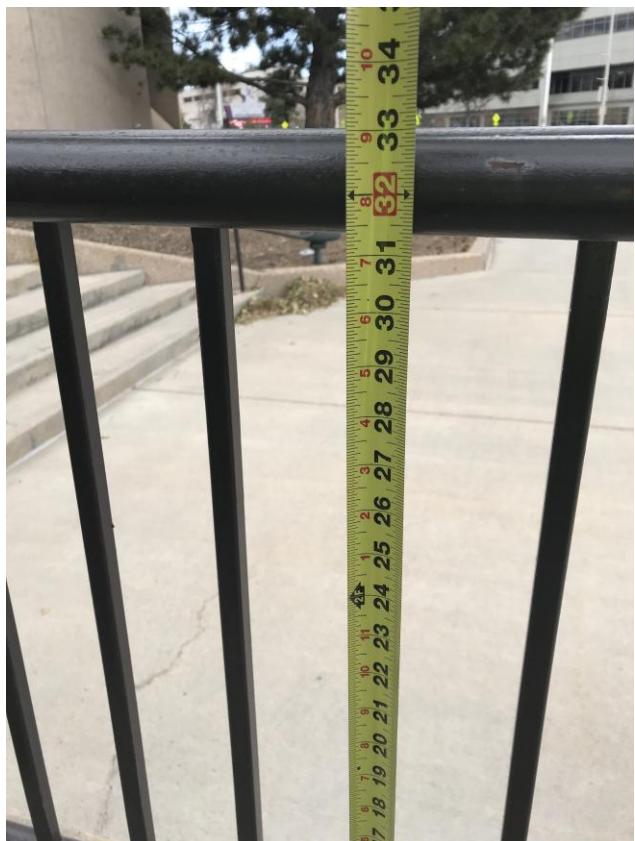
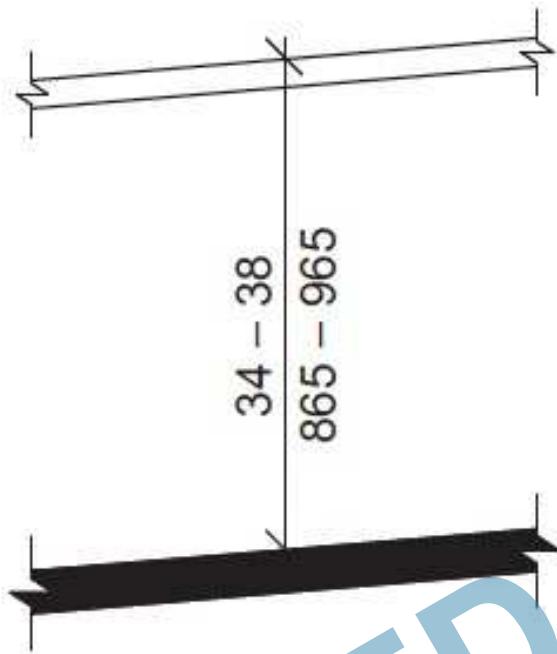
The handrails are mounted too low.

2010 ADAS Section 505.4

Handrail height
between 32 and 33
inches above finished
floor

Modify existing handrails and ensure handrails are installed between 34 inches and 38 inches above finished floor.

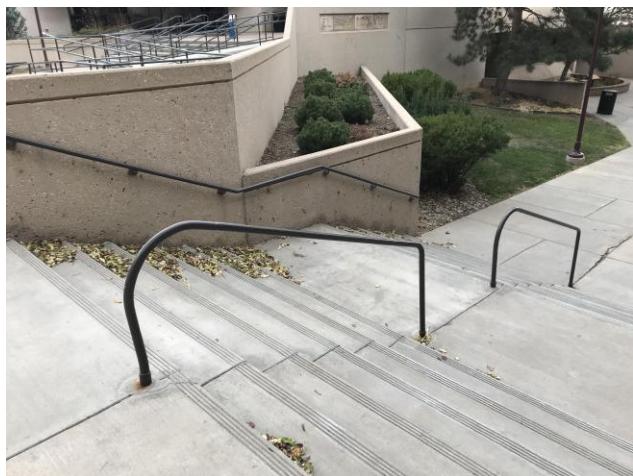
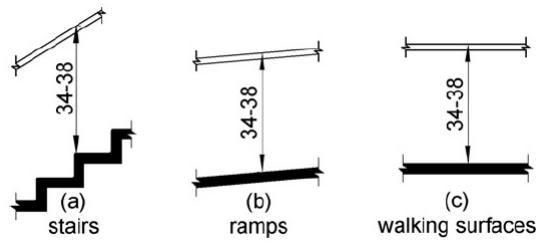
Finding 297823 Main Photo

The handrails as well as the handrail extensions are not at the correct height.

2010 ADAS Section 505.4

**Handrails below 34
inches minimum
height required**

Re-place existing handrails with handrails no lower than 34 inches from the top of the griping surface and ensure extensions are also included at the top and bottom landings.

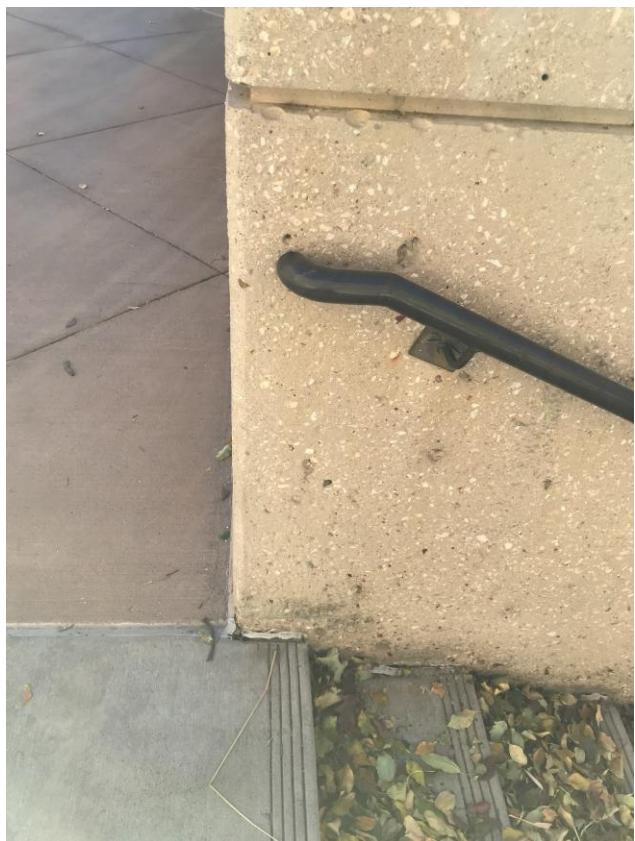
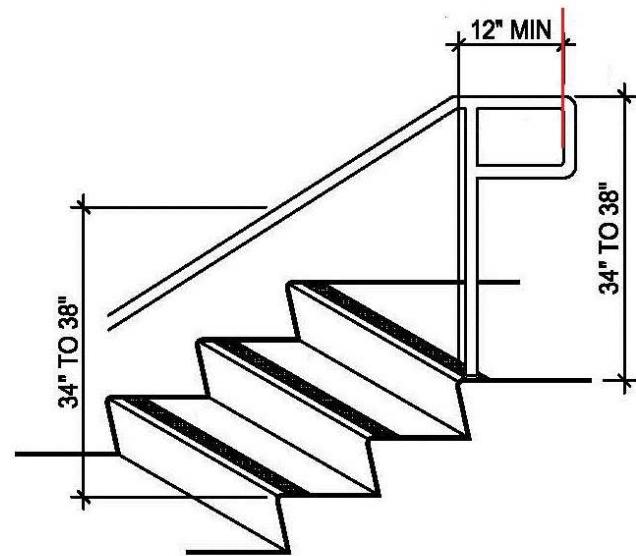
Finding 298357 Main Photo

The handrail projects less than 12 inches beyond the landing at the top of the stairs parallel to the floor or ground.

2010 ADAS Section 505.10.2

31.75 inches above
finished floor

Re-construct or modify existing handrails and ensure handrails are installed between 34 inches and 38 inches above finished floor and extend horizontally above the landing for 12 inches minimum.

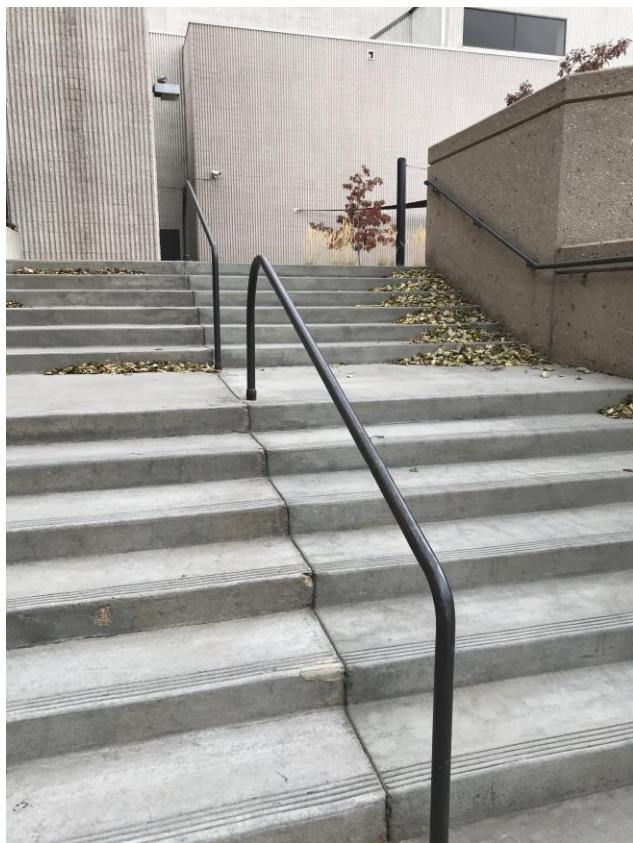
Finding 298358 Main Photo

The handrail does not have a compliant extension at the bottom of the stair flight.

2010 ADAS Section 505.10.3

Does not extend the length of one tread

Re-construct or modify existing handrails and ensure handrails are installed between 34 inches and 38 inches above finished floor and extend a horizontal distance at least equal to one tread depth beyond the last riser nosing.

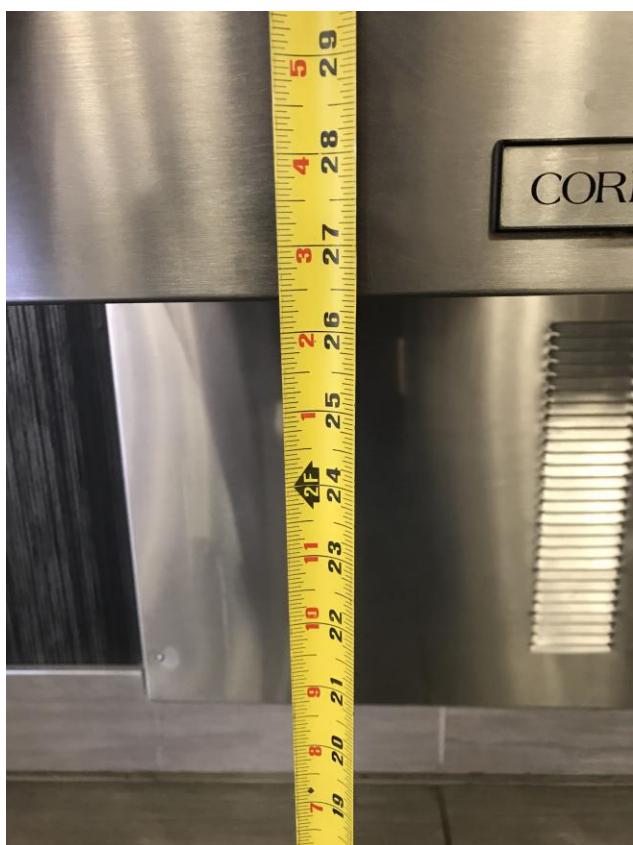
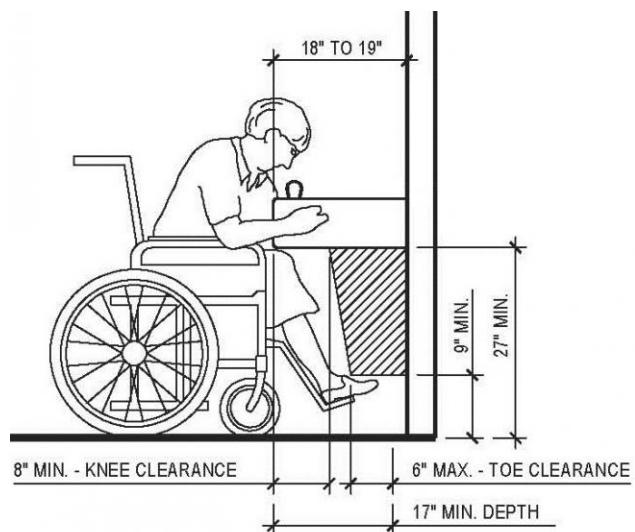
Finding 297764 Main Photo

There is not enough knee clearance under the drinking fountain.

2010 ADAS Section 602.2

Bottom edge of
drinking fountain at
26.5 inches

Adjust drinking fountain height to provide 27 inches of clearance.

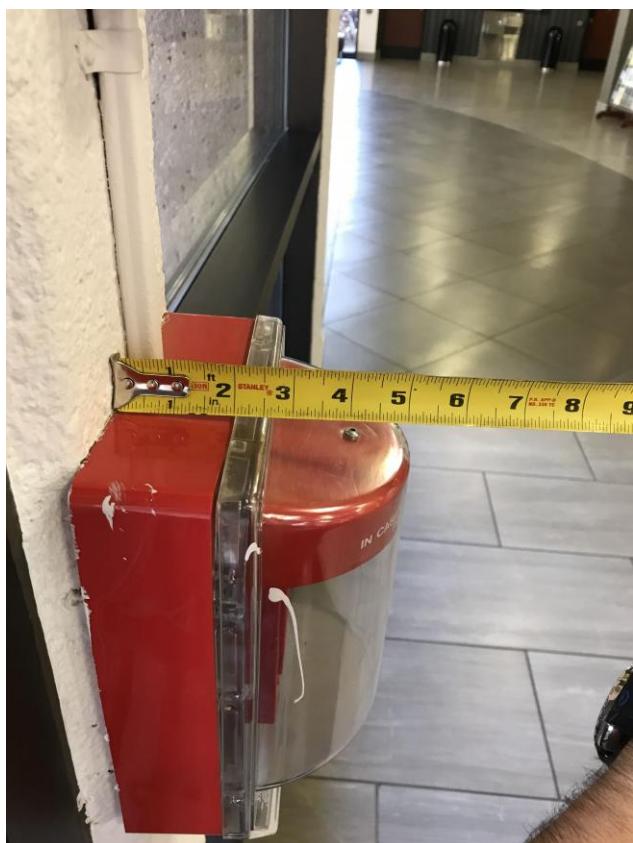
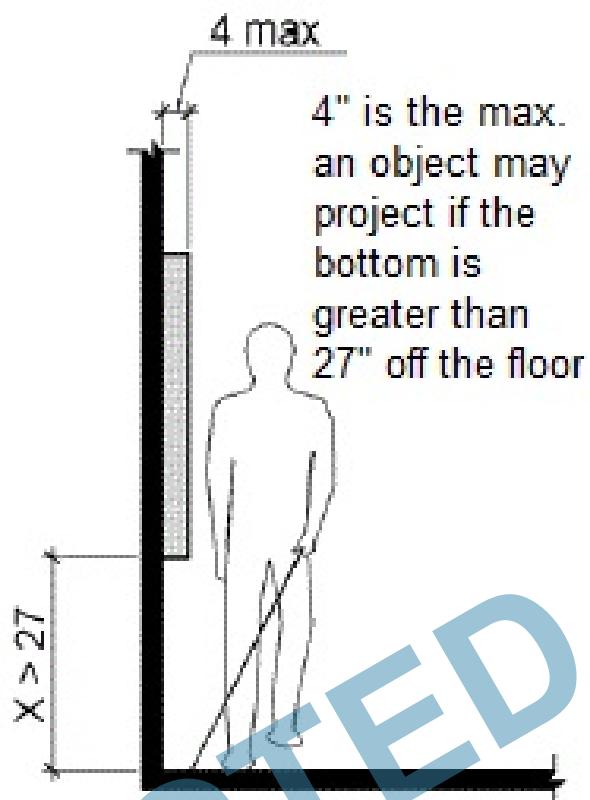
Finding 297765 Main Photo

The fire alarm housing projects more than 4 inches into the circulation path.

2010 ADAS Section 307.2

Protrudes 6 inches
from wall

If possible, replace fire alarm housing with low profile housing or recess housing into wall to meet the 4 inch maximum protrusion.

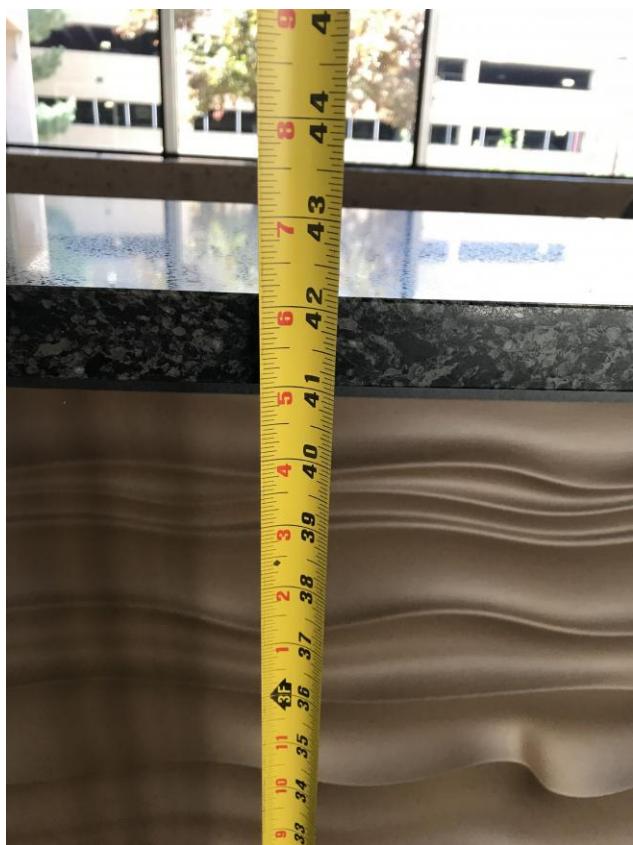
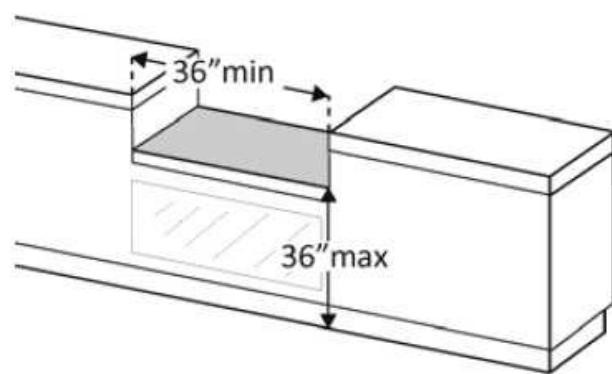
Finding 297766 Main Photo

The transaction counter is too high.

2010 ADAS Section: 904.4.2, 904.4.1

**42 inches above
finished floor**

Install compliant service counter or addition to existing service counter that includes a section of counter surface that is 36 inches long minimum and 36 inches high maximum.

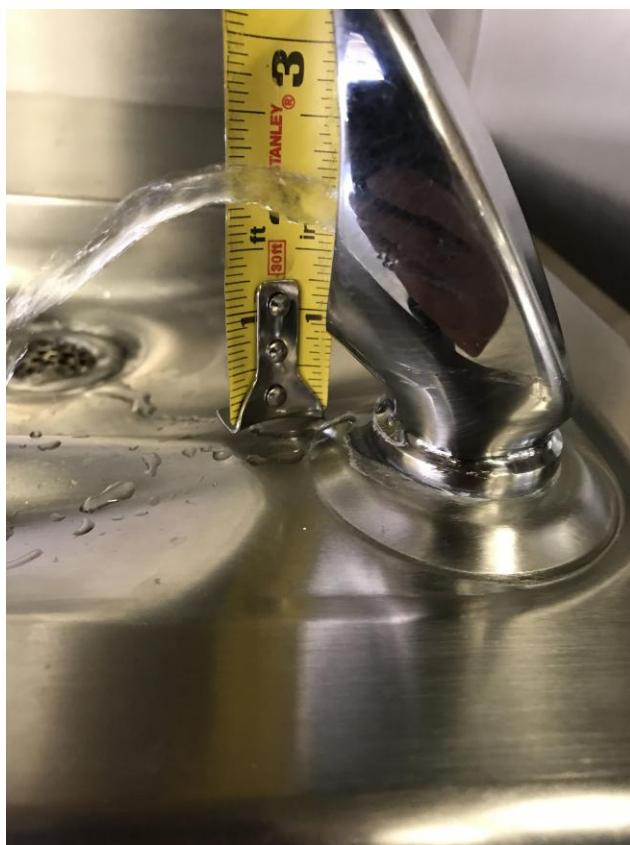
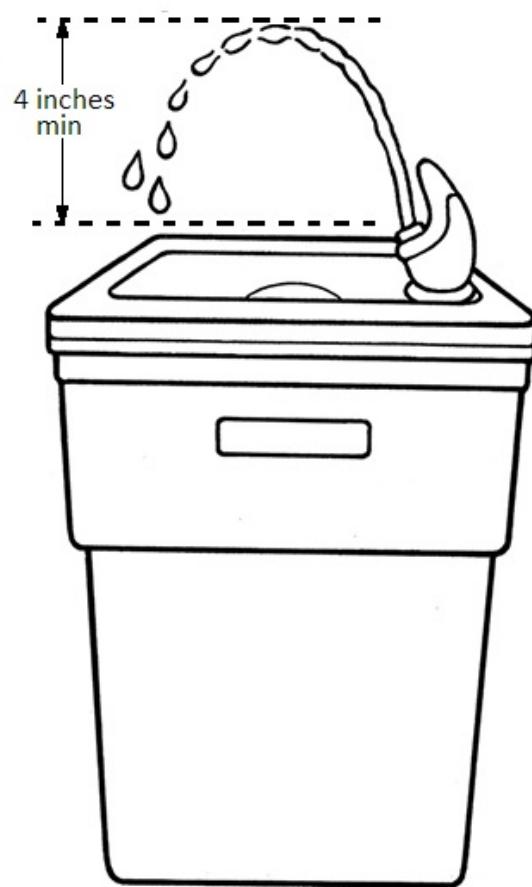
Finding 297815 Main Photo

The water flow from the spout is too low..

2010 ADAS Section 602.6

**1.5 inches flow of
water**

Adjust water flow pressure to provide flow of water 4 inches high minimum.

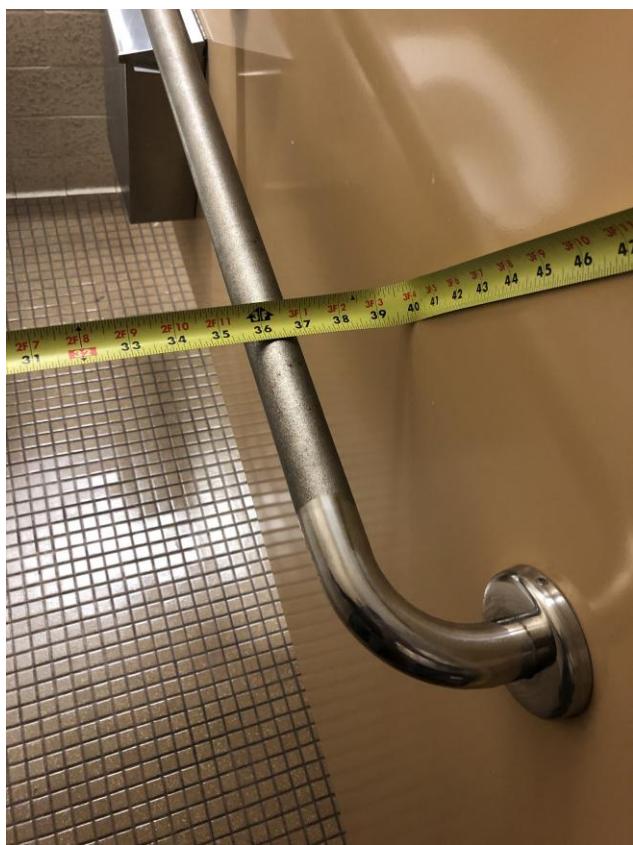
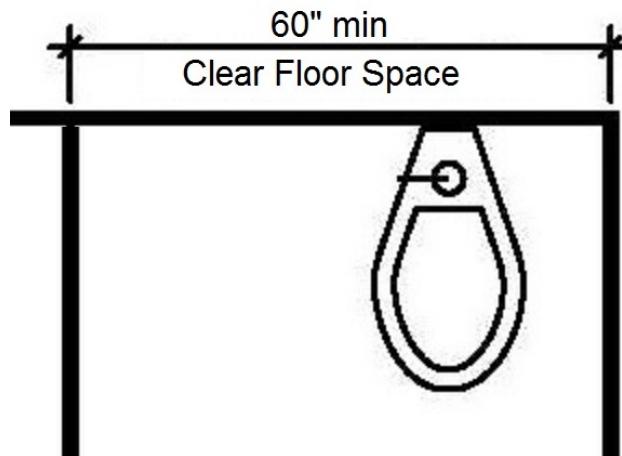
Finding 297049 Main Photo

The toilet compartment is not wide enough.

2010 ADAS Section 604.8.1.1

40 inches wide

Re-design and remodel restroom to meet compliance to the extent feasible.

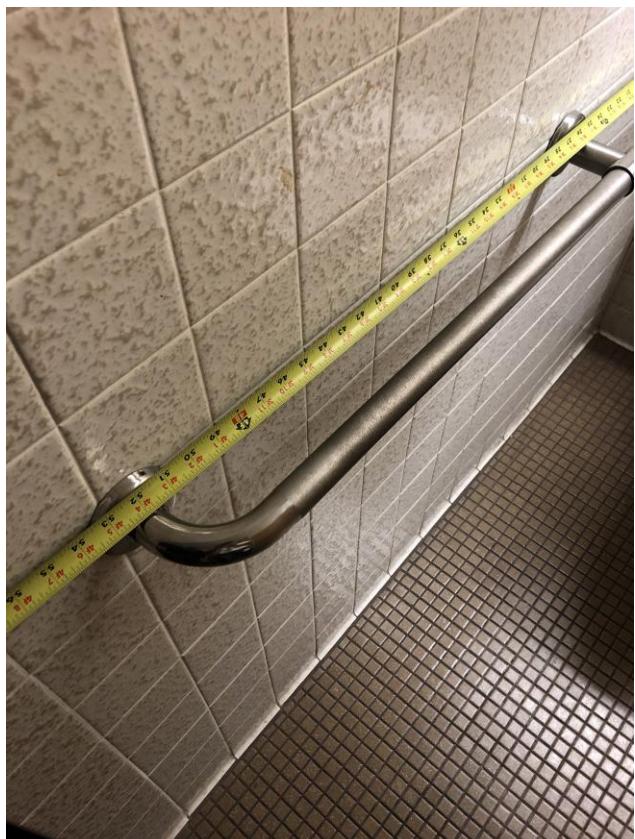
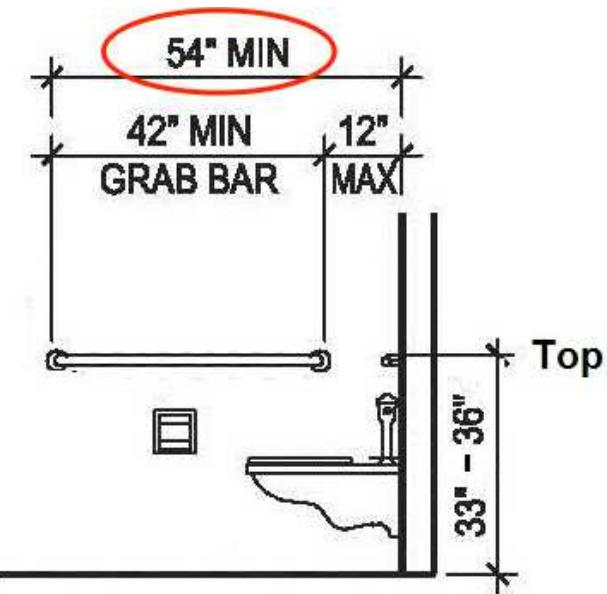
The side grab bar does not extend far enough from the rear wall.

2010 ADAS Section 604.5.1

10 inches from rear
wall

Upon remodel install new side grab bar to meet compliance.

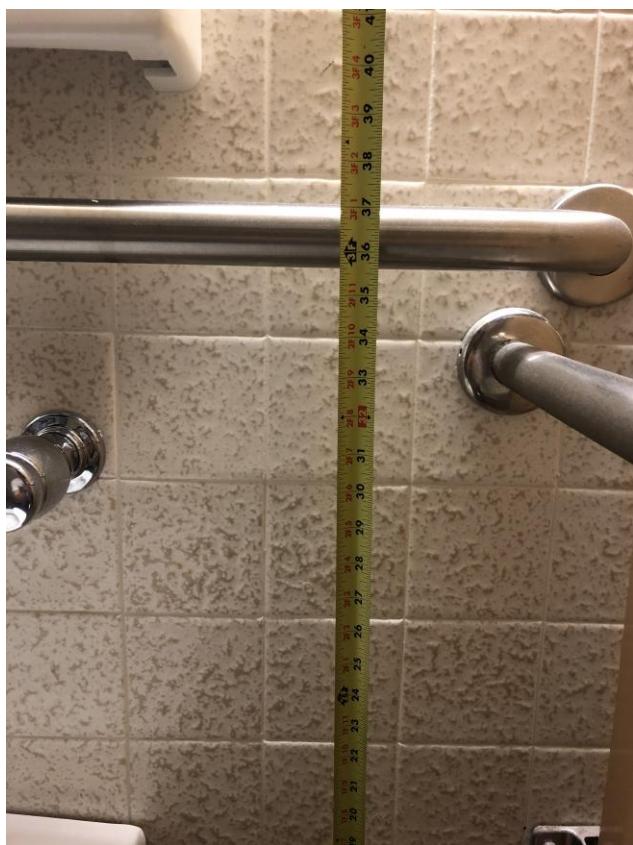
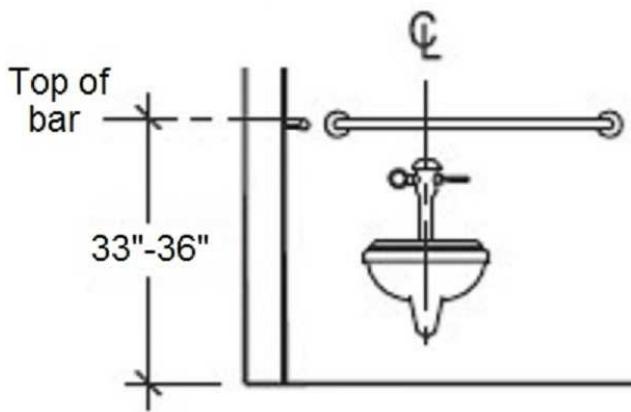
Finding 297051 Main Photo

The rear grab bar is too high.

2010 ADAS Section 609.4

37 inches above
finished floor

Lower grab bar between 1 and 3 inches to meet compliance.

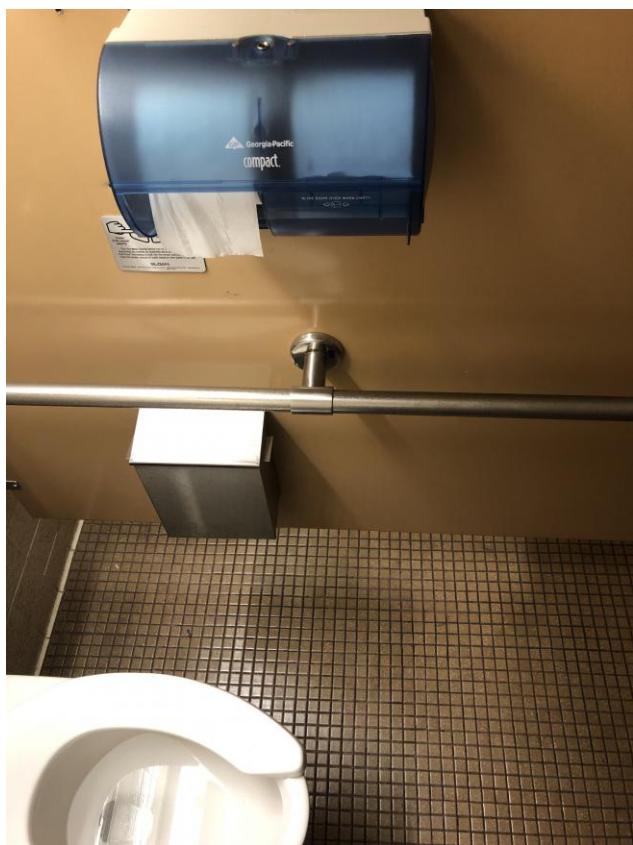
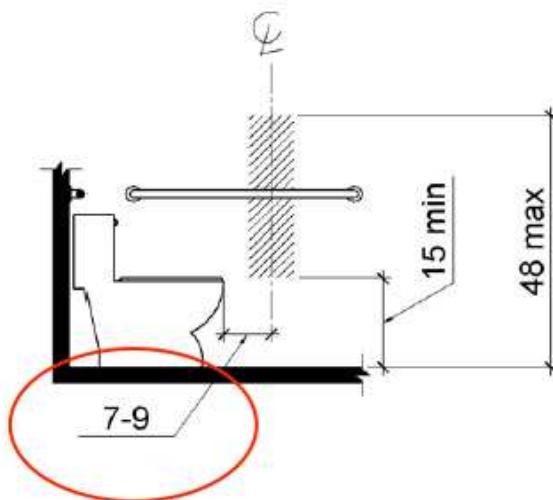
Finding 297052 Main Photo

The toilet paper is not installed within the compliant range in front of the toilet.

2010 ADAS Section 604.7

2 inches in front of
toilet

Re-design and remodel restroom to meet compliance to the extent feasible.

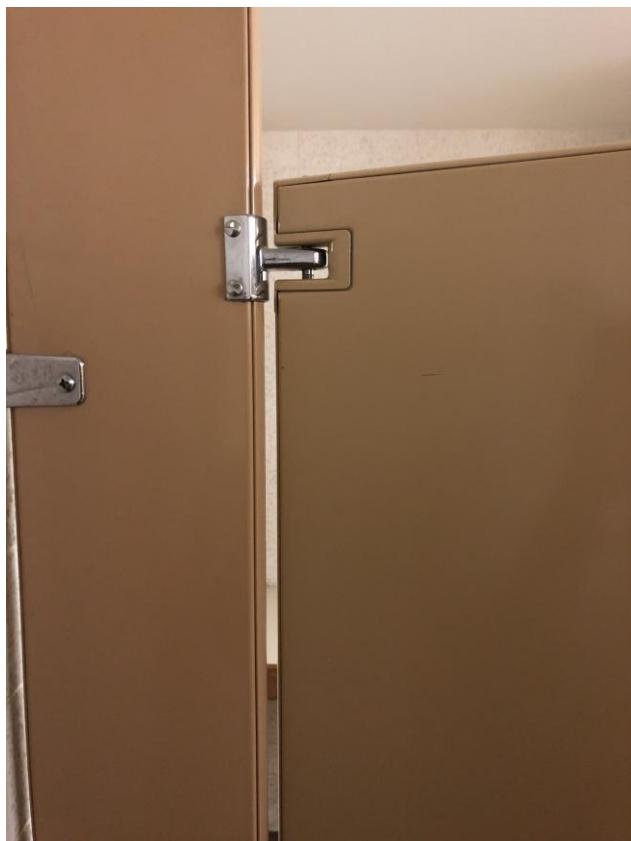
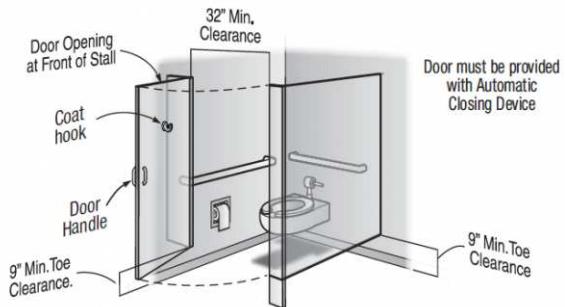
The compartment door is not self closing.

2010 ADAS Section 604.8.1.2

Door not-self closing

Re-design and remodel restroom to meet compliance to the extent feasible.

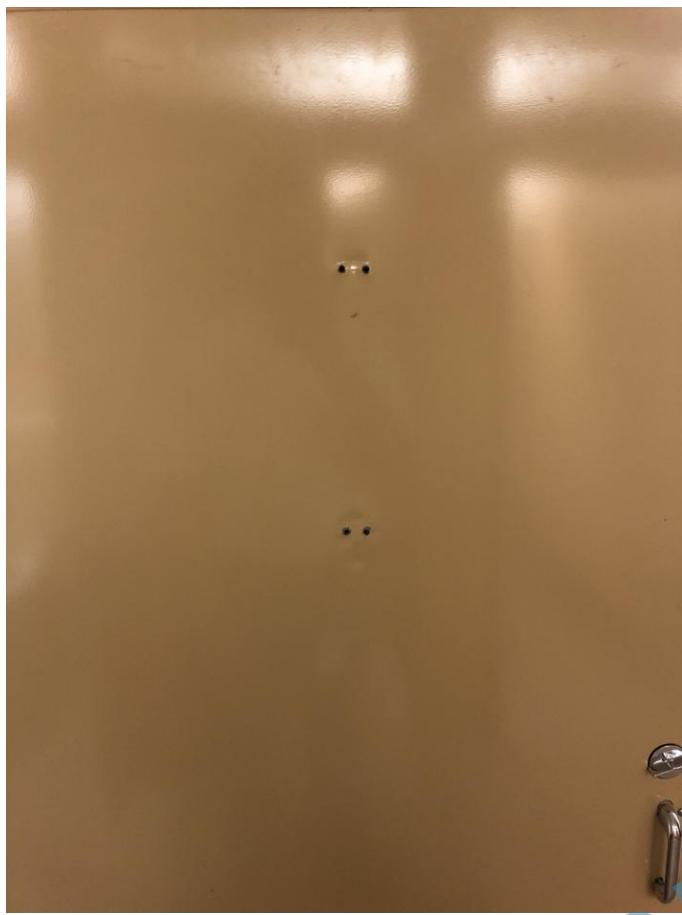
Finding 297047 Main Photo

The coat hook is missing.

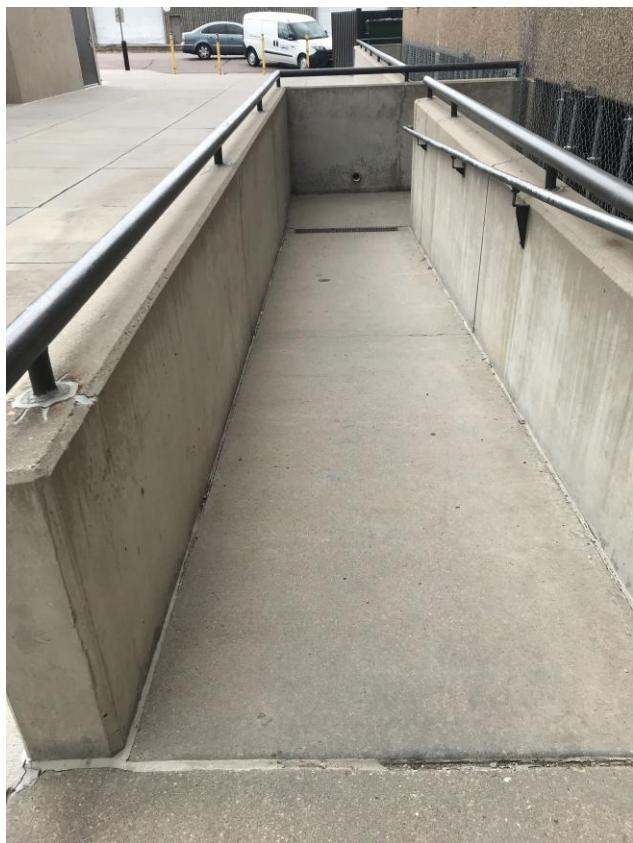
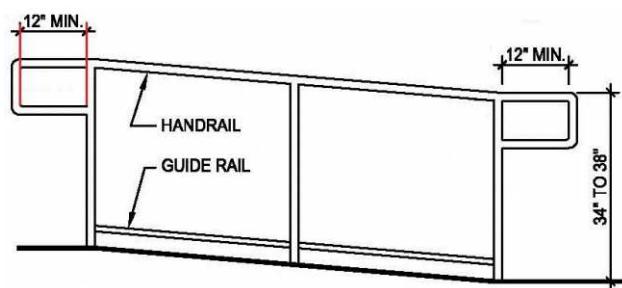
Finding 297771 Main Photo

**Missing handrail on
one side of ramp**

Install missing handrail for entire length of ramp between 34 and 38 inches to top of gripping surface measured above the finished floor. Handrail must extend beyond the top and bottom of the ramp 12 inches and be parallel to the floor or ground surface
