Site Accessibility Evaluation

Americans with Disabilities Act Title II (Public Services: State and Local Government)

Fair and Events Complex

**366 10th St
Calhan, CO 80808**

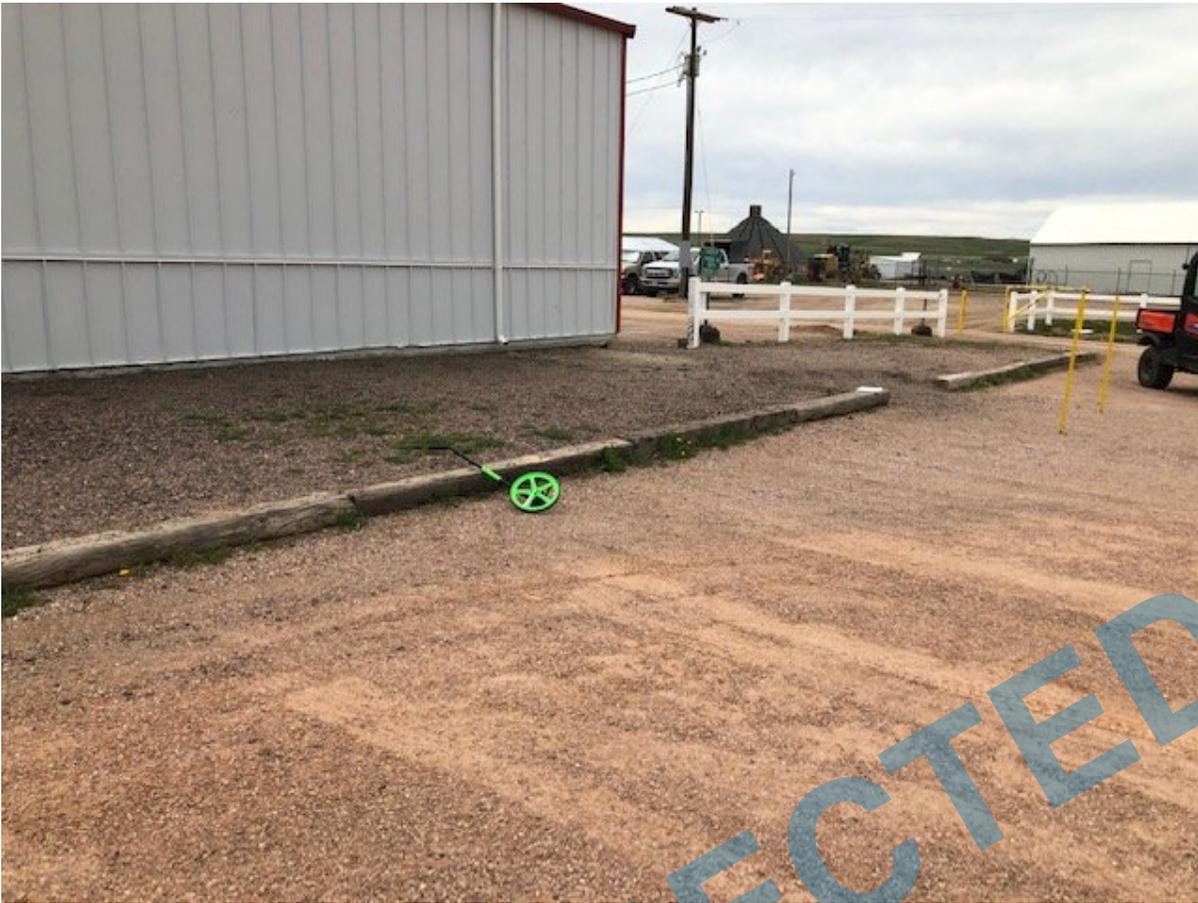
Finding 297090 Main Photo

Finding: 1

The surfaces of the accessible parking spaces and access aisles are not firm, stable, and slip resistant.

Gravel / loose dirt

Pave and stripe northern parking lot to meet compliance. Parking lot currently is usable but during the annual County Fair event, the parking lot is strictly used for accessible parking only. During this time the parking lot is not compliant and does not meet the 2010 ADA Standards. Due to estimated costs and time frame, parking lot will be earmarked for the upcoming year to be presented to the Board of County Commissioners for budget approval.

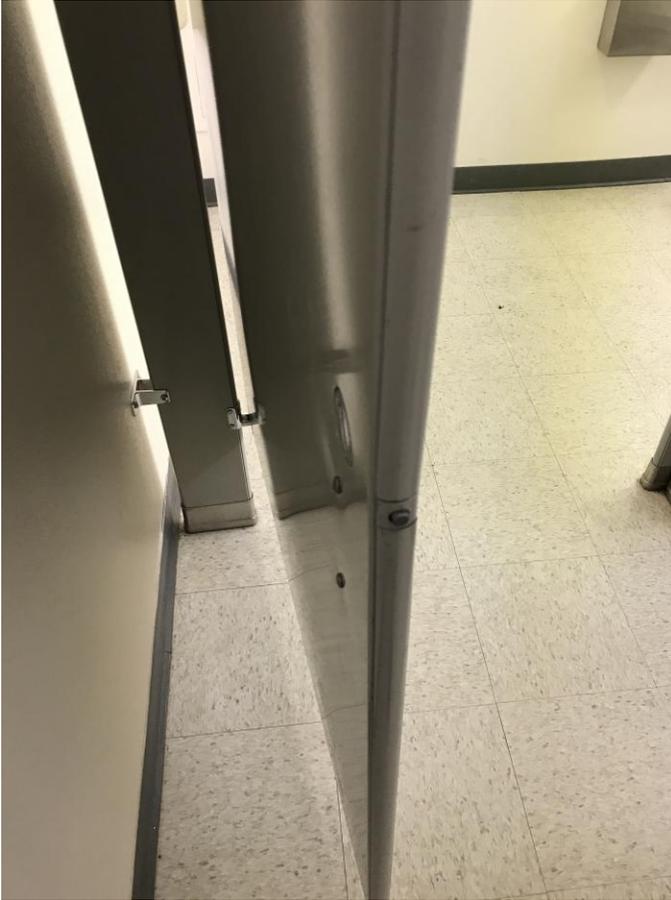
Finding 297895 Main Photo

The water closet compartment door is missing a loop handle on the outside.

Missing loop handle
on outside of
compartment door

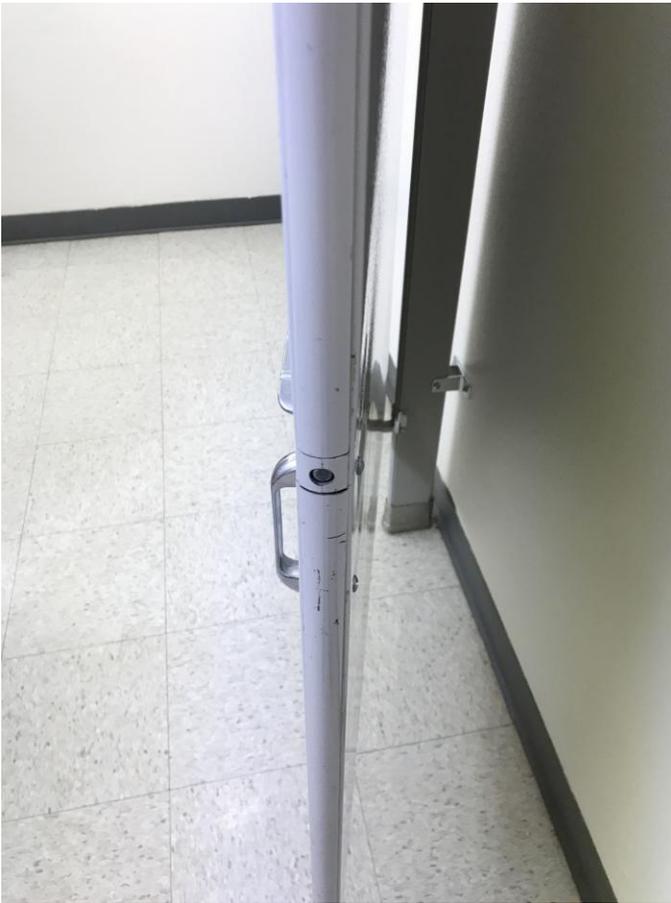
Finding 297884 Main Photo

The water closet compartment door is missing a loop handle on the outside.

Missing loop handle
on outside of
compartment door

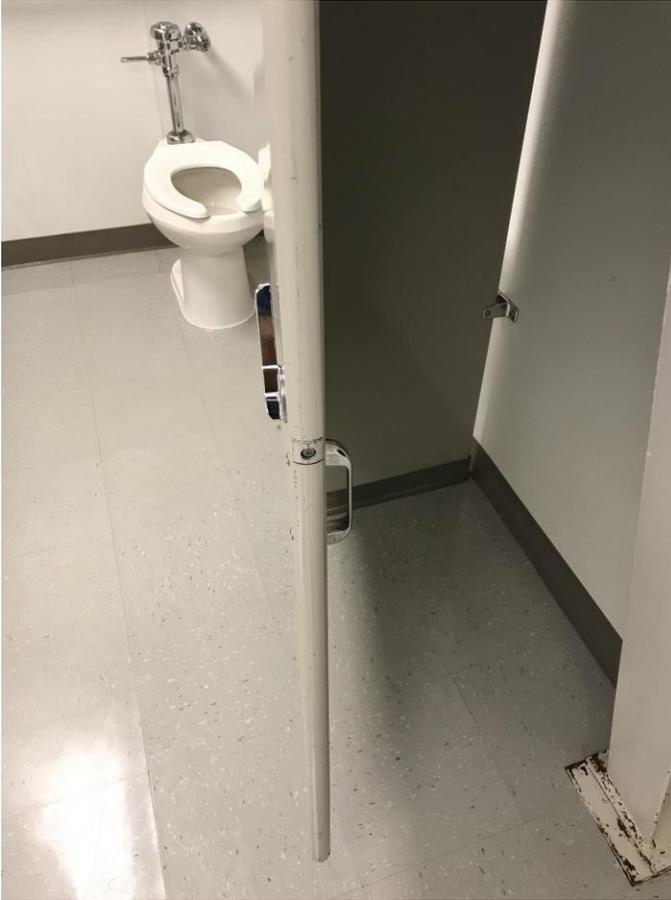
Finding 297975 Main Photo

The water closet compartment door is missing a loop handle on the outside.

Missing loop handles
on outside of
compartment door

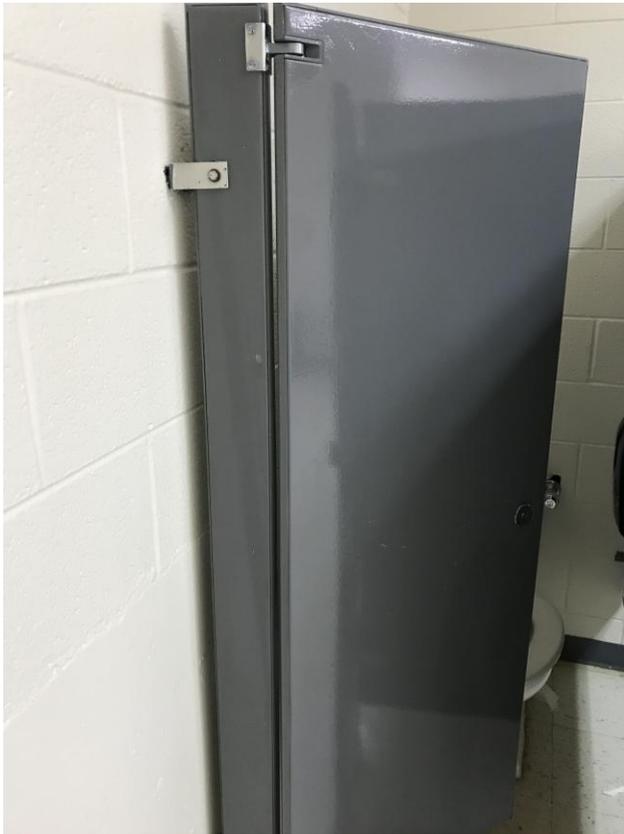
Finding 297961 Main Photo

The water closet compartment door is missing a loop handle.

Missing loop handles
on both sides of
compartment door
