Site Accessibility Evaluation

Americans with Disabilities Act Title II (Public Services: State and Local Government)

Pikes Peak Center

***Inspection Date: 04/10/2018
Inspector: David Mejia***

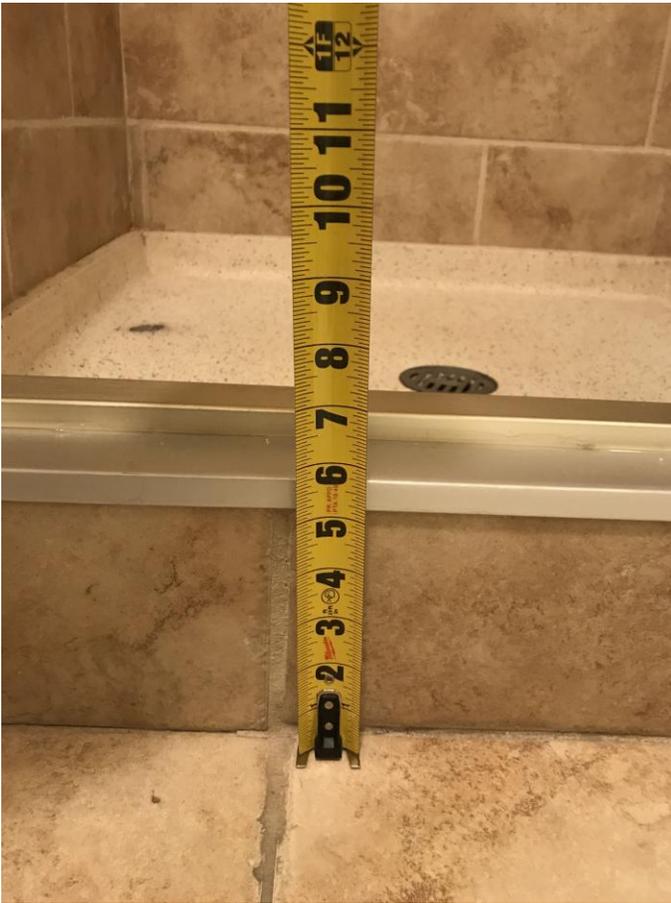
Finding 299082 Main Photo

Dressing Room 4

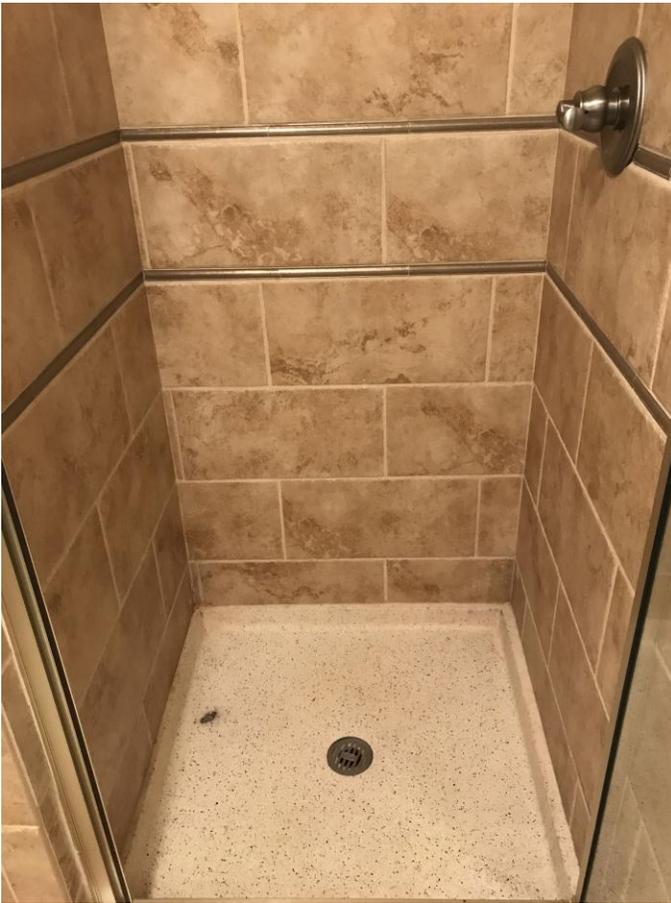
Finding 299085 Main Photo

Dressing Room 4

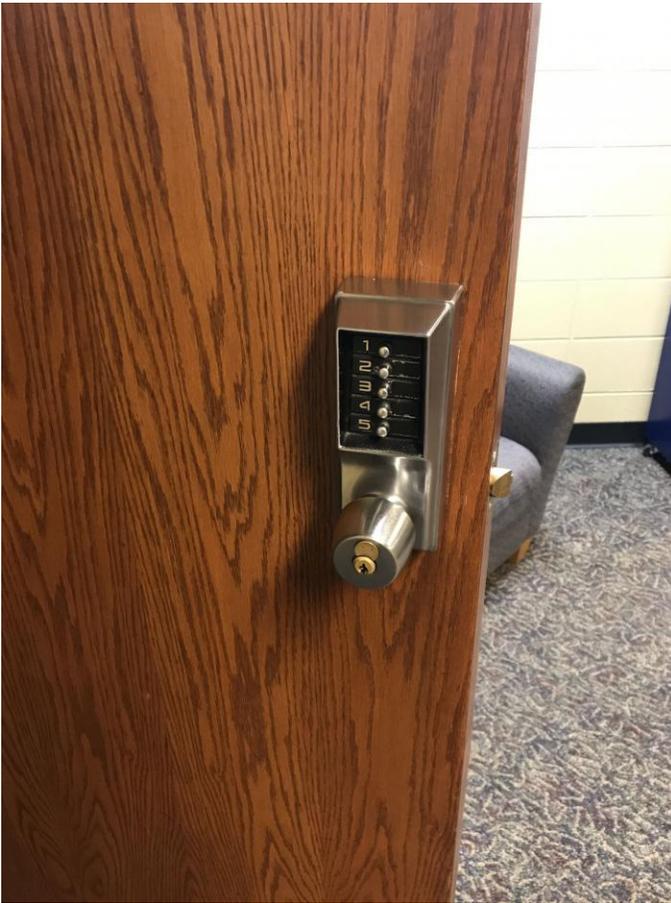
Finding 299089 Main Photo

1st Floor, N. side, Performers Mens ADA Restrooms (Orchestra Level)

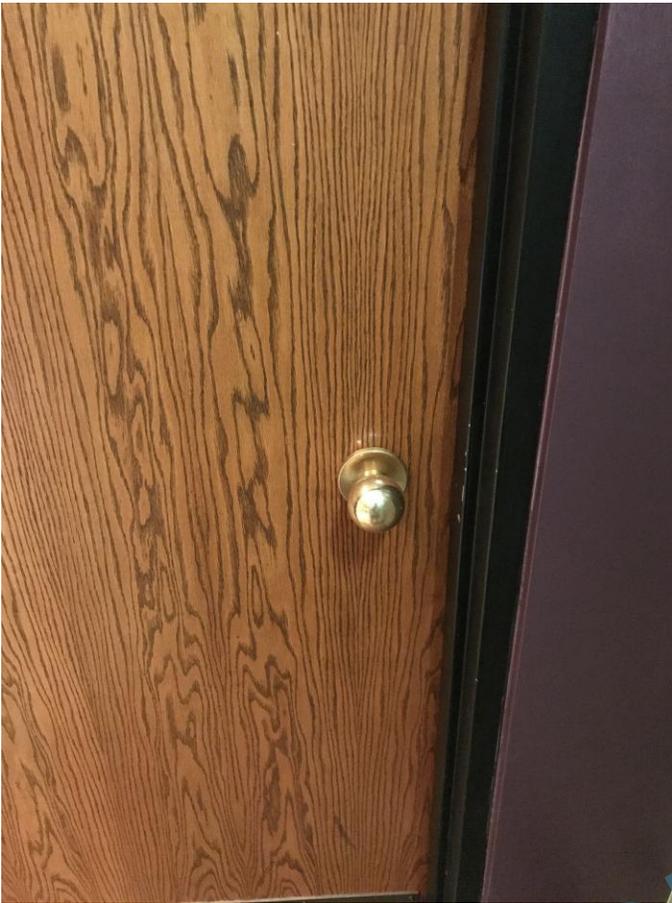
Finding 298951 Main Photo

1st Floor, N. side, Studio Bee, Mens Restrooms (Orchestra Level)

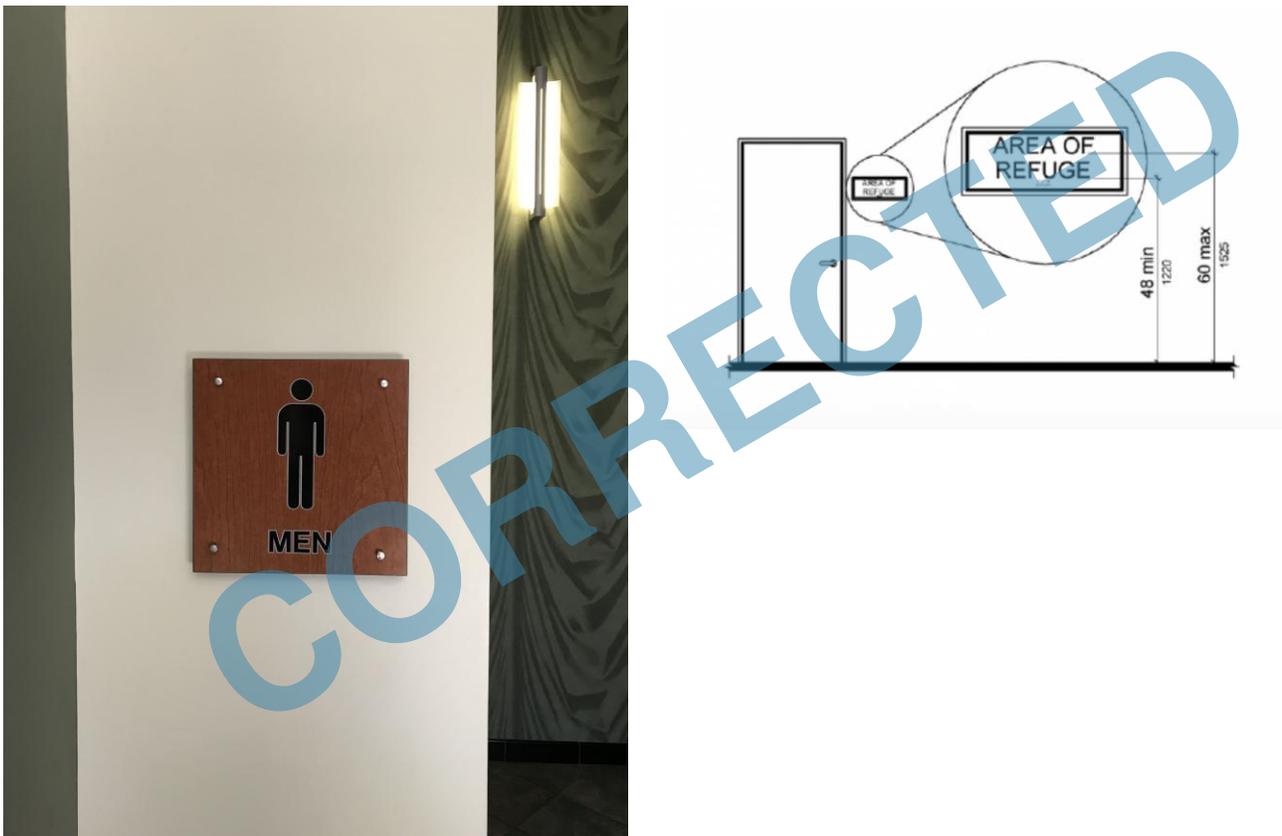
Finding 299007 Main Photo

1st Floor, S. side, Mens Restrooms (Orchestra Level)

Providing the minimum required width clearance to the restroom is technically infeasible at this time because existing structural conditions would require removing or altering a load-bearing member that is an essential part of the structural frame; or because other existing physical or site constraints prohibit modification or addition of elements, spaces, or features that are in full and strict compliance with the minimum requirements. Best practice measures are recommended to ensure restroom is accessible to the maximum extent feasible. Would recommend updating restroom when feasible or during alteration or new construction to meet current ADA standards.

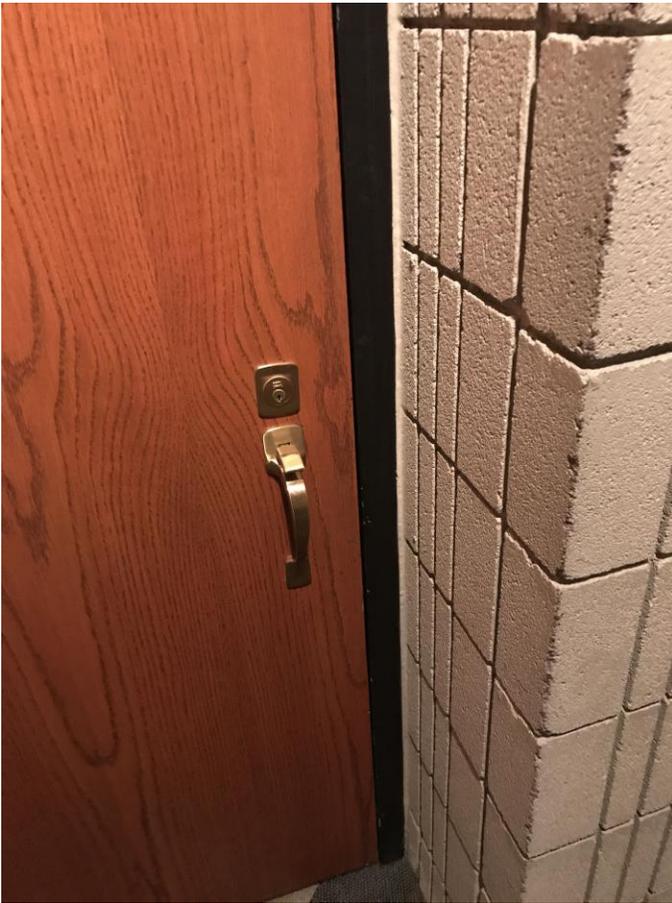
Finding 299065 Main Photo

Northside Loge Ramp/Entrance Orchestra Level

Recommend installing automatic door opener to provide access to Loge area and eliminate barrier.

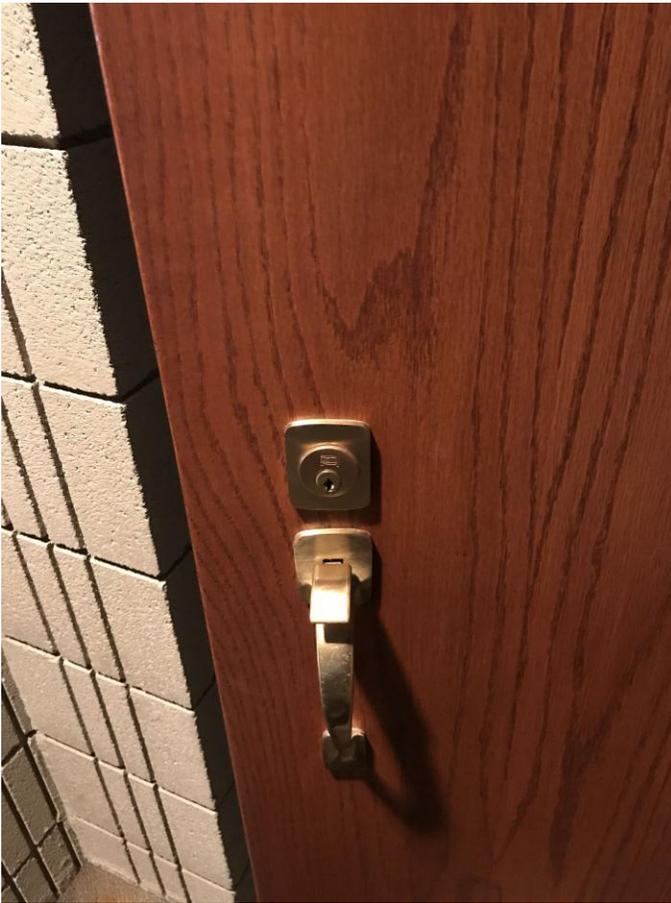
Finding 299069 Main Photo

Loge Seating Area
