Site Accessibility Evaluation

Sahwatch Parking Garage

**255 Sahwatch St
Colorado Springs, CO
80903**

Accessibility Evaluation

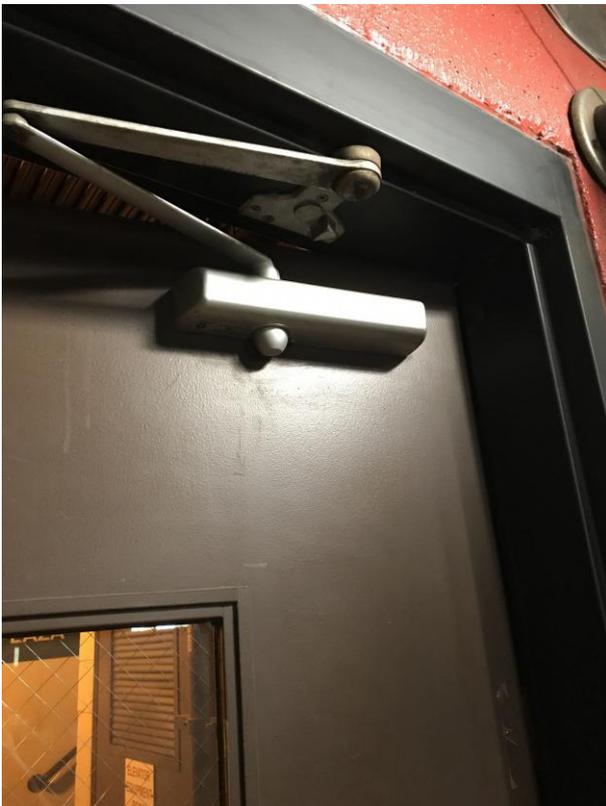
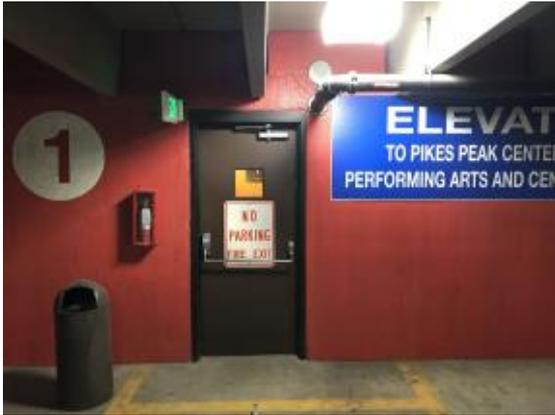
Finding 297982 Main Photo

The door is equipped with a door closer and returns to a closed position too quickly.

As Built:

2.5 seconds to closed position

Adjust door closer to allow a minimum of 5 seconds before returning to a position of 12 degrees from the latch/locking mechanism.

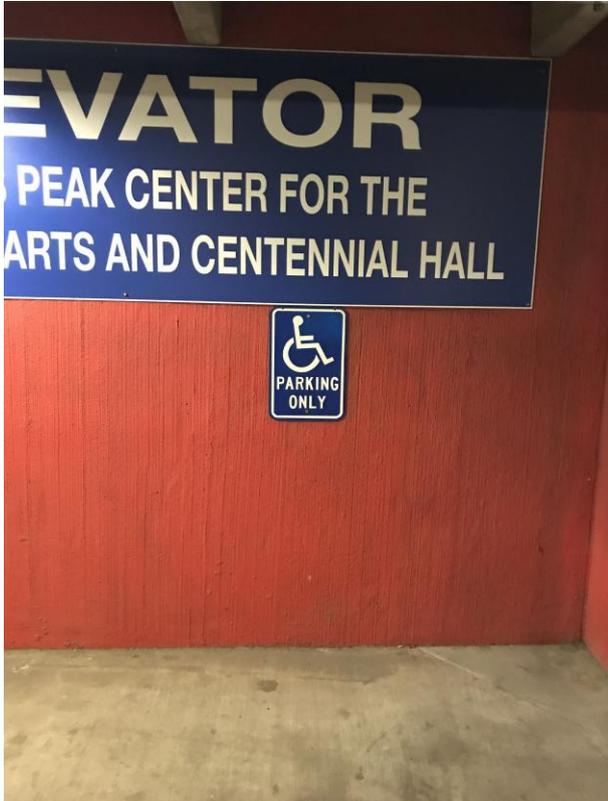
Finding 297983 Main Photo

The van stall is missing a sign identifying it as a van accessible stall.

As Built:

Van accessible sign missing

Replace existing sign with ISA sign that also includes "Van Accessible" verbiage.

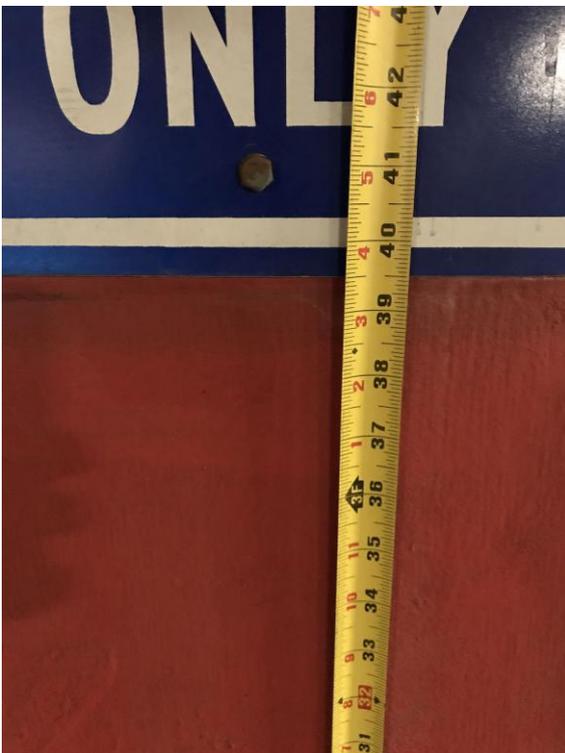
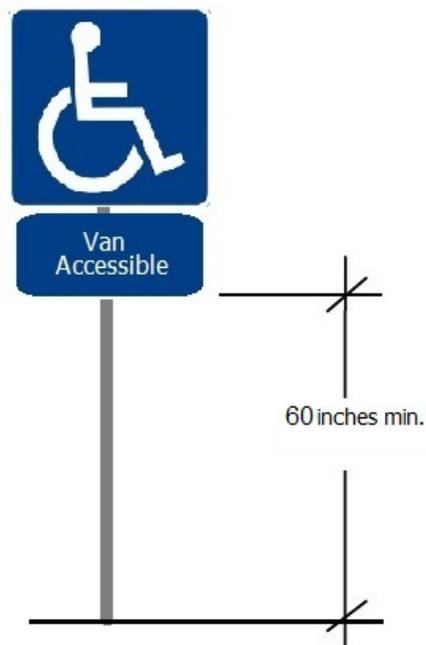
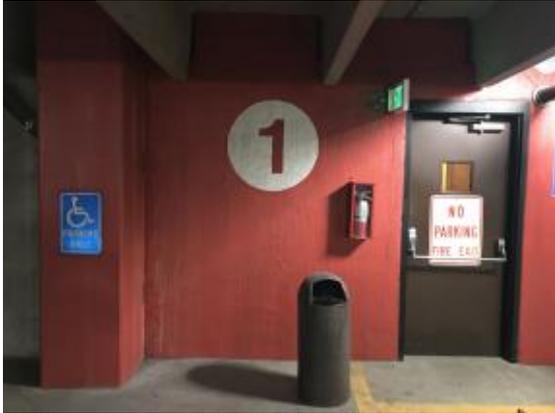
Finding 297984 Main Photo

The parking sign is mounted too low.

As Built:

39.5 inches above finished floor

Ensure new ISA van sign is placed no lower than 60 inches minimum measured from the bottom edge of the sign above the finished floor.

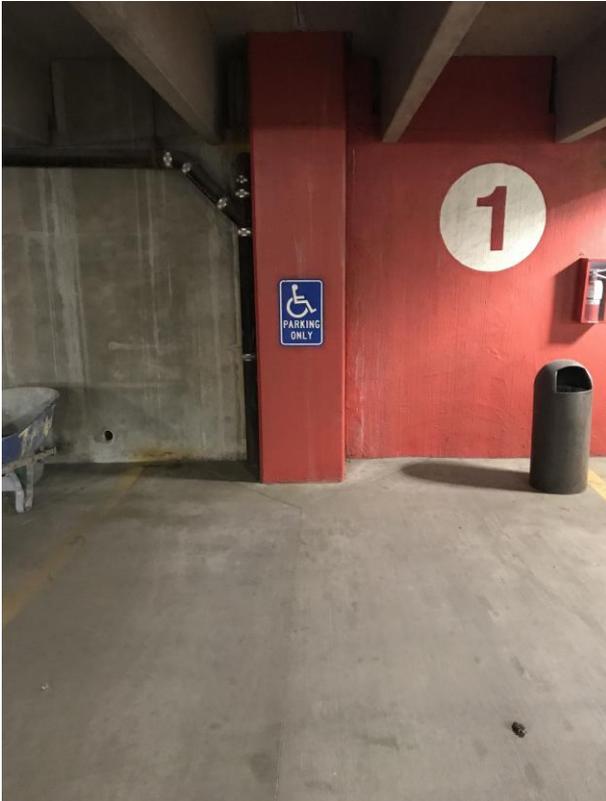
Finding 297985 Main Photo

The van stall is missing a sign identifying it as a van accessible stall.

As Built:

Van accessible sign missing

Replace existing sign with ISA sign that also includes "Van Accessible" verbiage.

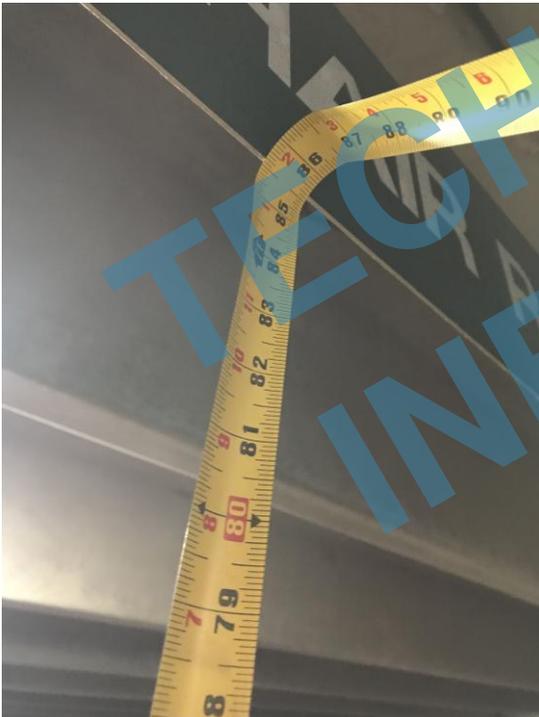
Finding 297986 Main Photo

The vehicle route to the accessible parking contains vertical clearances less than 98 inches.

As Built:

85.5 inches above
finish floor

Providing the minimum required height clearance to the parking structure is technically infeasible at this time because existing structural conditions would require removing or altering a load-bearing member that is an essential part of the structural frame; or because other existing physical or site constraints prohibit modification or addition of elements, spaces, or features that are in full and strict compliance with the minimum requirements. Best practice measures are recommended to ensure parking structure is accessible to the maximum extent possible.

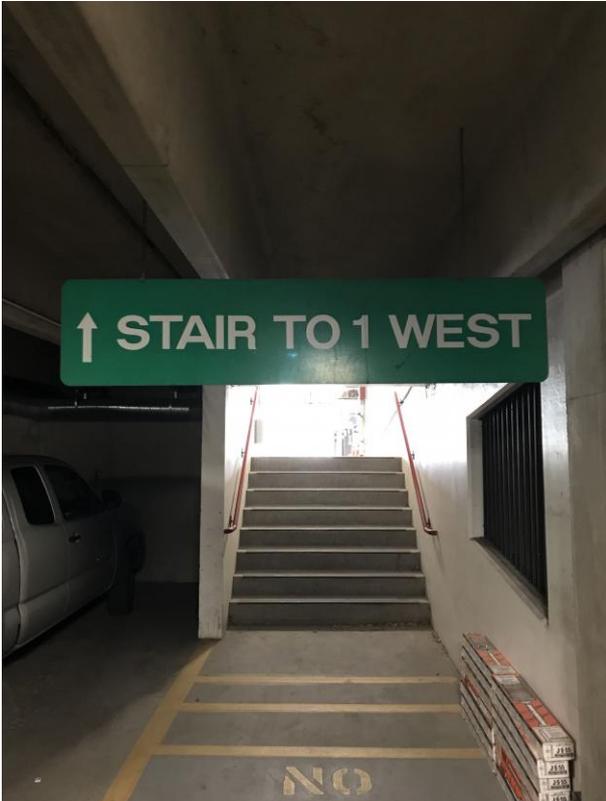
Finding 297987 Main Photo

The "Stair to 1 West" overhanging sign extends down too close to the route of travel.

As Built:

75.5 inches above finished floor

Adjust overhanging sign to provide a minimum of 80 inches above the walking surface measured from the bottom edge of the sign.

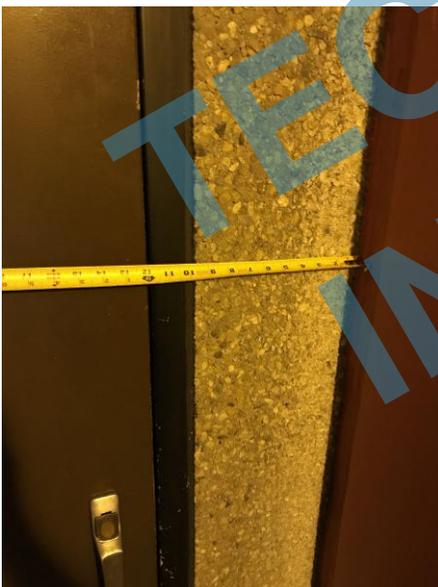
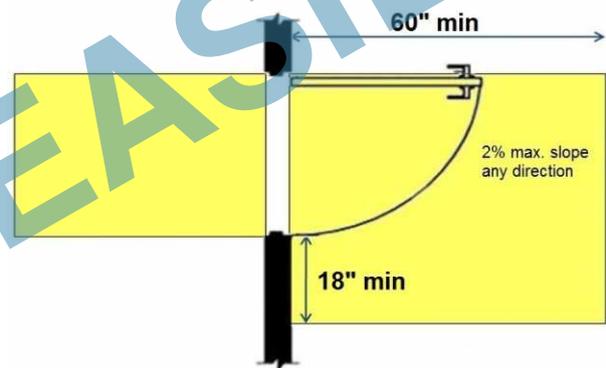
Finding 297988 Main Photo

The maneuvering space on the pull side of the door or gate does not adequately extend beyond the latch side of the door.

As Built:

12 inches of maneuvering space on the pull side

Providing the minimum required maneuvering space on the pull side of the door is technically infeasible at this time because existing structural conditions would require removing or altering a load-bearing member that is an essential part of the structural frame; or because other existing physical or site constraints prohibit modification or addition of elements, spaces, or features that are in full and strict compliance with the minimum requirements. Best practice measures are recommended to ensure parking garage is accessible to the maximum extent possible.

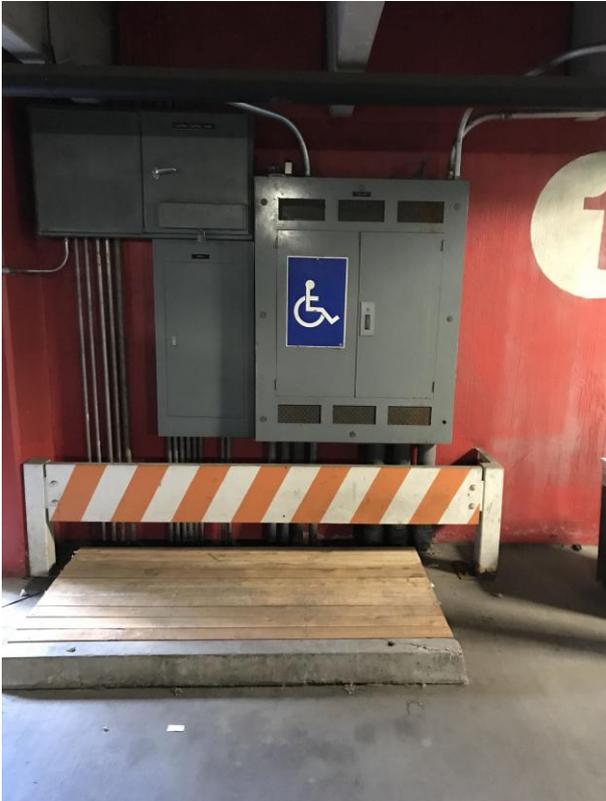
Finding 297989 Main Photo

The van stall is missing a sign identifying it as a van accessible stall.

As Built:

Van accessible sign missing

Replace existing sign with ISA sign that also includes "Van Accessible" verbiage.

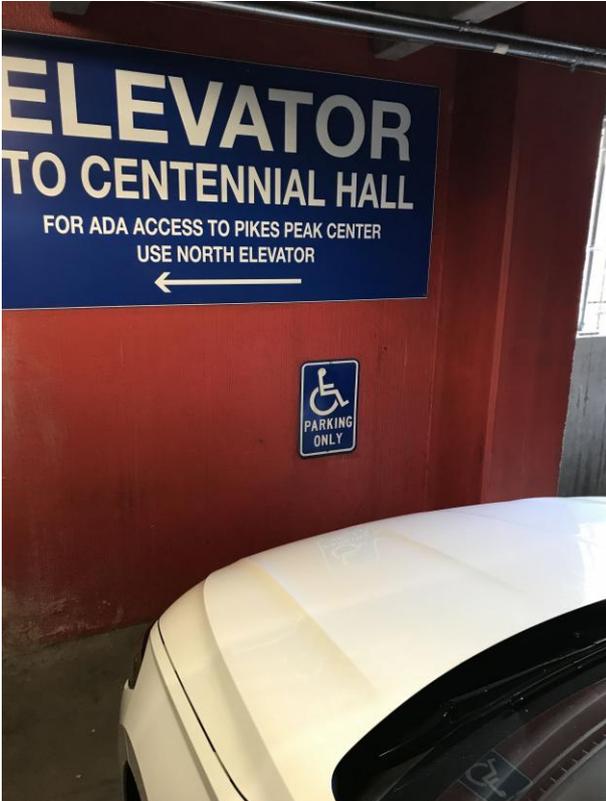
Finding 297990 Main Photo

The van stall is missing a sign identifying it as a van accessible stall.

As Built:

Van accessible sign missing

Replace existing sign with ISA sign that also includes "Van Accessible" verbiage.

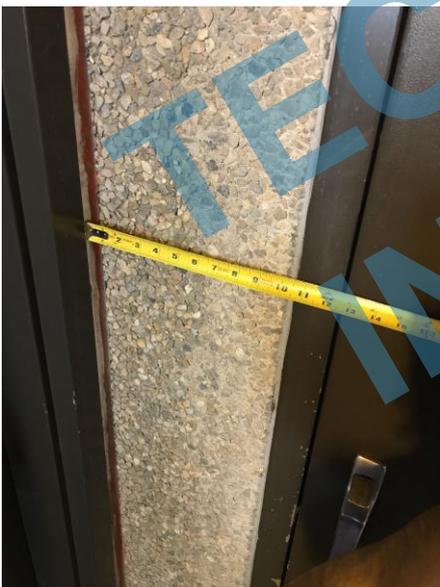
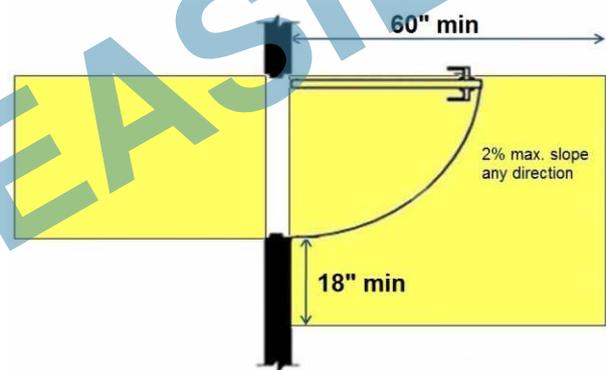
Finding 297991 Main Photo

The maneuvering space on the pull side of the door or gate does not adequately extend beyond the latch side of the door.

As Built:

12 inches of maneuvering space on the pull side

Providing the minimum required maneuvering space on the pull side of the door is technically infeasible at this time because existing structural conditions would require removing or altering a load-bearing member that is an essential part of the structural frame; or because other existing physical or site constraints prohibit modification or addition of elements, spaces, or features that are in full and strict compliance with the minimum requirements. Best practice measures are recommended to ensure parking garage is accessible to the maximum extent possible.

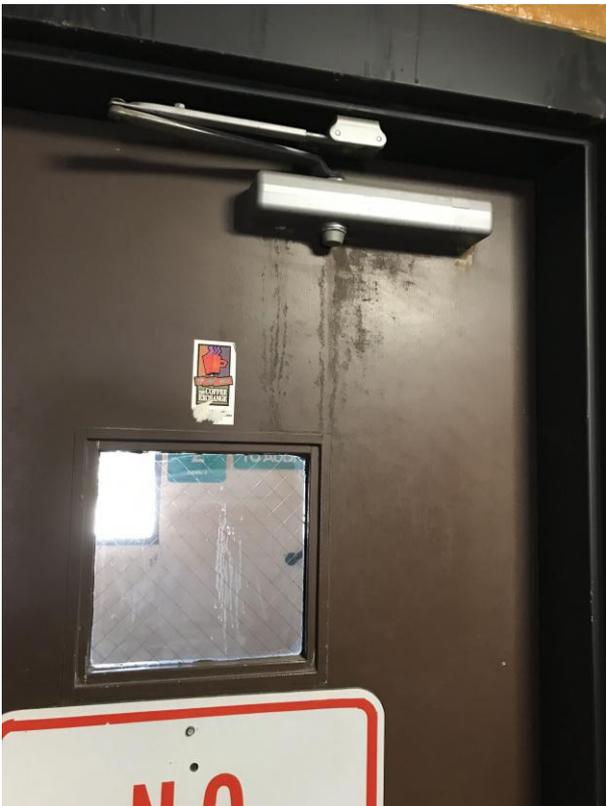
Finding 297992 Main Photo

The door is equipped with a door closer and returns to a closed position too quickly.

As Built:

3.63 seconds to closed position

Adjust door closer to allow a minimum of 5 seconds before returning to a position of 12 degrees from the latch/locking mechanism.

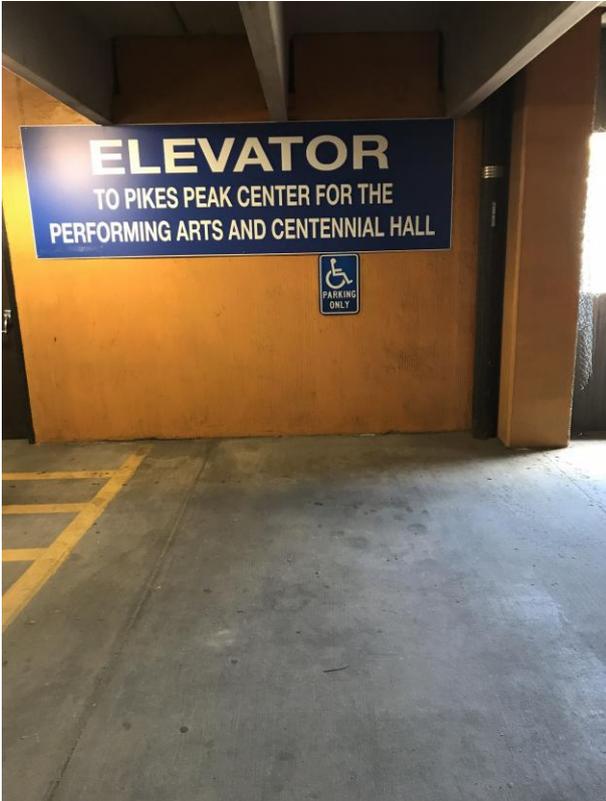
Finding 297993 Main Photo

The van stall is missing a sign identifying it as a van accessible stall.

As Built:

Van accessible sign missing

Replace existing sign with ISA sign that also includes "Van Accessible" verbiage.

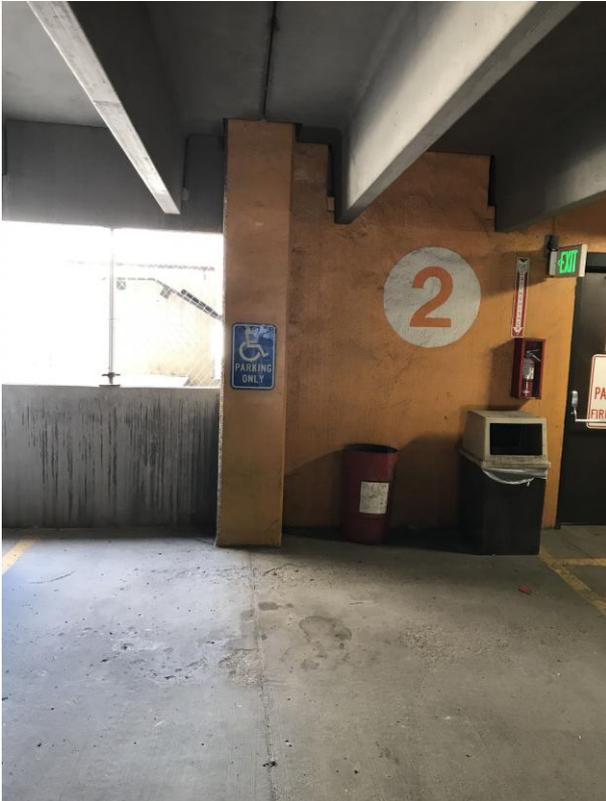
Finding 297994 Main Photo

The van stall is missing a sign identifying it as a van accessible stall.

As Built:

Van accessible sign missing

Replace existing sign with ISA sign that also includes "Van Accessible" verbiage.

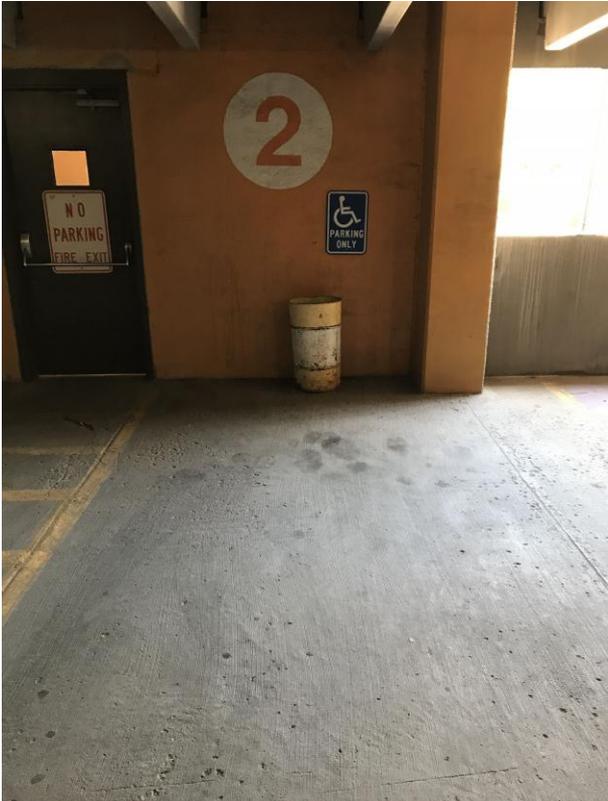
Finding 298017 Main Photo

The van stall is missing a sign identifying it as a van accessible stall.

Van accessible sign missing

Replace existing sign with ISA sign that also includes "Van Accessible" verbiage.

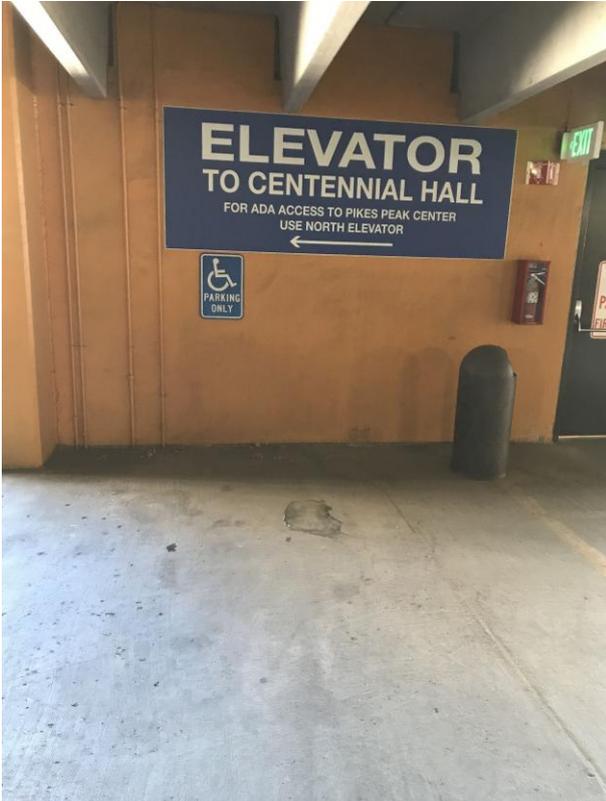
Finding 298019 Main Photo

The van stall is missing a sign identifying it as a van accessible stall.

Van accessible sign missing

Replace existing sign with ISA sign that also includes "Van Accessible" verbiage.

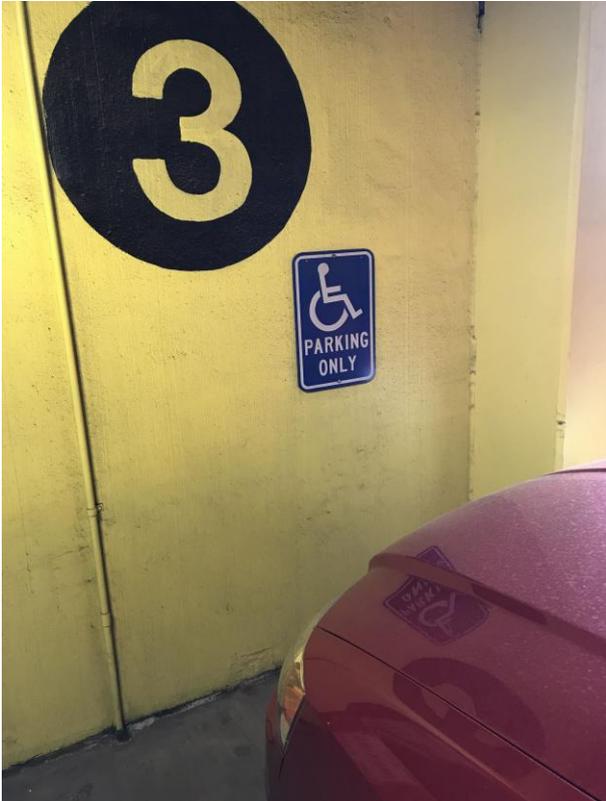
Finding 298022 Main Photo

The van stall is missing a sign identifying it as a van accessible stall.

Van accessible sign missing

Replace existing sign with ISA sign that also includes "Van Accessible" verbiage.

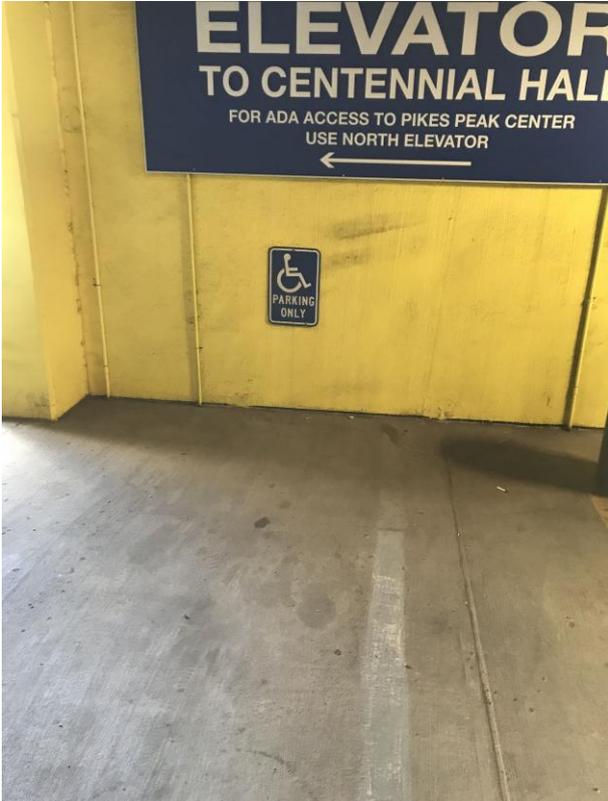
Finding 298023 Main Photo

The van stall is missing a sign identifying it as a van accessible stall.

Van accessible sign missing

Replace existing sign with ISA sign that also includes "Van Accessible" verbiage.

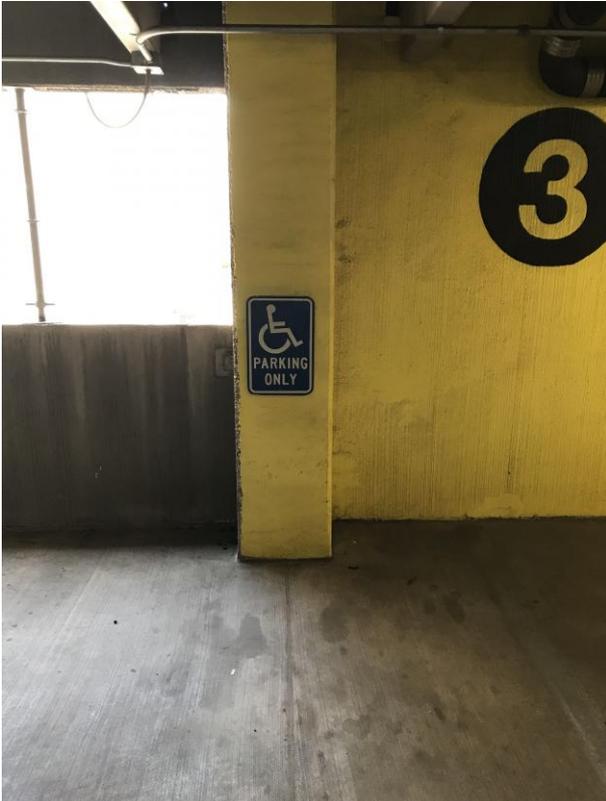
Finding 298027 Main Photo

The van stall is missing a sign identifying it as a van accessible stall.

Van accessible sign missing

Replace existing sign with ISA sign that also includes "Van Accessible" verbiage.

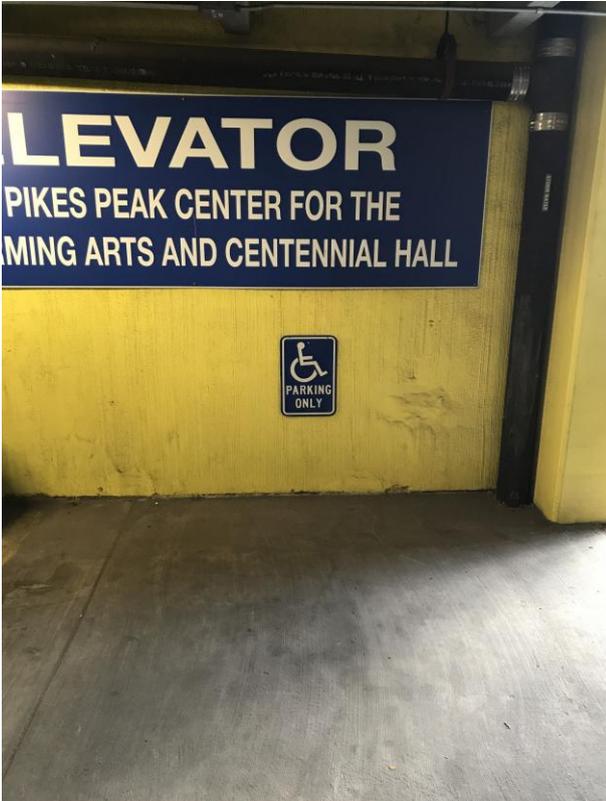
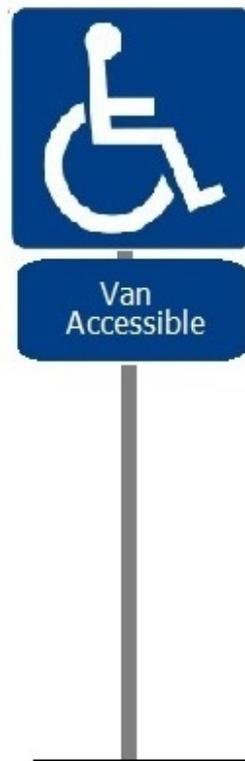
Finding 298028 Main Photo

The van stall is missing a sign identifying it as a van accessible stall.

Van accessible sign missing

Replace existing sign with ISA sign that also includes "Van Accessible" verbiage.

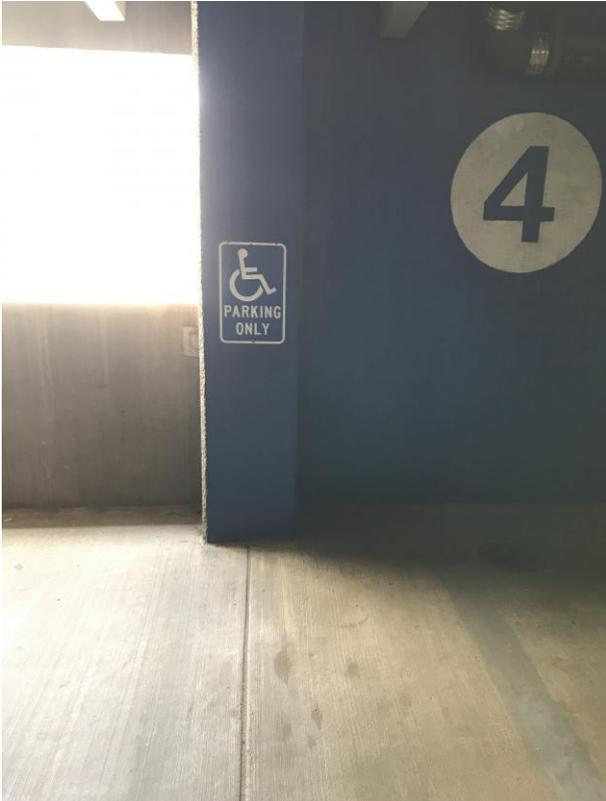
Finding 298032 Main Photo

The van stall is missing a sign identifying it as a van accessible stall.

Van accessible sign missing

Replace existing sign with ISA sign that also includes "Van Accessible" verbiage.

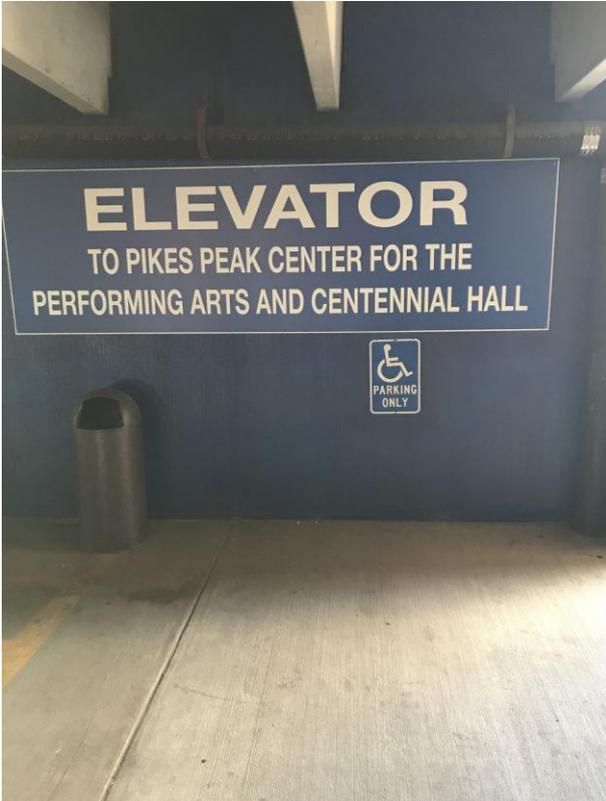
Finding 298033 Main Photo

The van stall is missing a sign identifying it as a van accessible stall.

Van accessible sign missing

Replace existing sign with ISA sign that also includes "Van Accessible" verbiage.

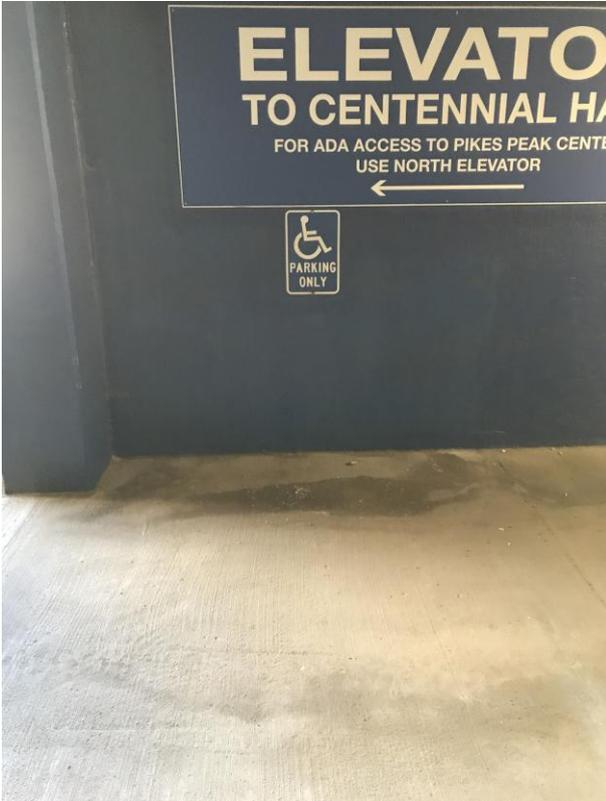
Finding 298038 Main Photo

The van stall is missing a sign identifying it as a van accessible stall.

Van accessible sign missing

Replace existing sign with ISA sign that also includes "Van Accessible" verbiage.

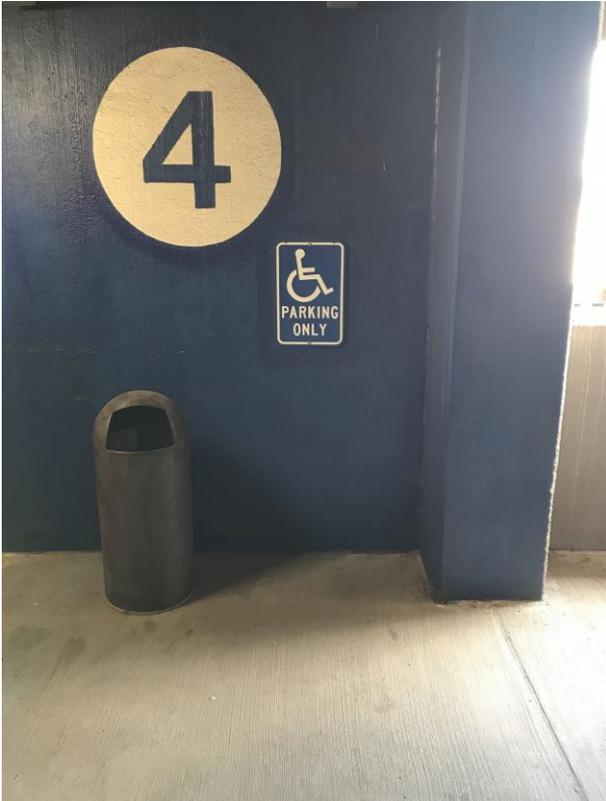
Finding 298039 Main Photo

The van stall is missing a sign identifying it as a van accessible stall.

Van accessible sign missing

Replace existing sign with ISA sign that also includes "Van Accessible" verbiage.

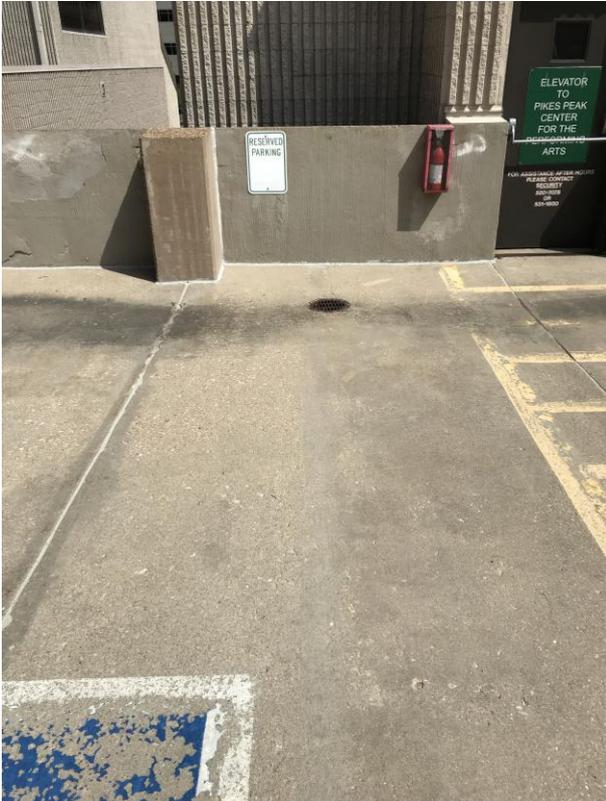
Finding 298043 Main Photo

The van stall is missing a sign identifying it as a van accessible stall.

Van accessible sign missing

Replace existing sign with ISA sign that also includes "Van Accessible" verbiage.

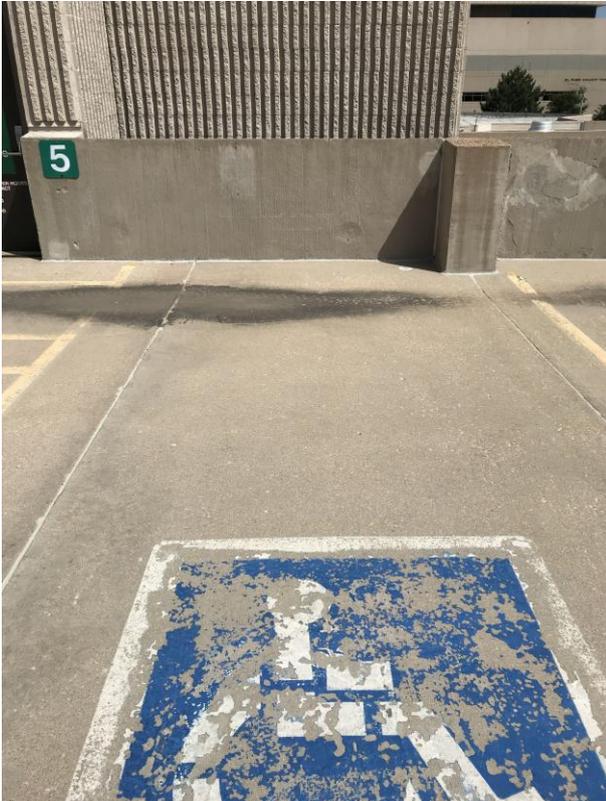
Finding 298044 Main Photo

The van stall is missing a sign identifying it as a van accessible stall.

Van accessible sign missing

Replace existing sign with ISA sign that also includes "Van Accessible" verbiage.

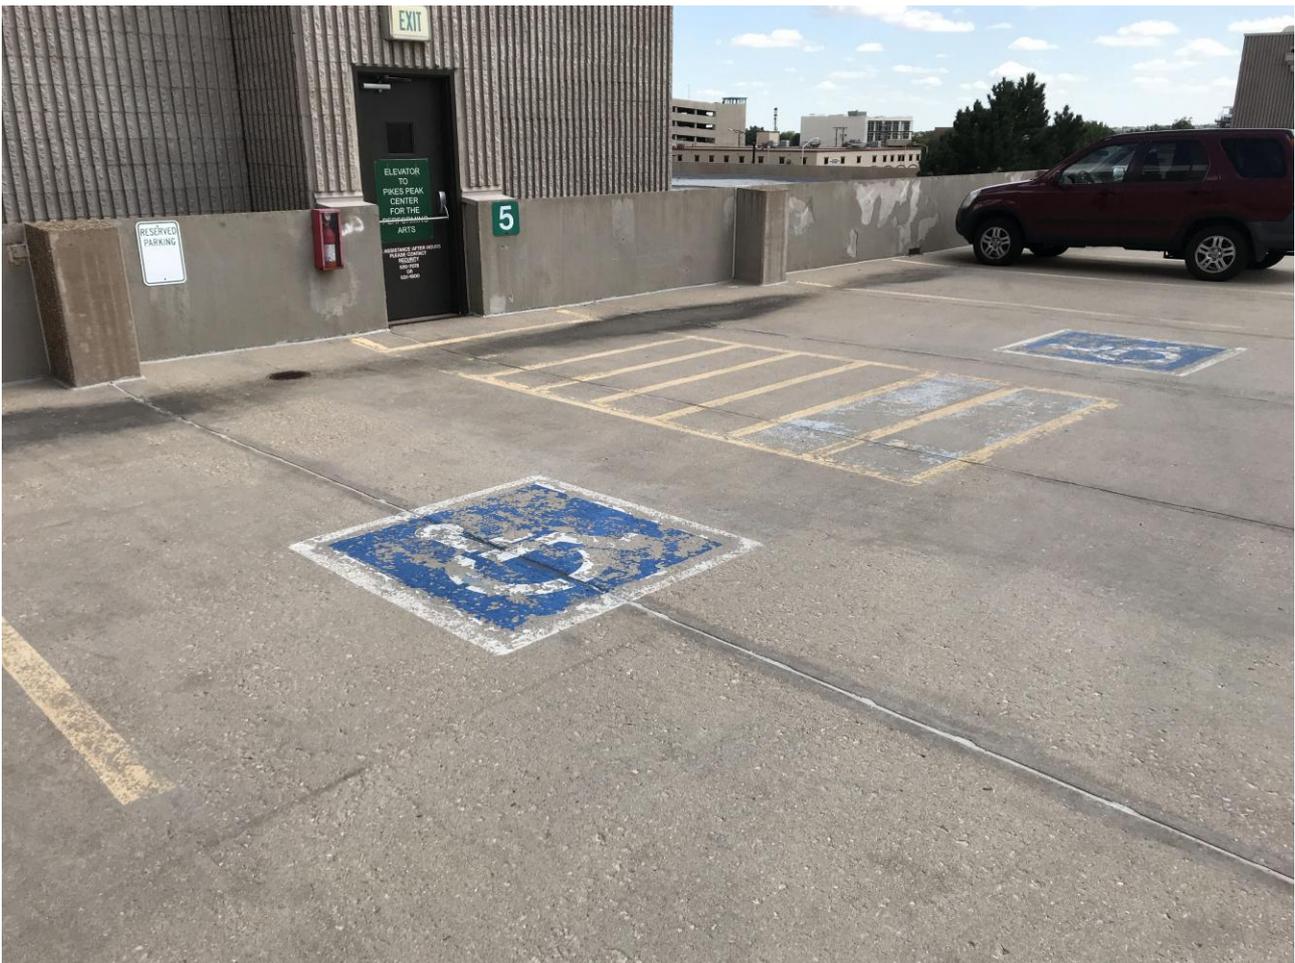
Finding 298045 Main Photo

The striping and markings for the accessible parking stall, loading/unloading access aisle are dilapidated and in need of repair and/or maintenance.

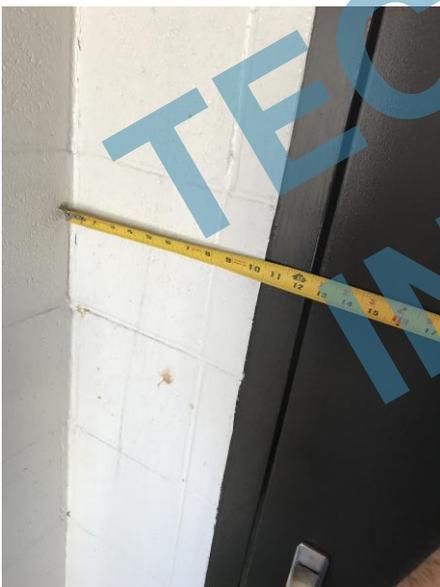
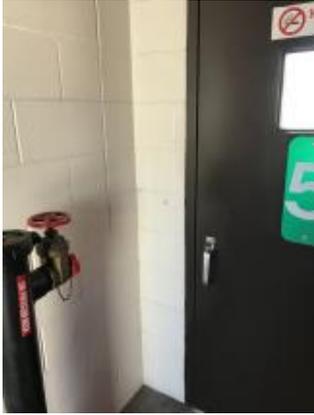
Finding 298046 Main Photo

TECHNICALLY
INFEASIBLE

Recommendation:

Providing the minimum required maneuvering space on the pull side of the door is technically infeasible at this time because existing structural conditions would require removing or altering a load-bearing member that is an essential part of the structural frame; or because other existing physical or site constraints prohibit modification or addition of elements, spaces, or features that are in full and strict compliance with the minimum requirements. Best practice measures are recommended to ensure parking garage is accessible to the maximum extent possible.

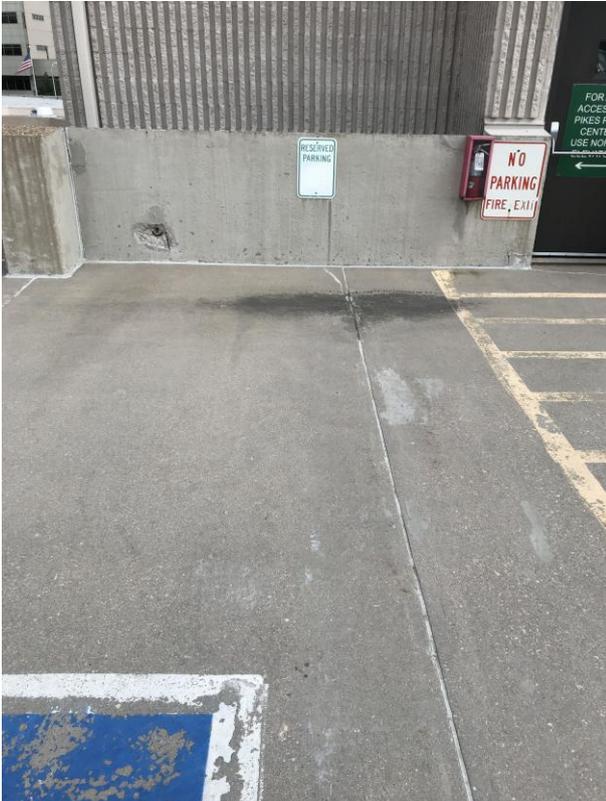
Finding 298048 Main Photo

The van stall is missing a sign identifying it as a van accessible stall.

Van accessible sign missing

Replace existing sign with ISA sign that also includes "Van Accessible" verbiage.

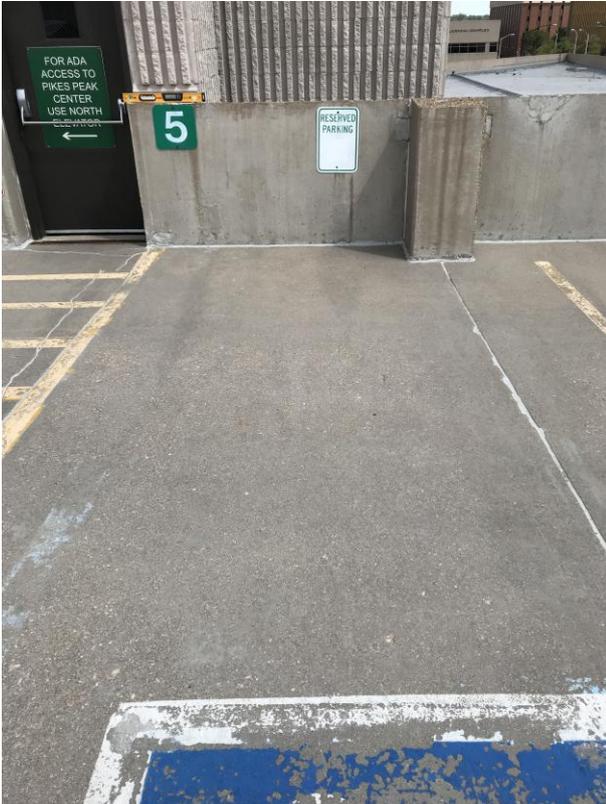
Finding 298049 Main Photo

The van stall is missing a sign identifying it as a van accessible stall.

Van accessible sign missing

Replace existing sign with ISA sign that also includes "Van Accessible" verbiage.

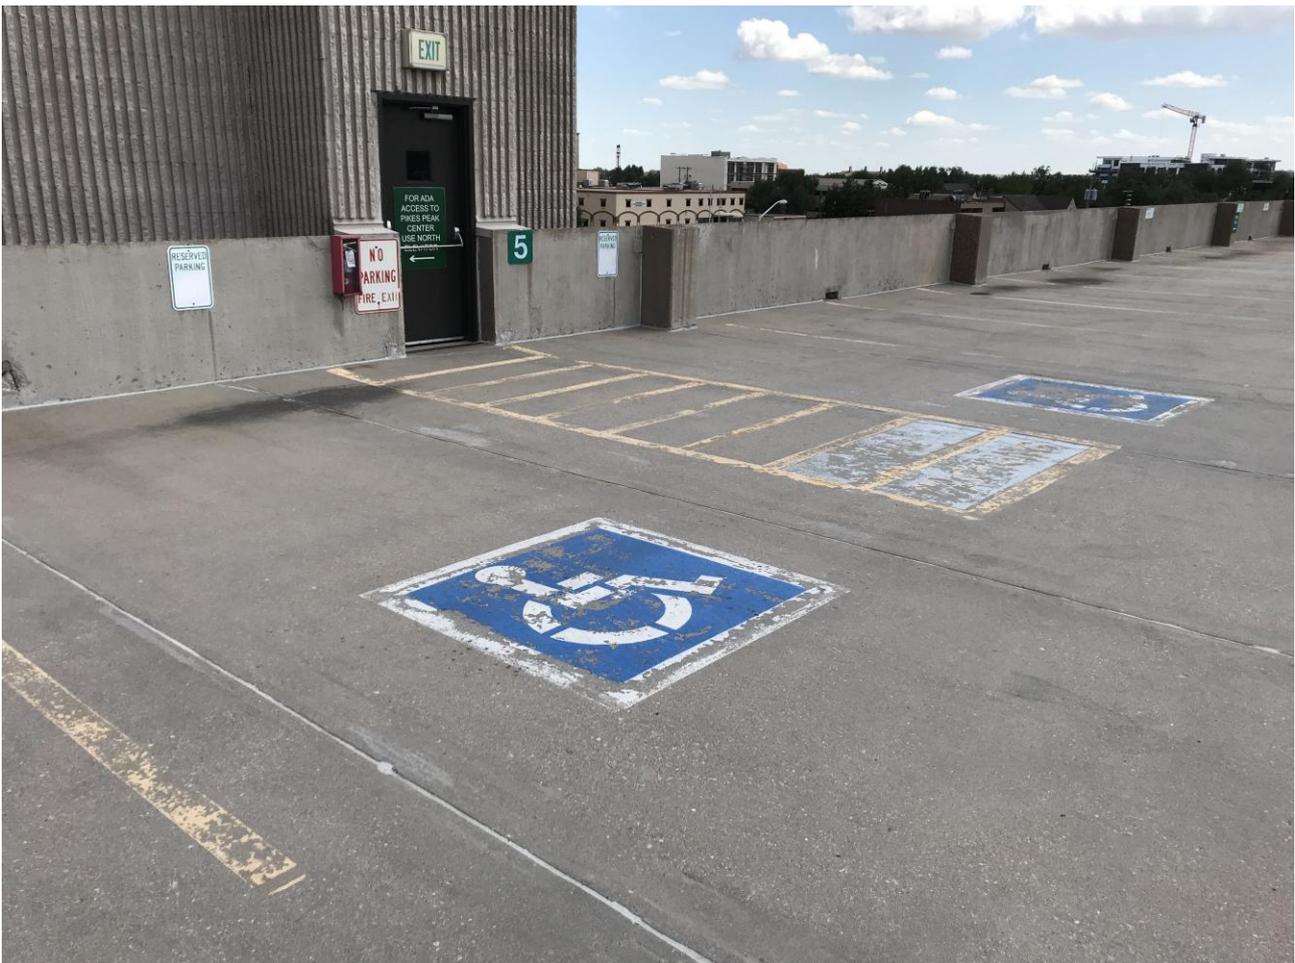
Finding 298052 Main Photo

The striping and markings for the accessible parking stall, loading/unloading access aisle are dilapidated and in need of repair and/or maintenance.
