Site Accessibility Evaluation

Americans with Disabilities Act Title II (Public Services: State and Local Government)

EPC Veteran Services

**5850 Championship View
Colorado Springs, CO
80922**

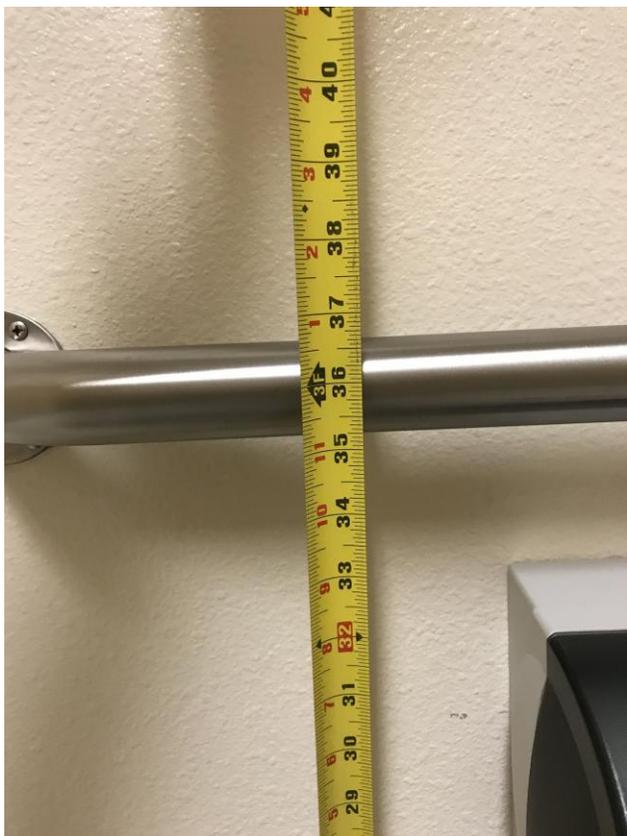
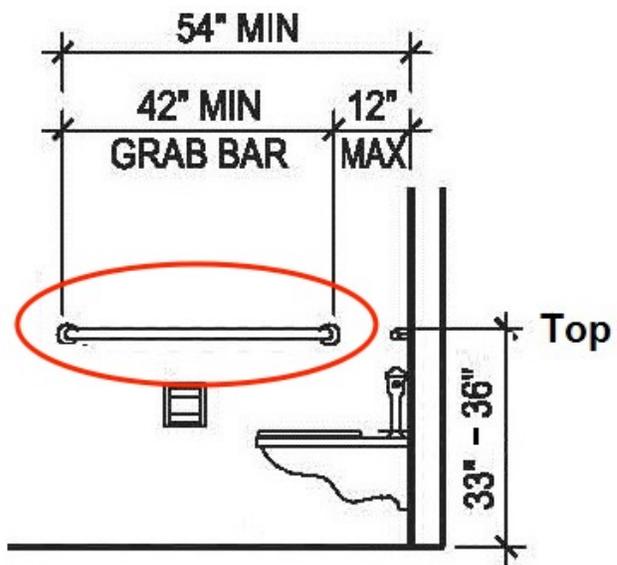
Finding 297268 Main Photo

The side grab bar is too high.

36.75 inches above
finished floor

Lower side grab bar 1 inch to meet compliance.

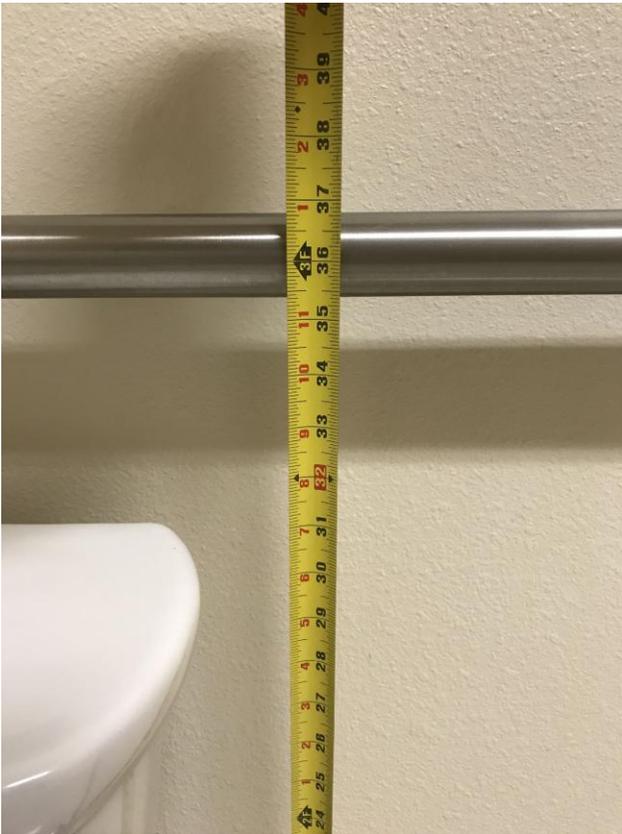
Finding 297269 Main Photo

The rear grab bar is too high.

37 inches above
finished floor

Lower rear grab bar 1 inch minimum to meet compliance.

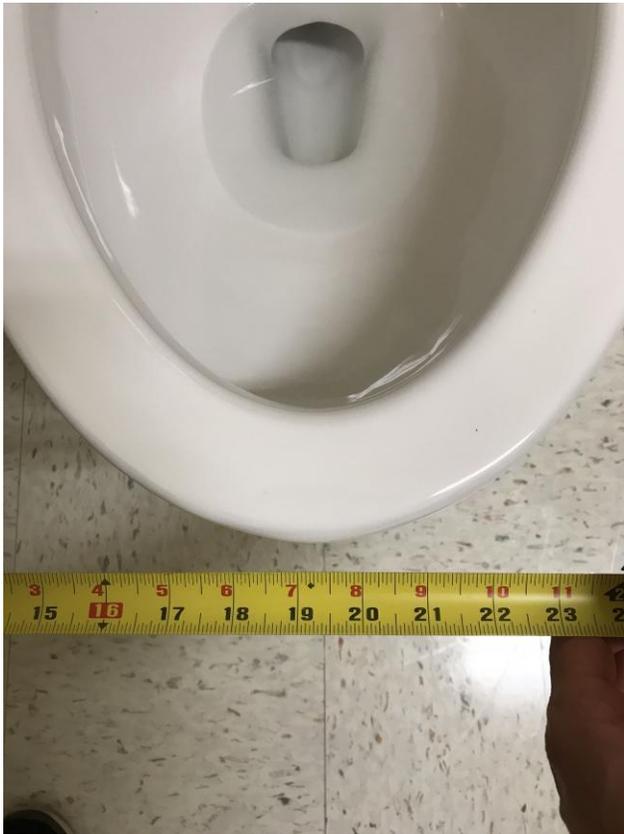
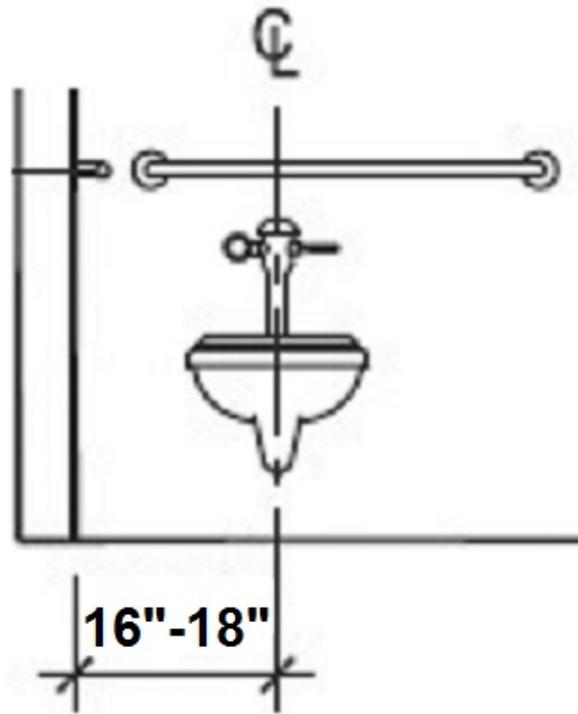
Finding 297270 Main Photo

The toilet is not located within the range allowed from the side wall or partition.

Citation:	As Built:	Budgeting Range:
2010 ADAS Section: 604.2	19.25 inches from side wall	\$3,500 - \$5,000.00

Adjust toilet so that it measures between 16 and 18 inches measured from the side wall to the centerline of the toilet.

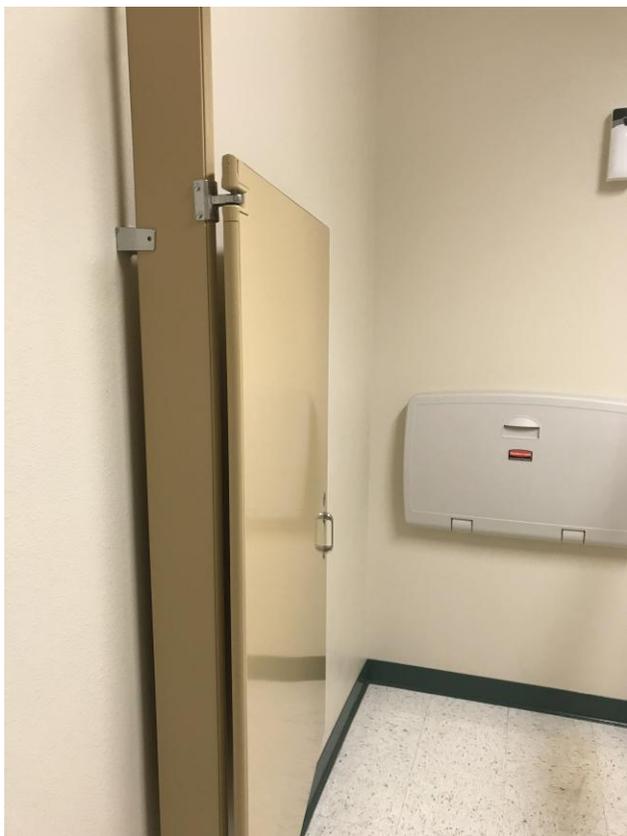
Finding 297271 Main Photo

The compartment door is not self closing.

Stall door not self closing

Install or adjust compartment door hinges to make compartment door self close.

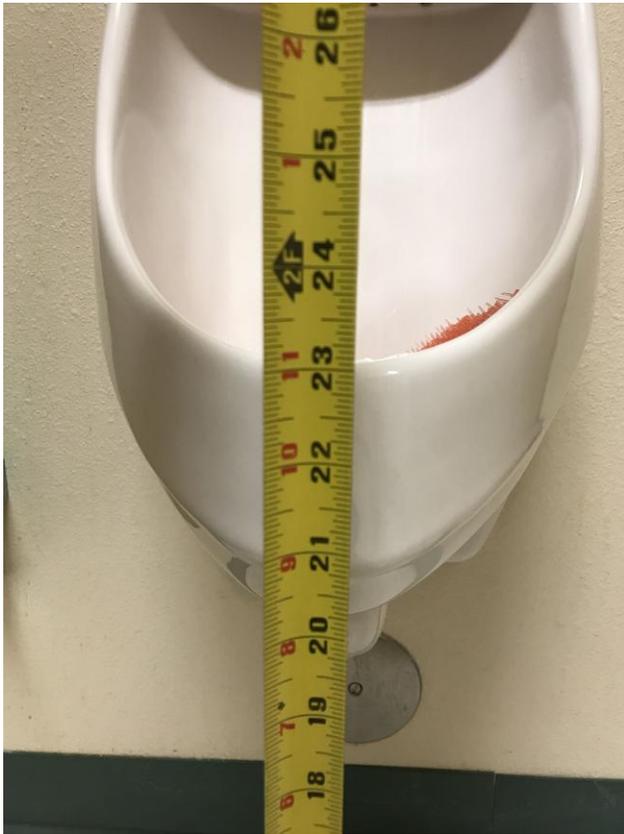
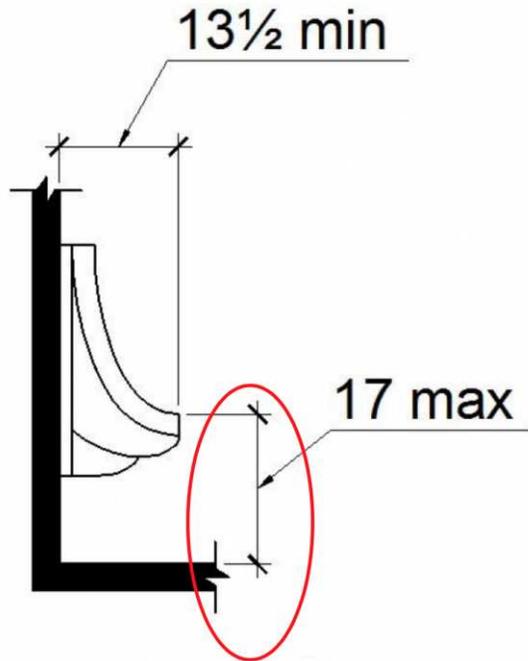
Finding 297272 Main Photo

The rim of the urinal is too high.

23 inches above
finished floor

Lower urinal a minimum of 6 inches to ensure a 17 inch maximum height above finished floor.

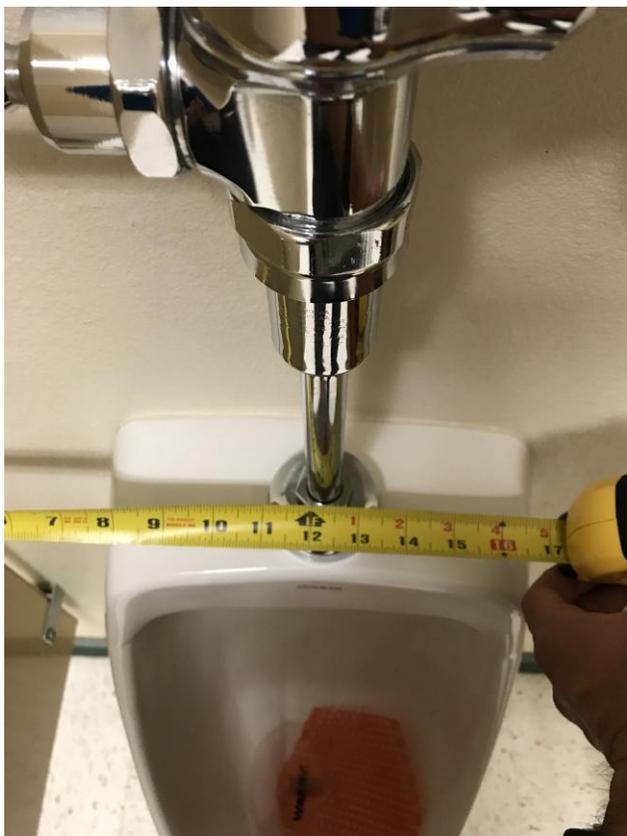
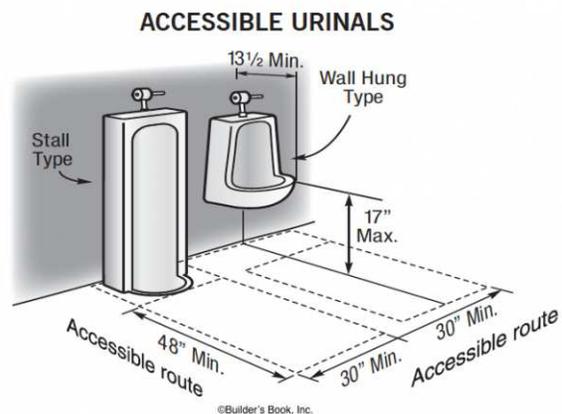
Finding 297273 Main Photo

The urinal is too close to the side wall.

12.25 inches from
nearest side wall

Re-position right side wall partition to provide a an additional 2 inches in width if the the left side wall partition is unable to provide 3 inches due to the required clear floor space of 60 inches needed at the water closet. The additional 2 inches will provide the required 30 inch width minimum required. Note that urinal will not be centered to the required clear floor space.

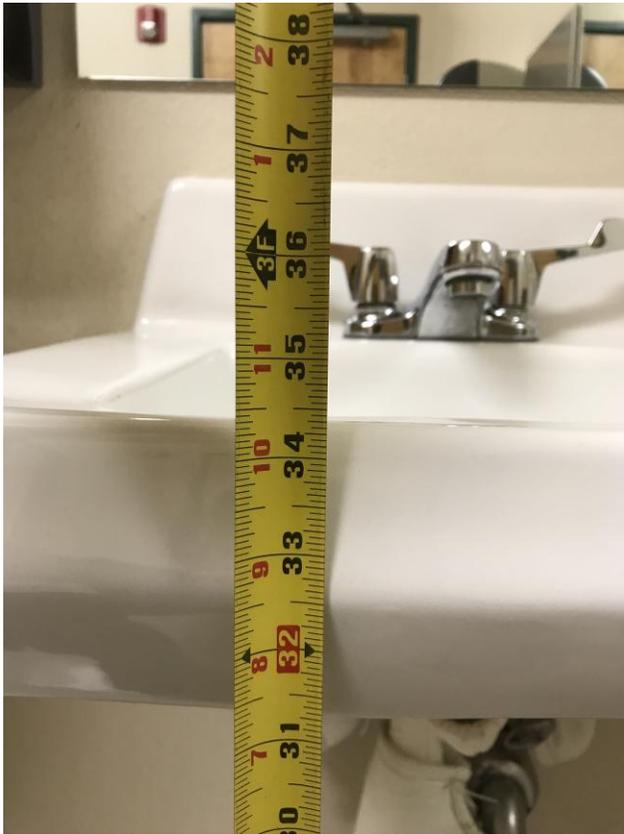
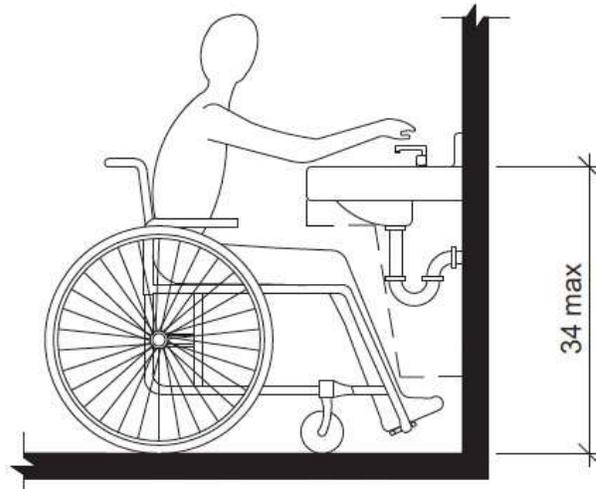
Finding 297274 Main Photo

The top rim of the lavatory is too high.

34.25 inches above
finished floor

Lower lavatory by a minimum of .5 inches to ensure top rim of lavatory does not exceed 34 inches above finished floor.

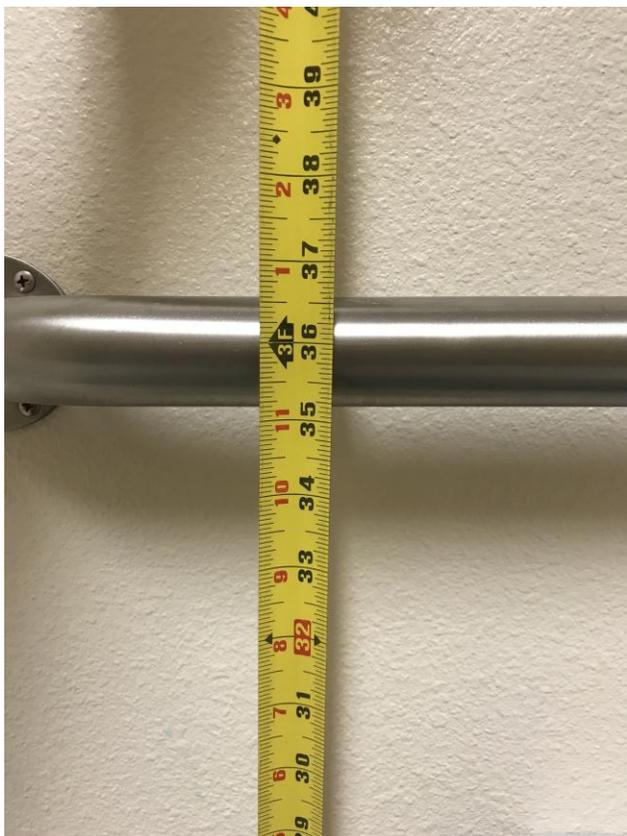
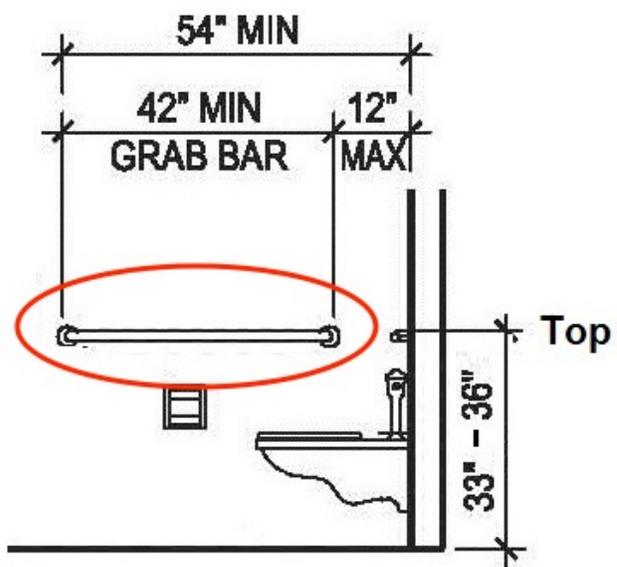
Finding 297276 Main Photo

The side grab bar is too high.

36.75 inches above
finished floor

Lower side grab bar by 1 inch to meet compliance. Top of gripping surface should not extend beyond 36 inches above finished floor.

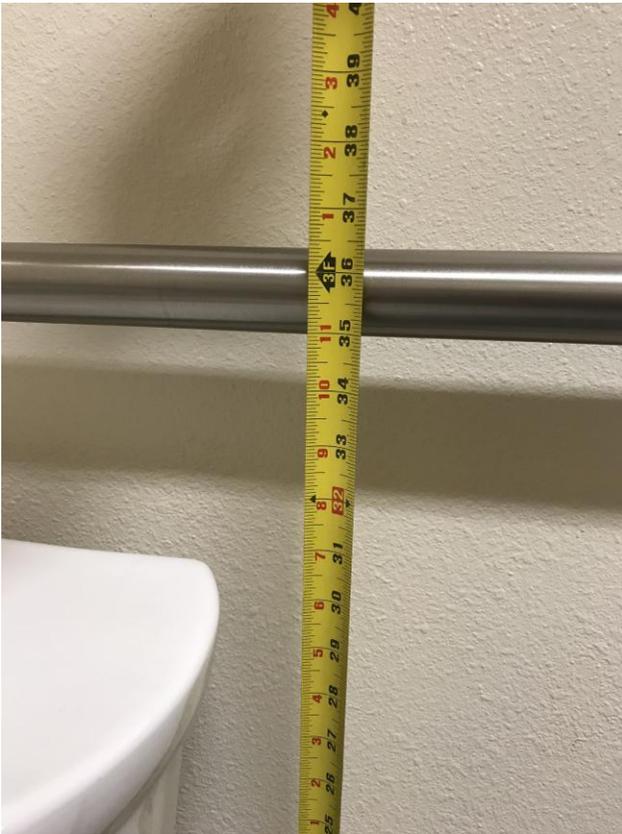
Finding 297277 Main Photo

The rear grab bar is too high.

36.5 inches above
finished floor

Lower rear grab bar by 1 inch to meet compliance. Top of gripping surface should not extend beyond 36 inches above finished floor.

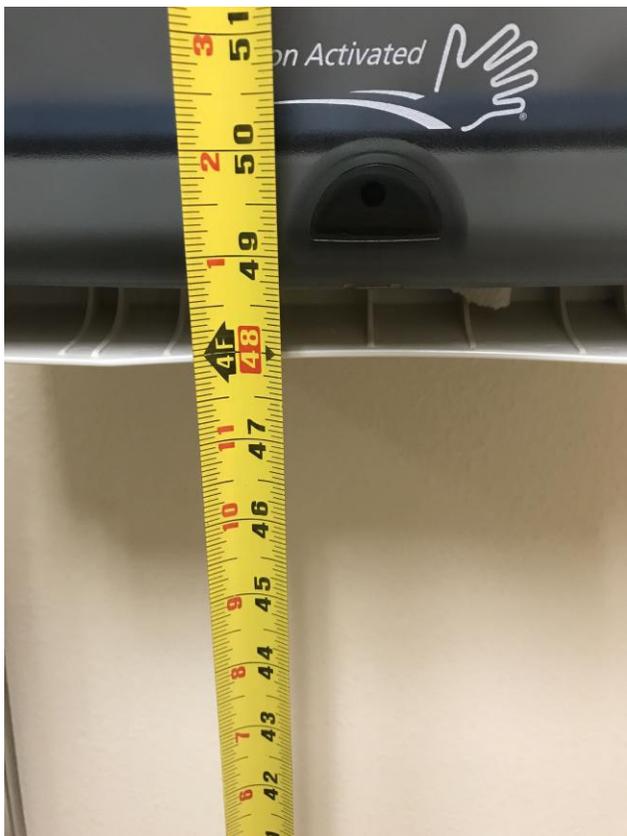
Finding 297278 Main Photo

The paper towel dispenser's operation mechanism is too high off the floor.

49.5 inches above
finished floor

Lower paper towel dispenser a minimum of 2 inches. Operable parts should be at 48 inches maximum above finished floor.
