# Site Accessibility Evaluation

## Americans with Disabilities Act Title II (Public Services: State and Local Government)

### **DOT Operations Center**

***Inspection Date: 09/27/2016  
Inspector: David Mejia***

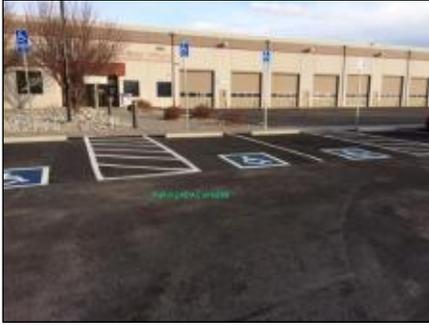
Finding 19554 Additional Photo

The accessible parking is not located on an accessible route of travel to the accessible building entrance.

Pedestrian ramp does not align w/aisle

Submit w/o for correction. Area needs to be re-striped and access aisle to sidewalk path of travel needs to align w/accessible ramp.

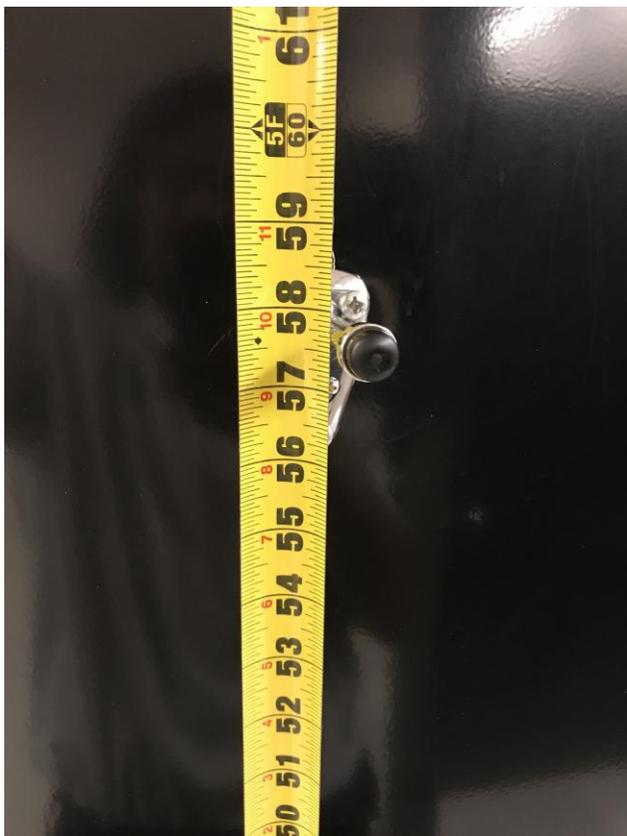
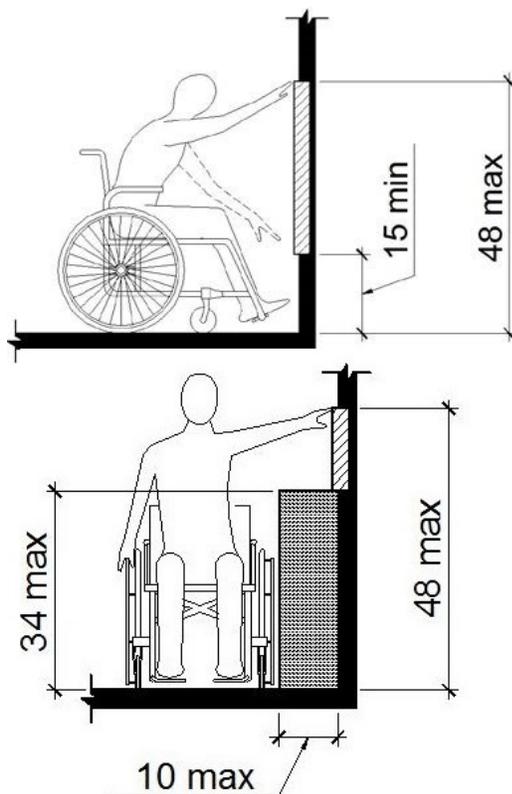
Finding 299201 Main Photo

Considered  
Unobstructed
