Site Accessibility Evaluation

Centennial Hall

Accessibility Evaluation

Inspection Date: 05/14/2019

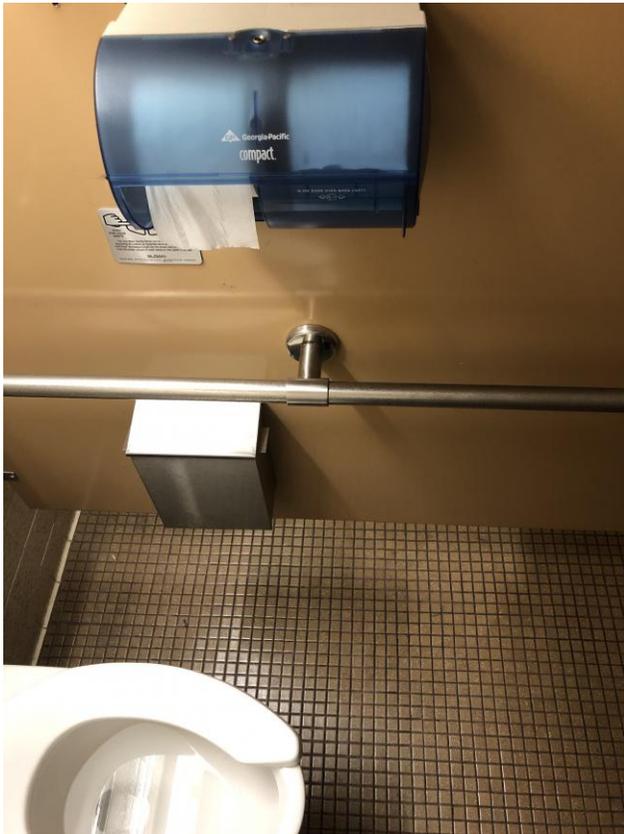
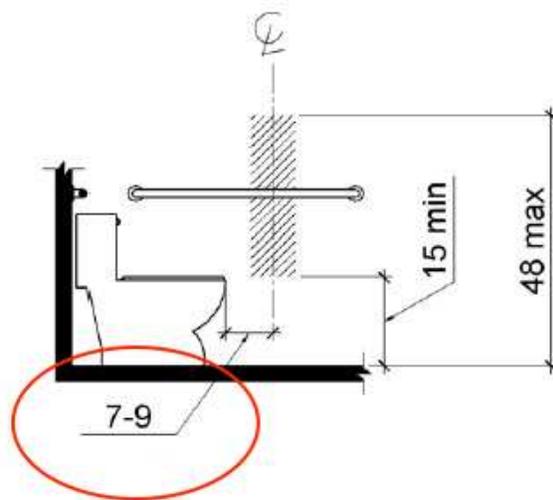
Finding 297052 Main Photo

Finding #13 Continued

CORRECTED

Corrective action: Work order #350373 submitted on 04/29/2016

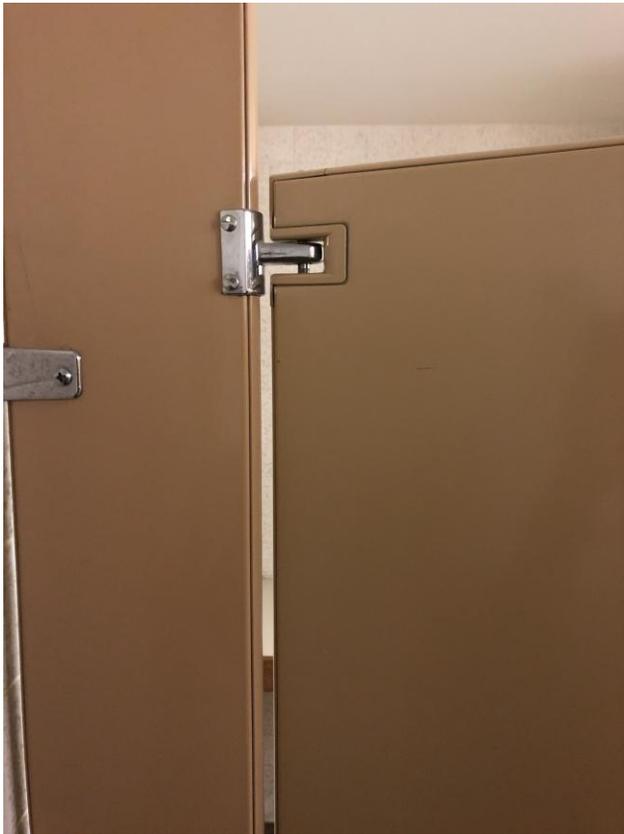
Women's Restroom 1st Floor

Finding #14 Continued

CORRECTED

Corrective action: Work order #350373 submitted on 04/29/2016

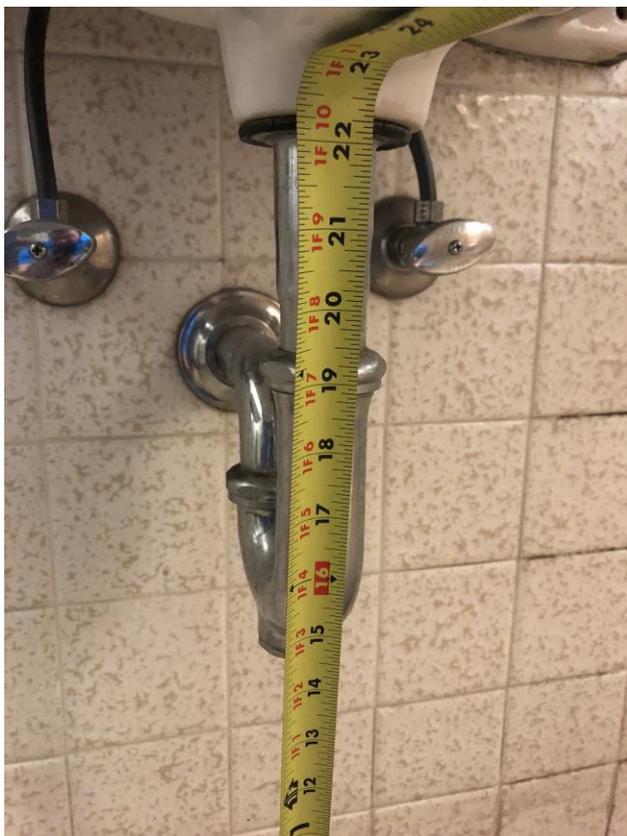
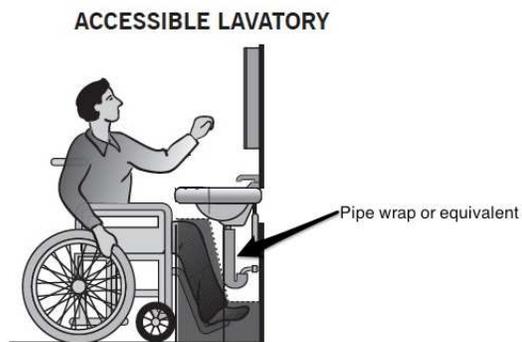
Finding 297092 Main Photo

Finding #16 Continued

CORRECTED

Corrective action: Work order #350373 submitted on 04/29/2016

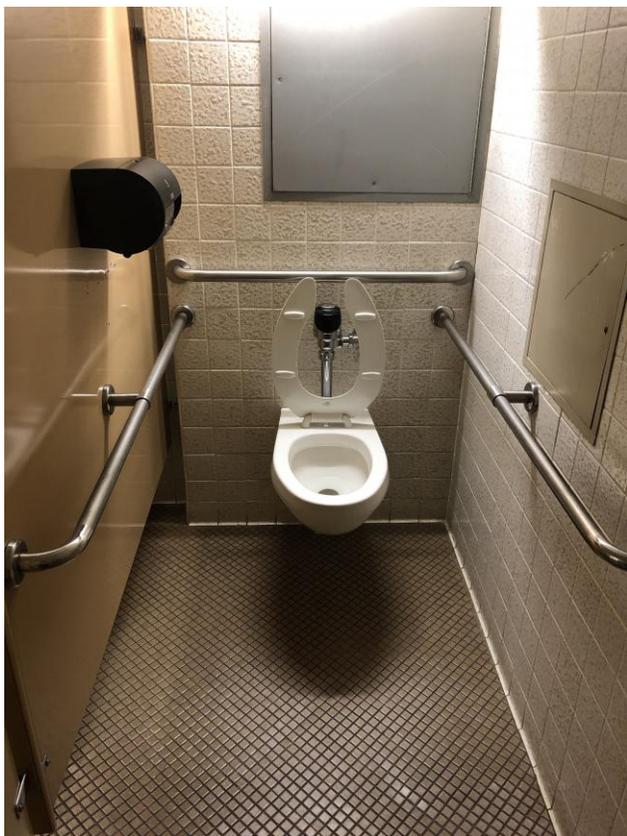
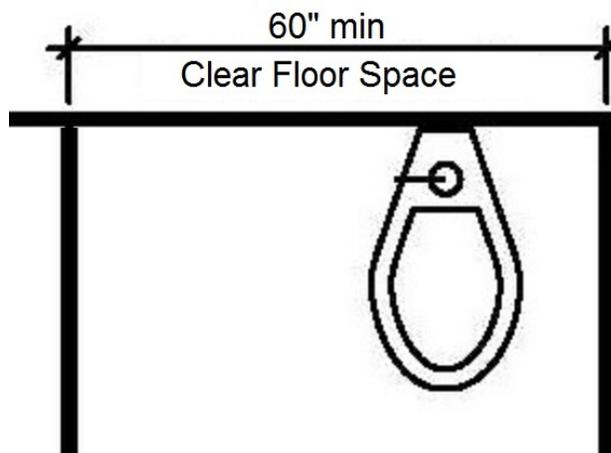
Finding 297042 Main Photo

Finding #18 Continued

CORRECTED

Corrective action: Work order #350373 submitted on 12/16/2015

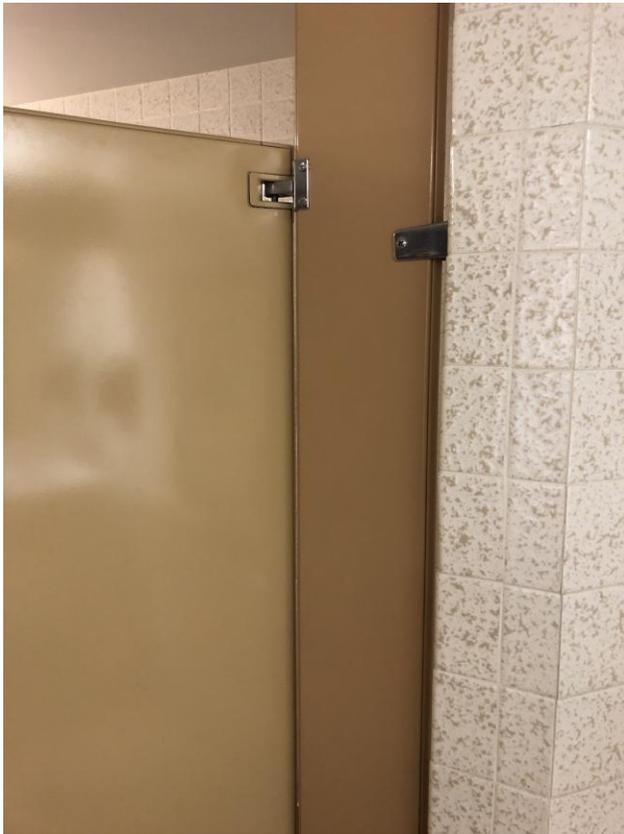
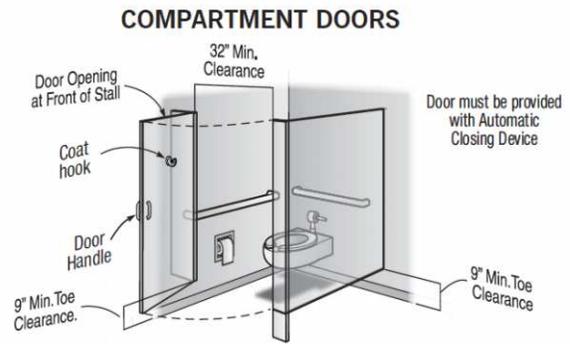
Men's Restroom 1st Floor

Finding #21 Continued

CORRECTED

Corrective action: Work order #350373 submitted on 12/16/2015

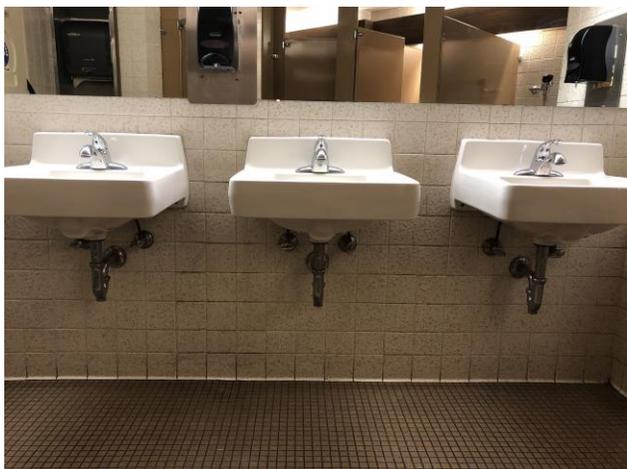
Finding 297048 Main Photo

Finding #23 Continued

CORRECTED

Corrective action: Work order #350373 submitted on 12/16/2015

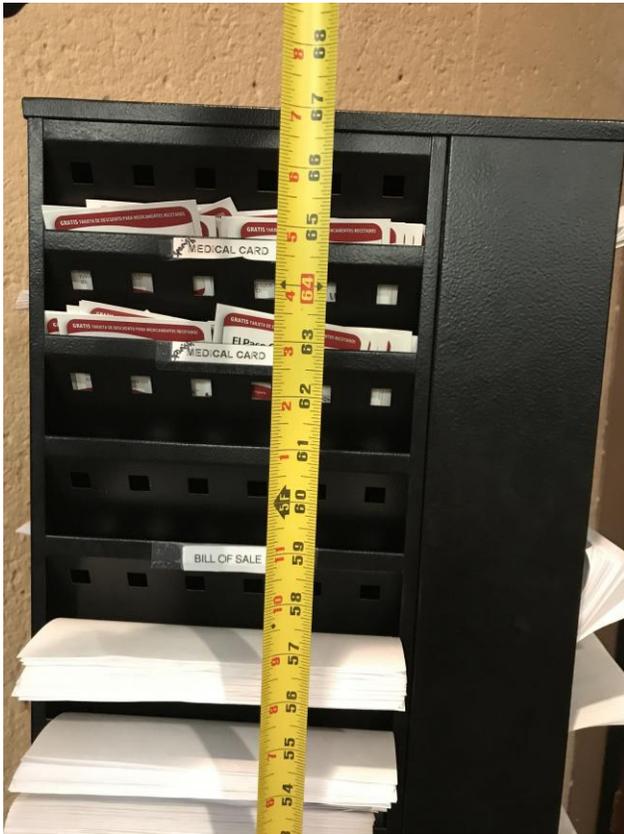
Finding 297769 Main Photo

Finding #27 Continued

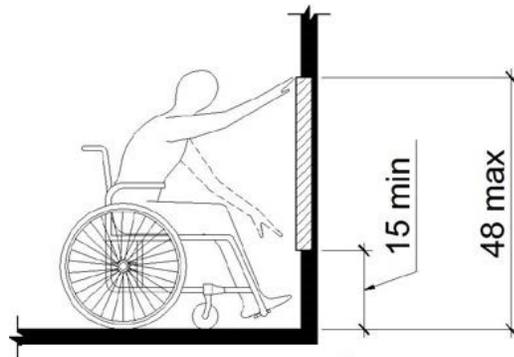
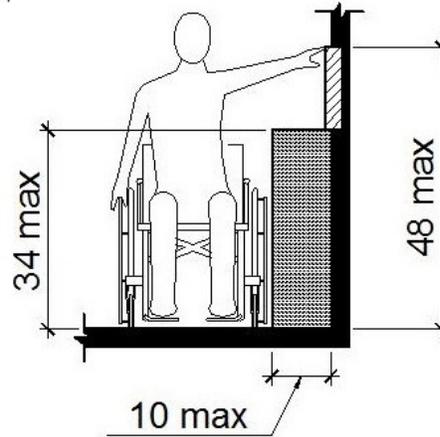
Finding #27 Additional Finding Photos

Considered
Unobstructed

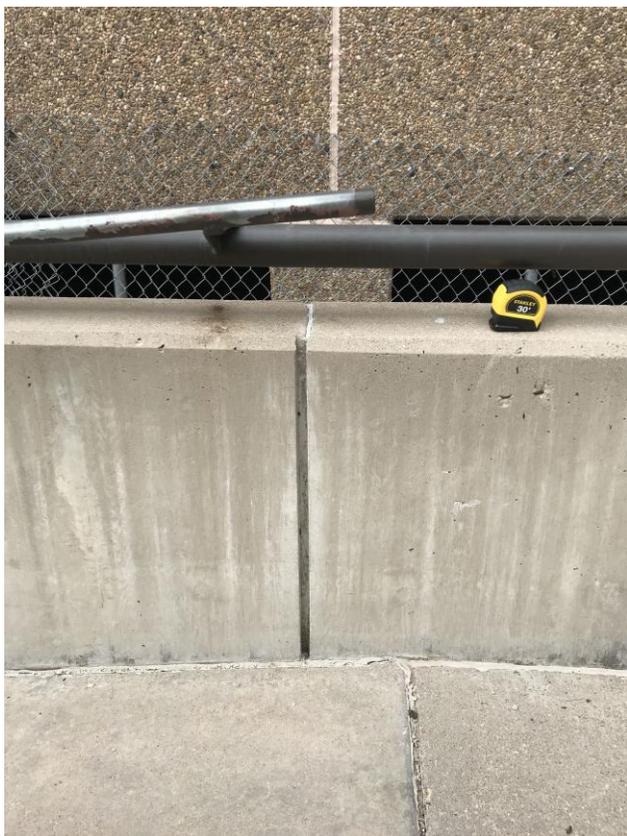
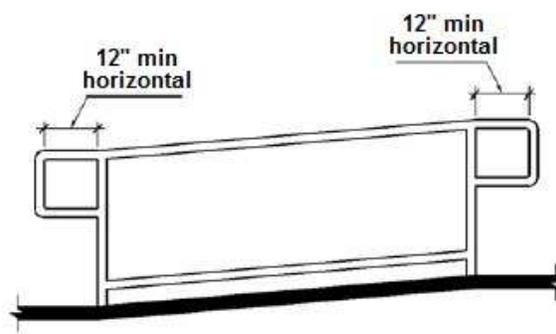
Finding 297770 Main Photo

Finding #28 Continued

CORRECTED
