# Site Accessibility Evaluation

## Americans with Disabilities Act Title II (Public Services: State and Local Government)

### County Professional Building

*Inspection Date: 07/24/2017*  
*Inspector: David Mejia*

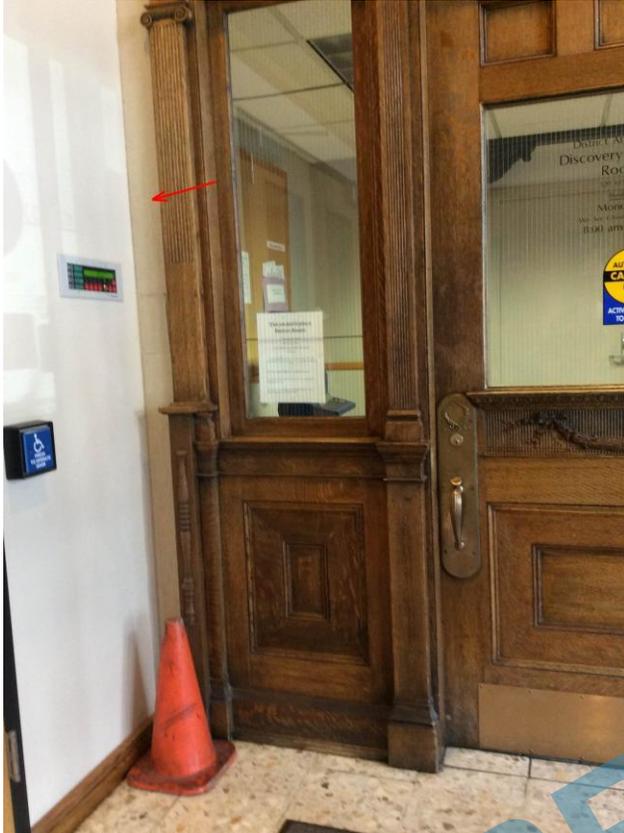
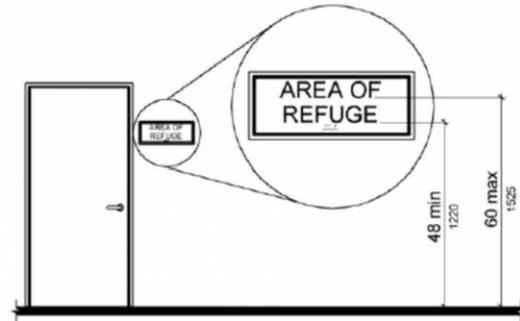
Finding 25852 Main Photo

Compliant room identification signs are missing on the strike side of the door.

Corrective Action: W/O 381203 submitted. Completed 2/24/2017.

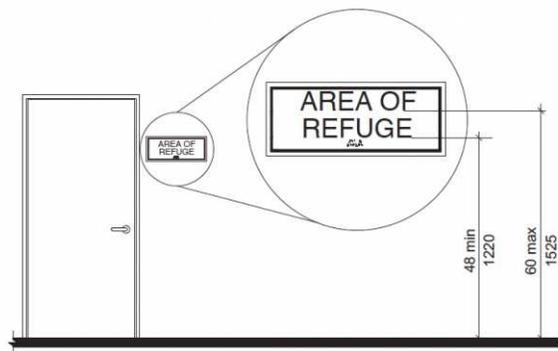
Finding 25855 Main Photo

62 inches  
high/character missing

Corrective Action: W/O 381215 completed 381215.

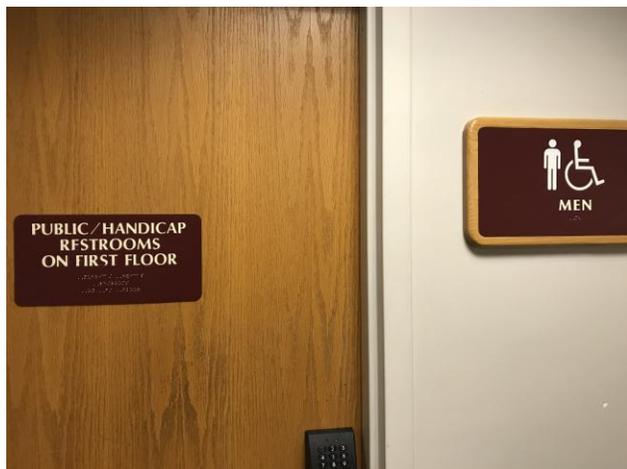
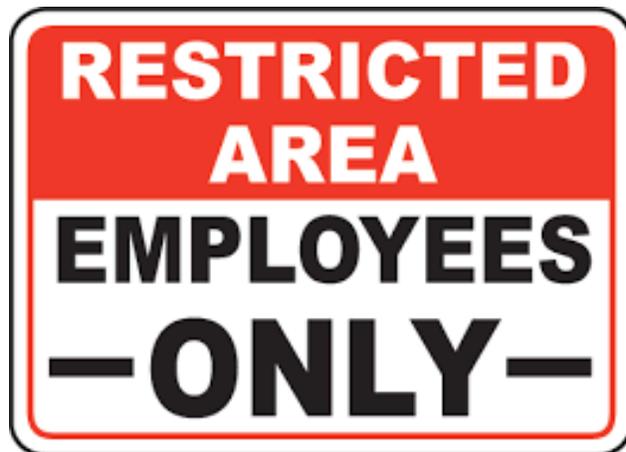
Finding 299158 Main Photo

Employees Only sign missing and use of the word "Handicapped" on existing sign

Add "Employees Only" sign. Also remove existing sign due to the word "handicap" and replace with new sign directing the public to the ADA accessible restrooms located on the first floor.

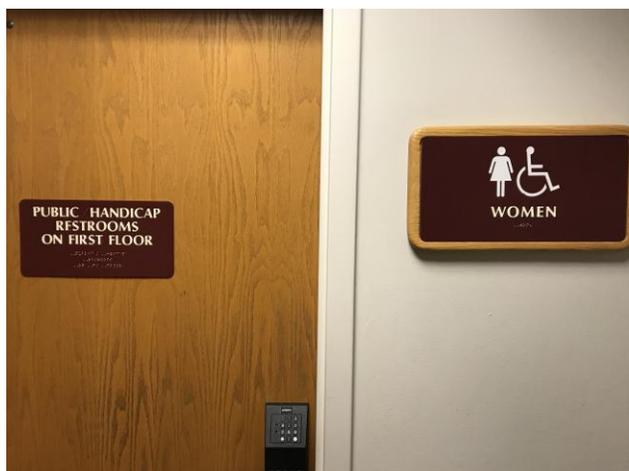
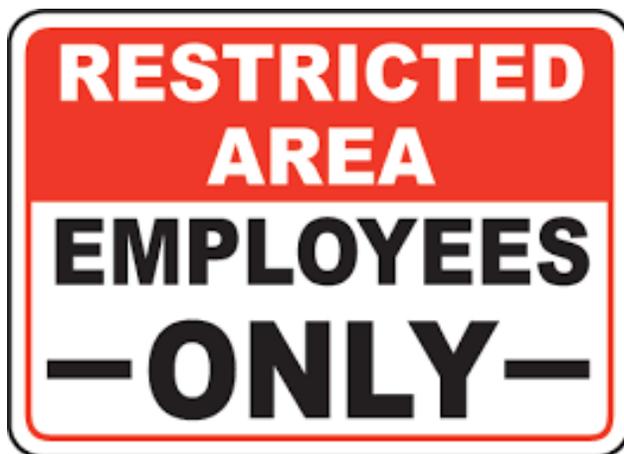
Finding 299159 Main Photo

Employees Only sign missing and use of the word "Handicapped" on existing sign

Add "Employees Only" sign. Also remove existing sign due to the word "handicap" and replace with new sign directing the public to the ADA accessible restrooms located on the first floor.

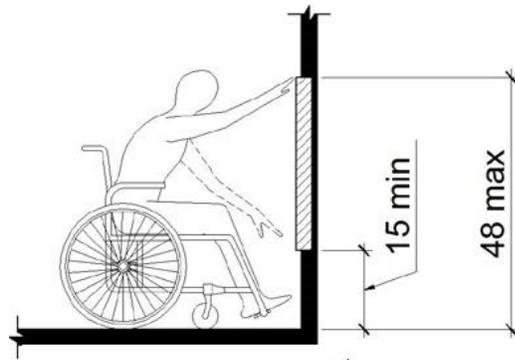
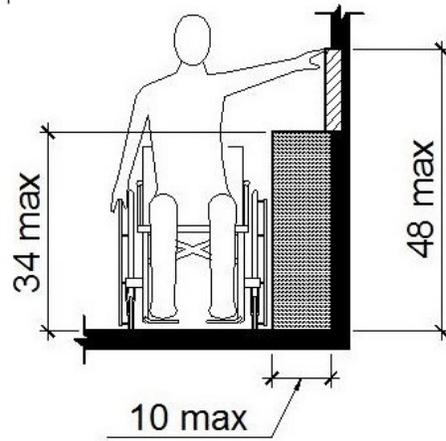
Finding 299107 Main Photo

Considered  
Unobstructed

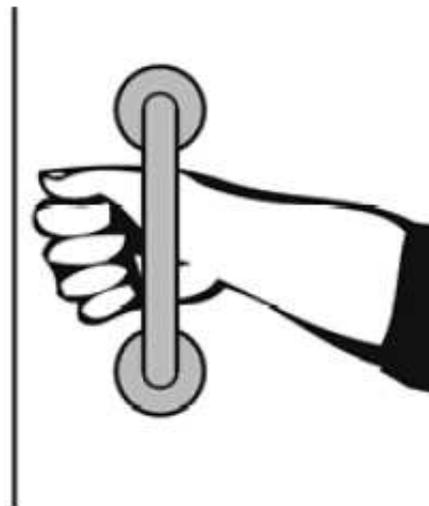
Finding 299113 Main Photo

The water closet compartment door is missing a loop handle on the inside.

Missing loop handle  
on inside of door
