# Site Accessibility Evaluation

## Americans with Disabilities Act Title II (Public Services: State and Local Government)

### County Professional Building

*Inspection Date: 07/24/2017*  
*Inspector: David Mejia*

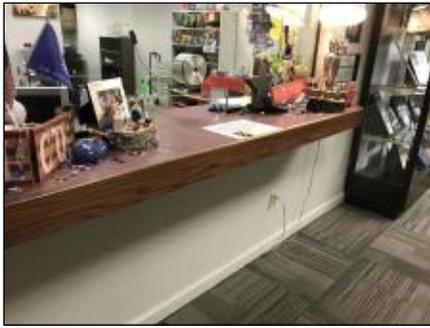
Finding 299326 Additional Photo

The transaction counter is too high.

36.25 inches above  
finished floor

Install new counter section that measures 36 inches maximum in height from the finish floor and lengthen that section of the counter to 36 inches minimum. A clear floor or ground space shall be provided for either a parallel or forward approach complying with section 305 and/or 306 respectively.

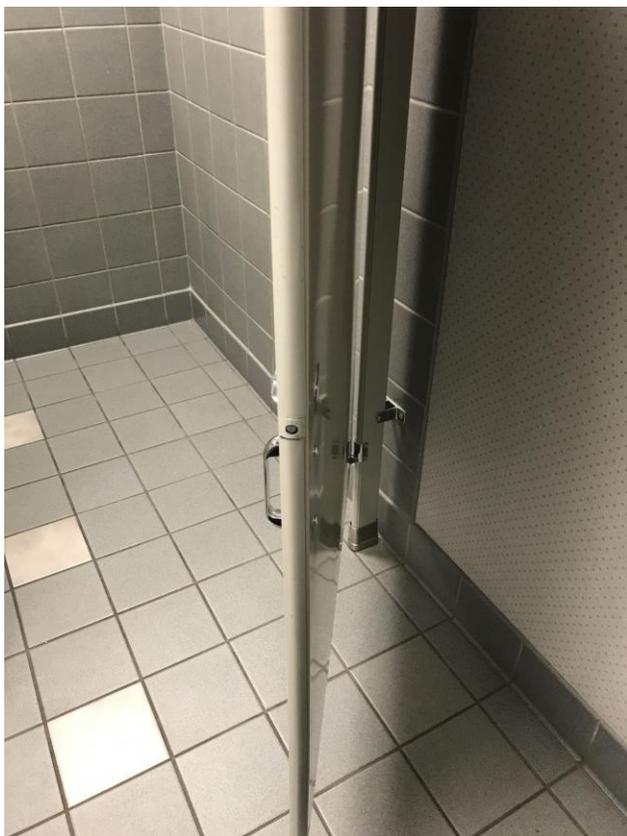
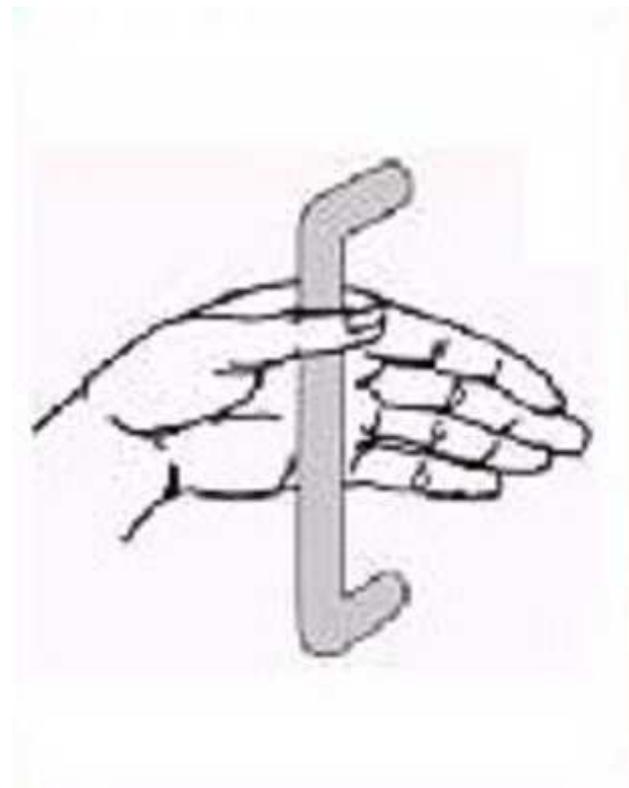
Finding 299122 Main Photo

The water closet compartment door is missing a loop handle on the outside.

Missing loop handle  
on outside of door

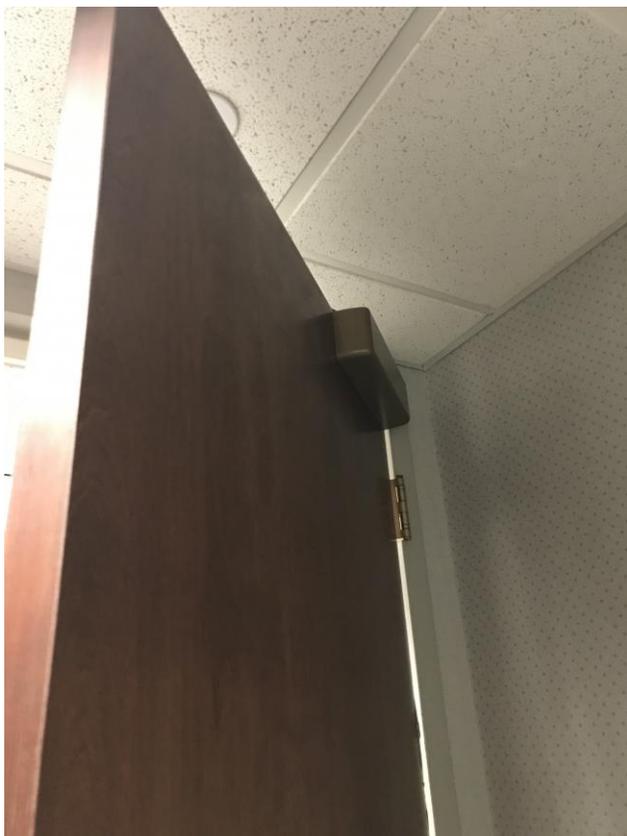
Finding 299129 Main Photo

The door is equipped with a door closer and returns to a closed position too quickly.

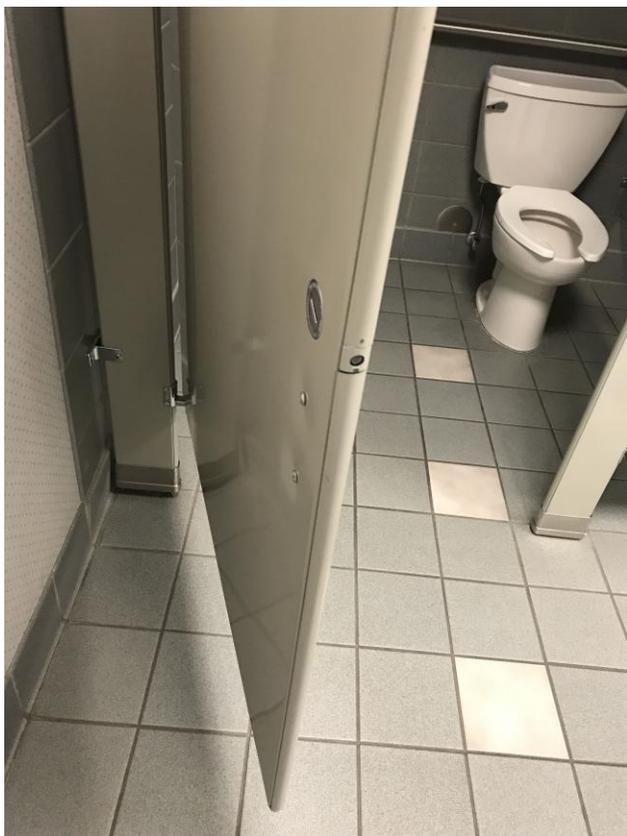
Finding 299132 Main Photo

The water closet compartment door is missing a loop handle on the outside.

Missing loop handle  
on outside of door

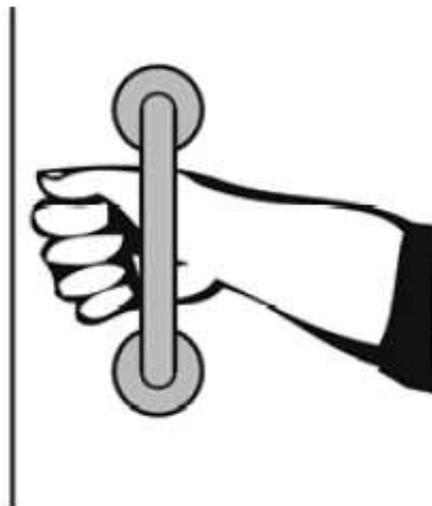
Finding 299106 Main Photo

The water closet compartment door is missing a loop handle on the inside.

Missing loop handle  
on inside of door
