Site Accessibility Evaluation

Environmental Building

**3255 Akers Dr
Colorado Springs, CO
80922**

Accessibility Evaluation

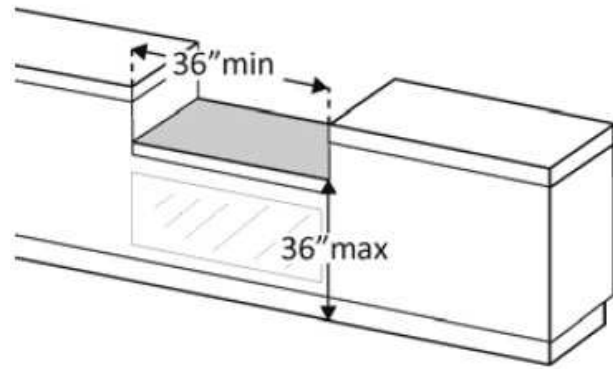
Finding 117888 Main Photo

Finding: 1

The transaction counter is too high.

2010 ADAS Section: 904.4.2, 904.4.1

Counter measured at 42.5 inches from surface to floor.

Modify or extend existing service counter or install new counter/section that includes a section of counter surface that is 36 inches long minimum and 36 inches high maximum.

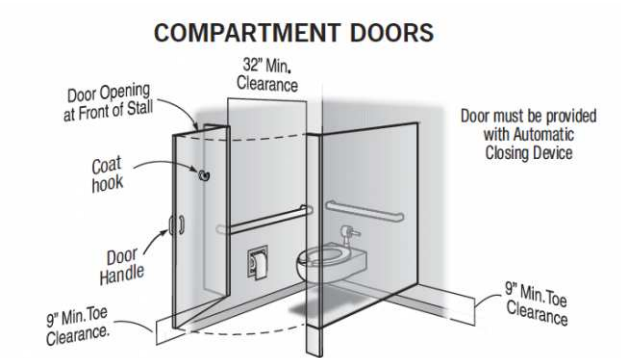
Womens Restroom

Finding: 3

Although not required per ADA Standards, but required under the ICC/ANSI A117.1

Citation:	As Built:	Budgeting Range:
2010 ADAS Section: Recommended	Vertical grab bar 37 inches above finished floor	\$0 - \$0.00

Re-position vertical grab bar so that bottom of grab bar measures a maximum of 41 inches but no less than 39 inches above finished floor.
