# Site Accessibility Evaluation

## Americans with Disabilities Act Title II (Public Services: State and Local Government)

### Fair and Events Complex

***Inspection Date: 10/29/2015***

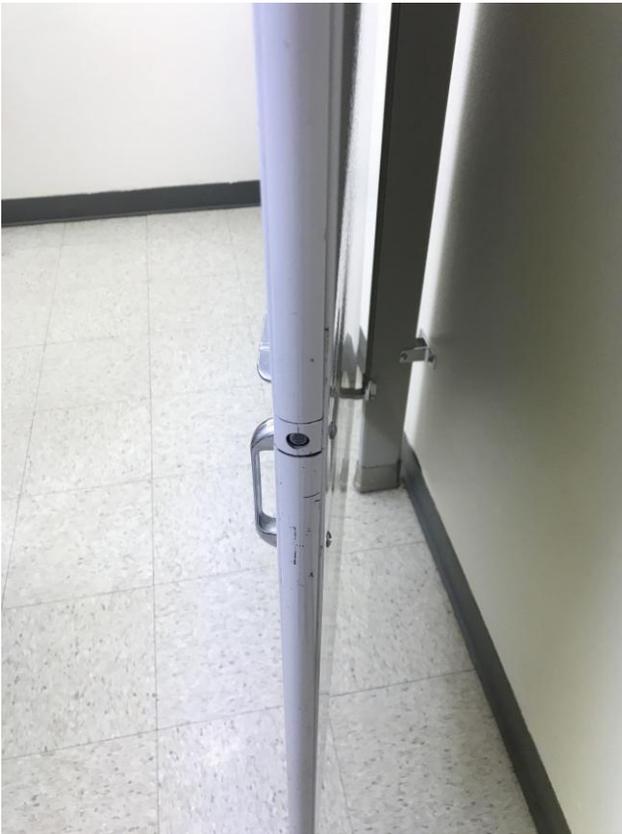
Finding 297884 Main Photo

The water closet compartment door is missing a loop handle on the outside.

Missing loop handle  
on outside of  
compartment door

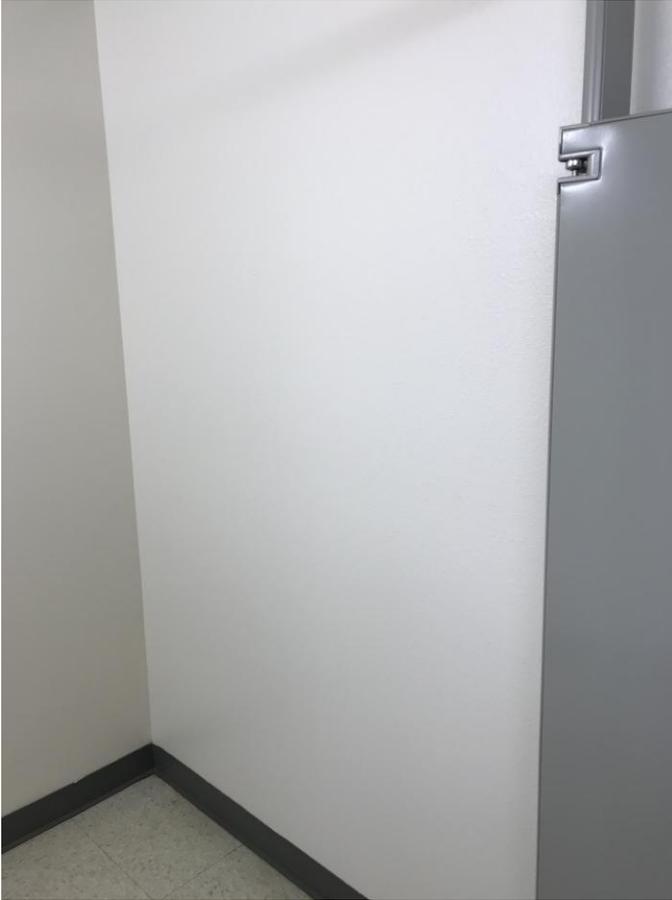
Finding #31 Continued

Citation:	As Built:	Budgeting Range:
2010 ADAS Section: Recommended	Baby changing table non existing	\$200 - \$400.00

Recommend installing baby changing station due to pedestrian traffic during the annual fair. Also, fair grounds complex supervisor inquired and asked if it would possible to install a changing station due to it's demand during the annual fair.

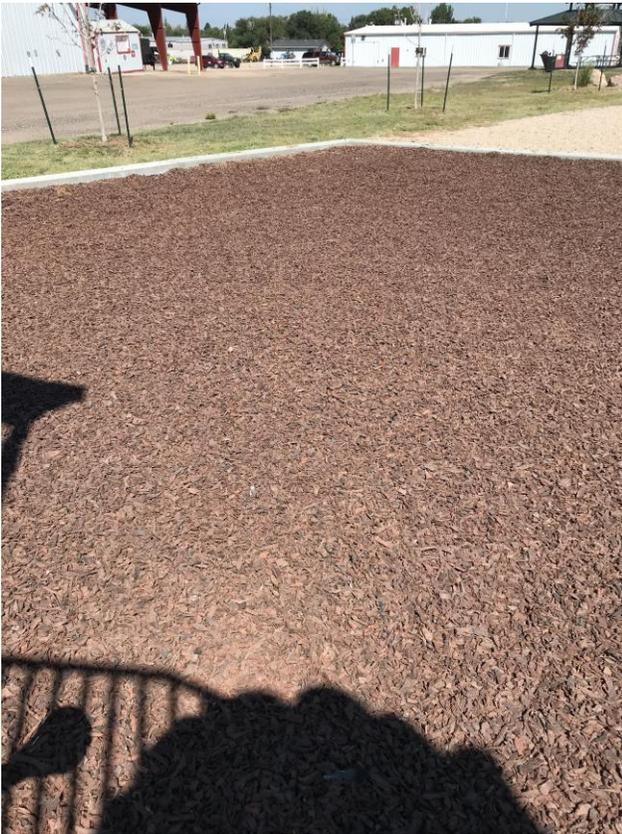
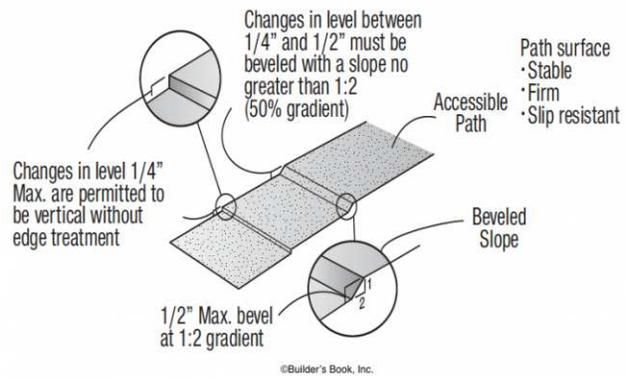
Finding 297914 Main Photo

The accessible route contains loose gravel and/or surfaces that do not provide for a stable, firm slip resistant surface.

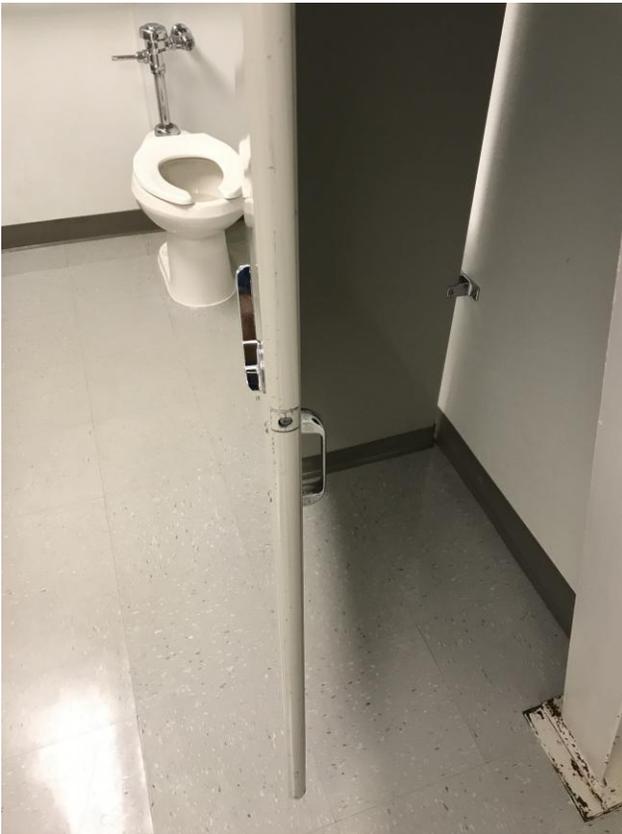
Finding 297975 Main Photo

The water closet compartment door is missing a loop handle on the outside.

Missing loop handles  
on outside of  
compartment door

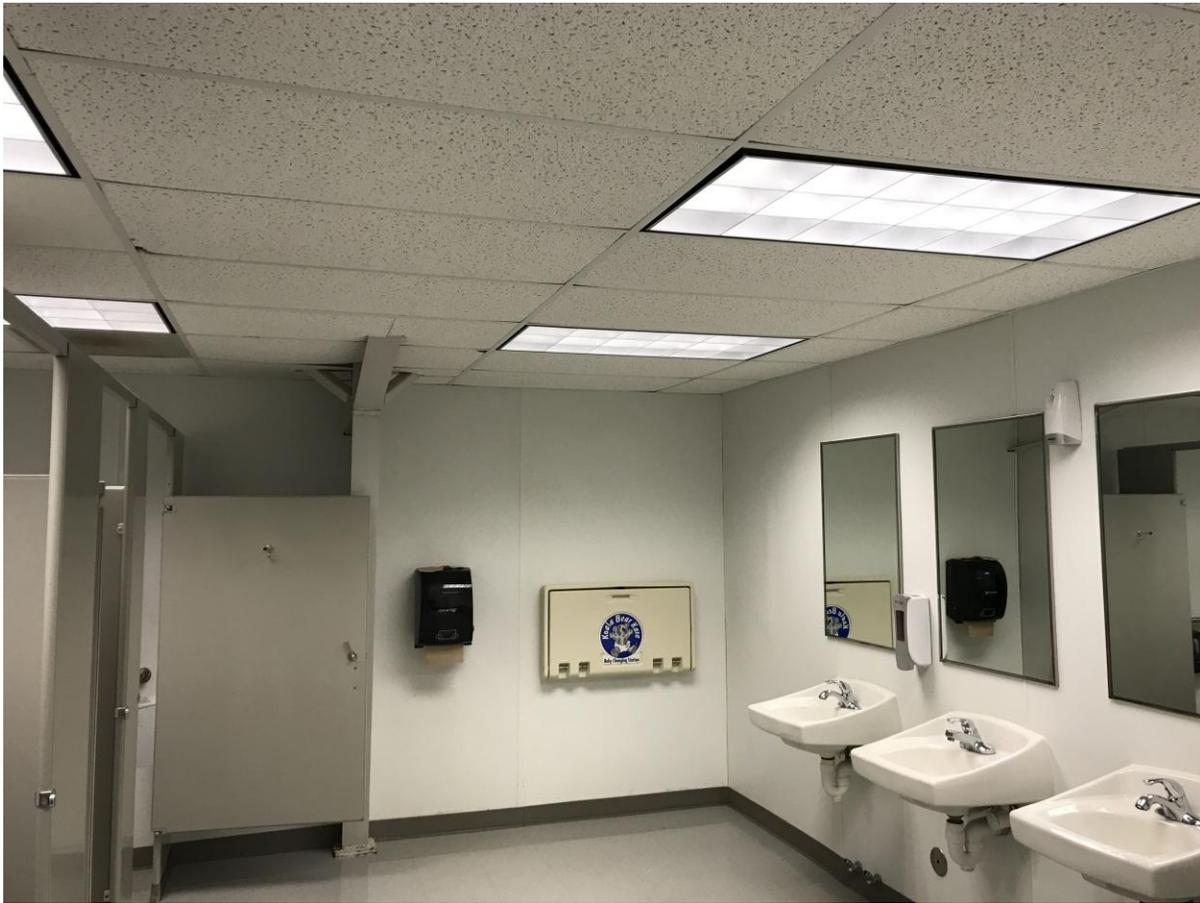
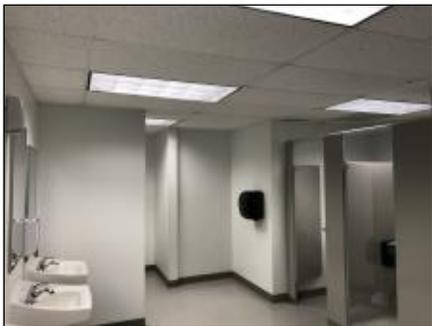
Finding 297978 Main Photo

Missing visual or audible fire alarm

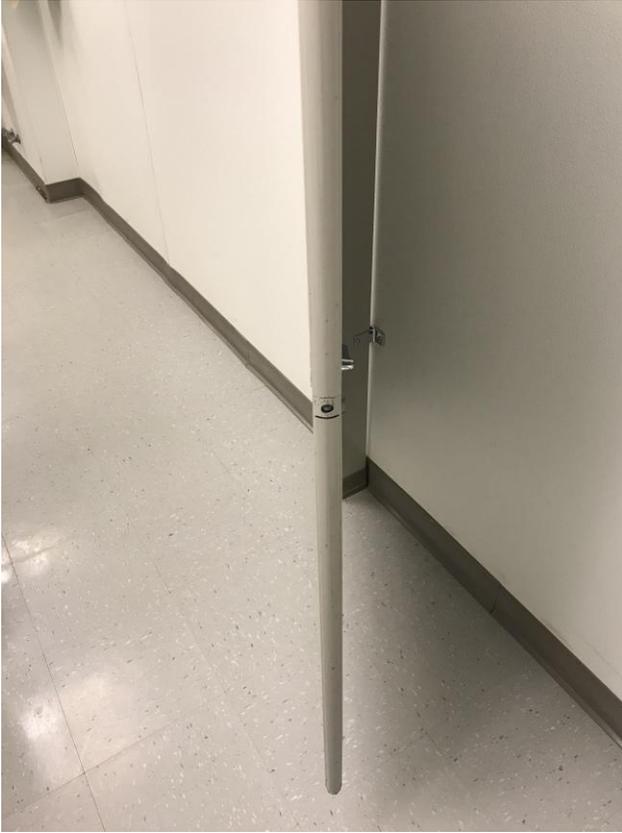
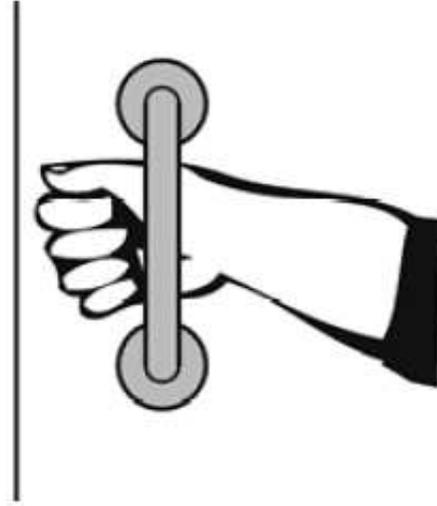
Finding 298005 Main Photo

The water closet compartment door is missing loop handles.

Missing loop handles  
on compartment door

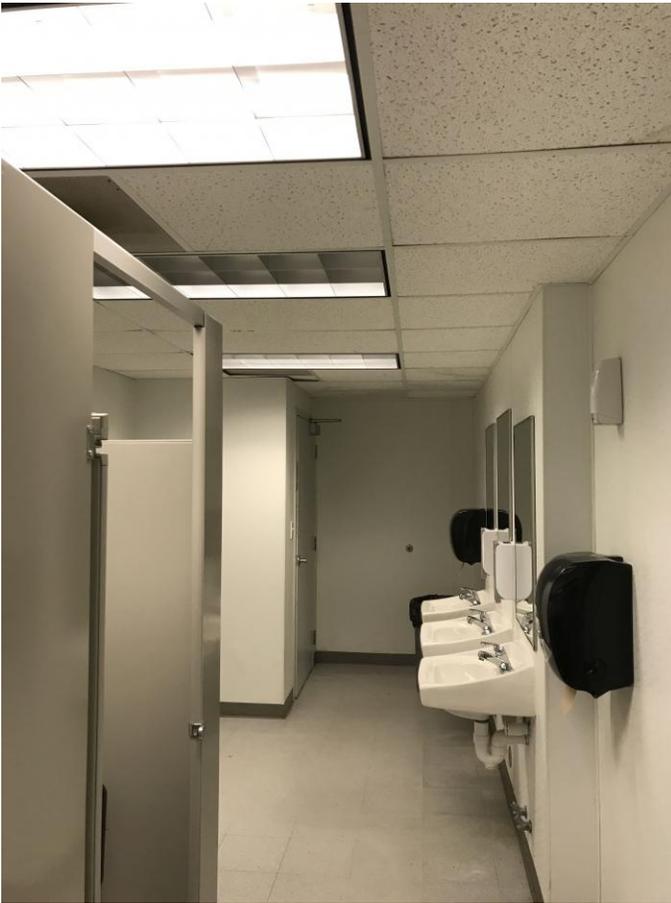
Finding 298006 Main Photo

Missing visual or audible fire alarm

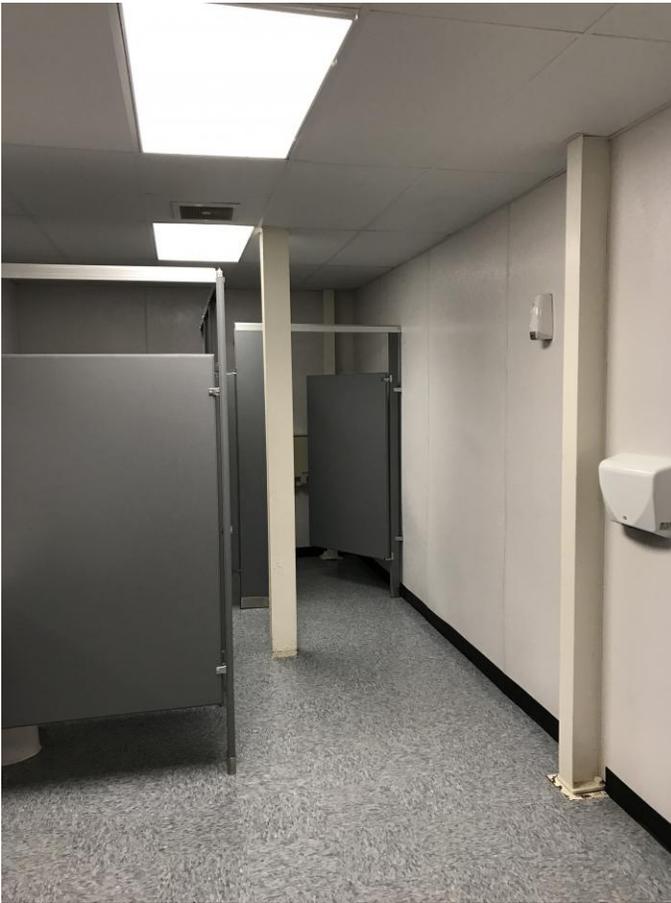
Finding 297926 Main Photo

Missing visual or audible fire alarm

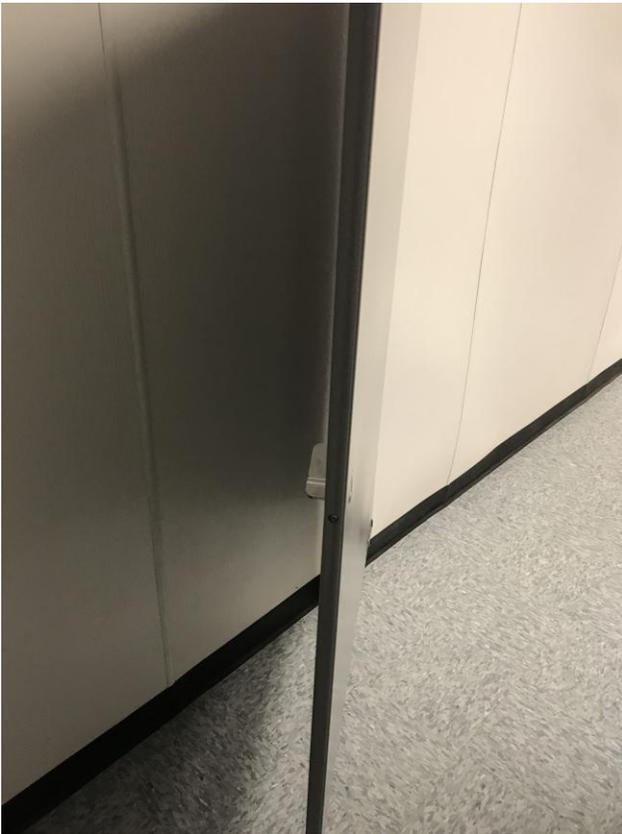
Finding 297925 Main Photo

The water closet compartment door is missing a loop handle.

Missing loop handles  
on compartment door

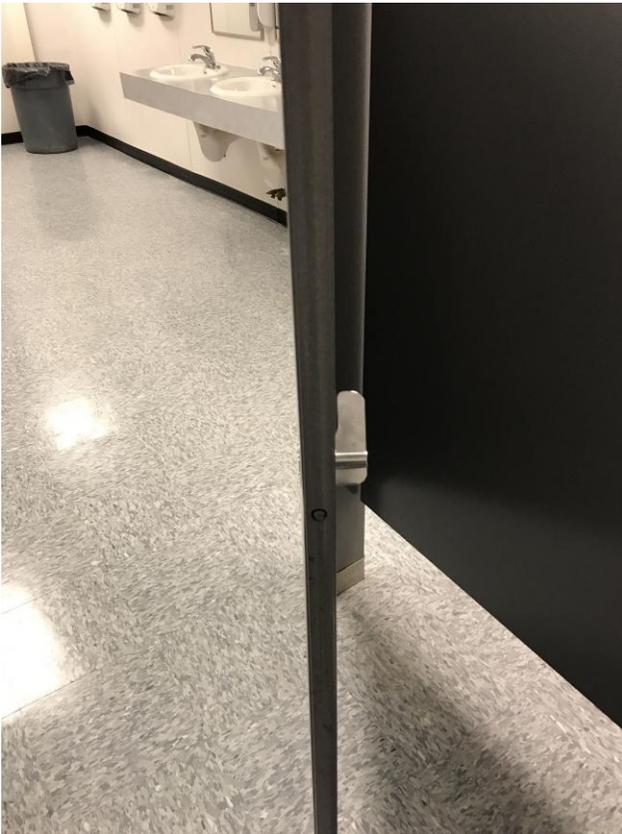
Finding 297918 Main Photo

The water closet compartment door is missing a loop handle.

Missing loop handles  
on compartment door

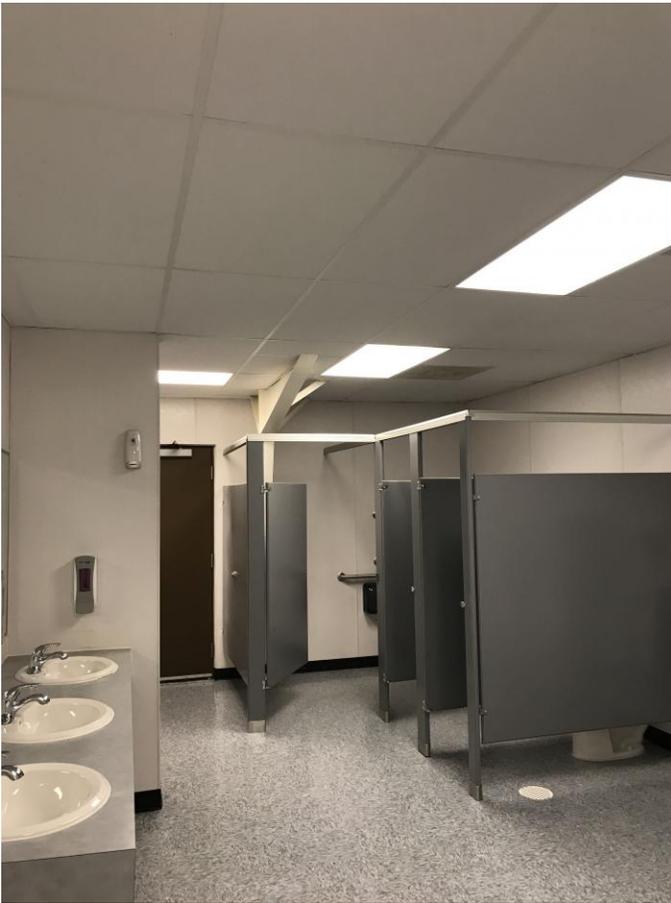
Finding 297919 Main Photo

Missing visual or audible fire alarm

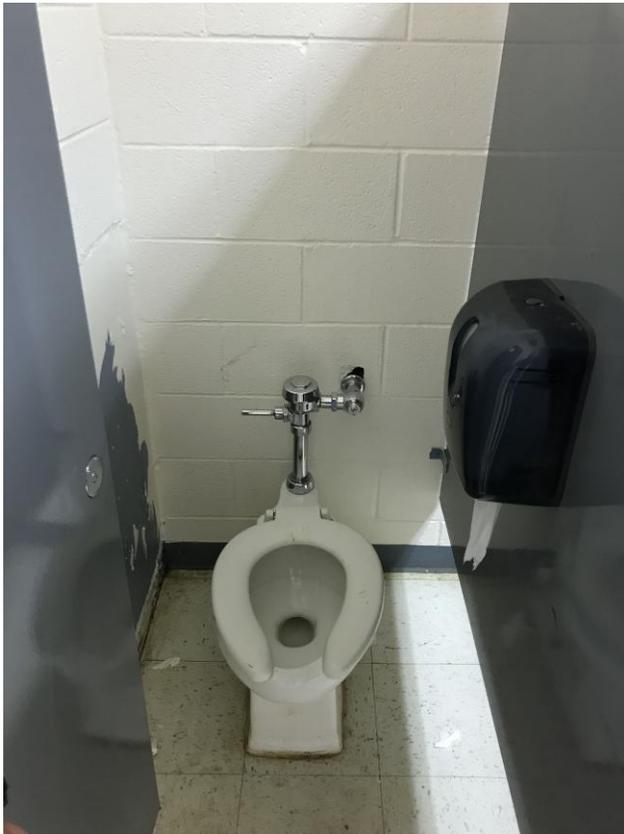
Finding 297958 Main Photo

Rear and side grab bars missing

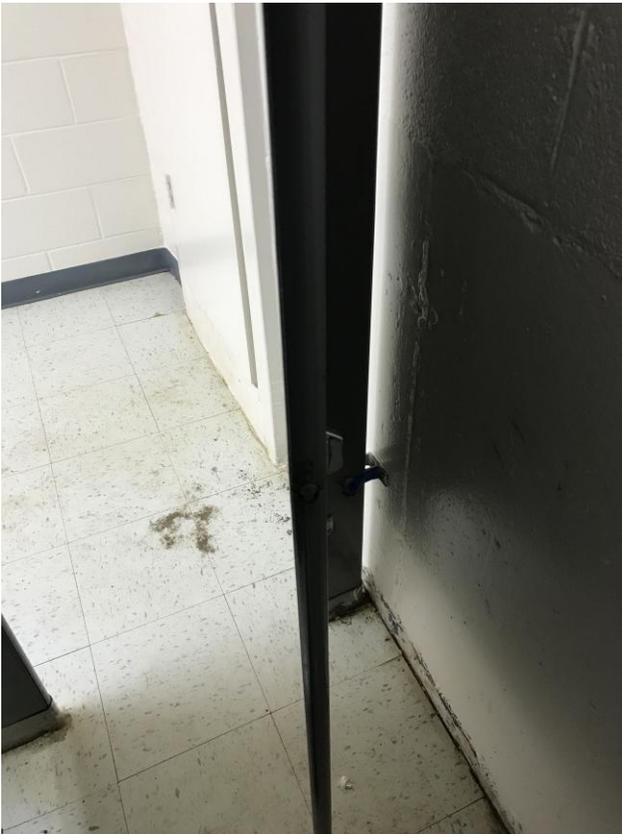
Finding 297962 Main Photo

The water closet compartment door is missing a loop handle.

Missing loop handles  
on both sides of  
compartment door

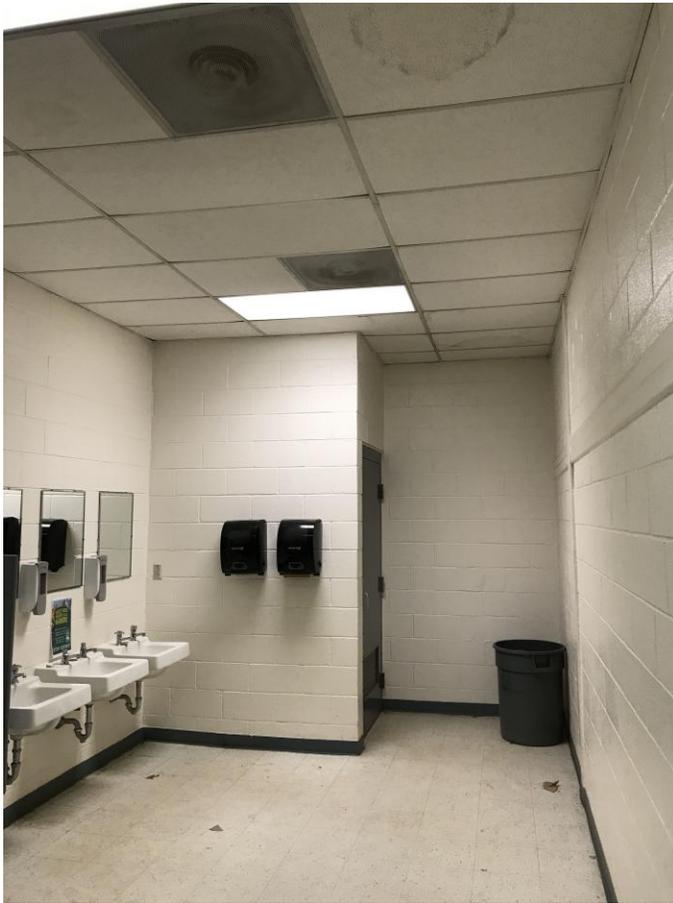
Finding 297964 Main Photo

Missing visual or audible fire alarm

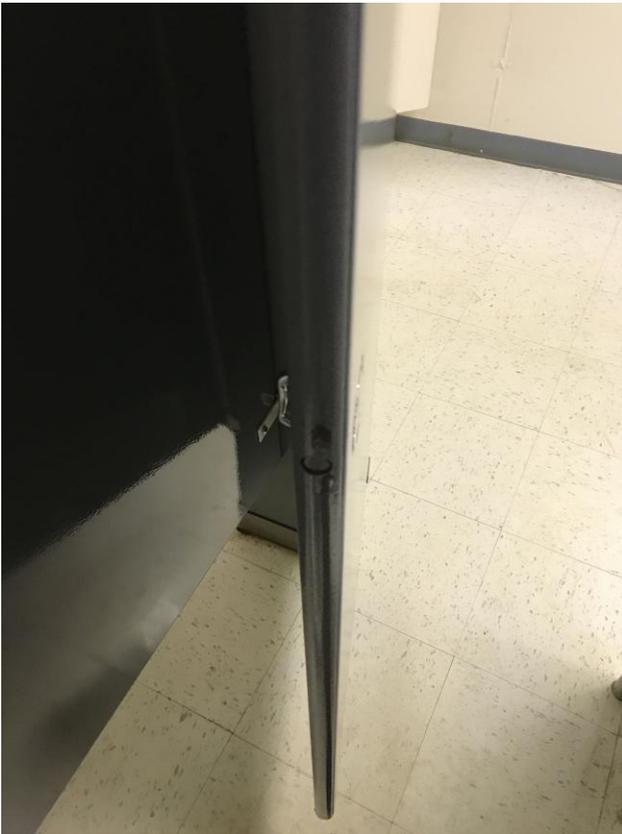
Finding 297945 Main Photo

The water closet compartment door is missing a loop handle.

Missing loop handles  
on both sides of  
compartment door

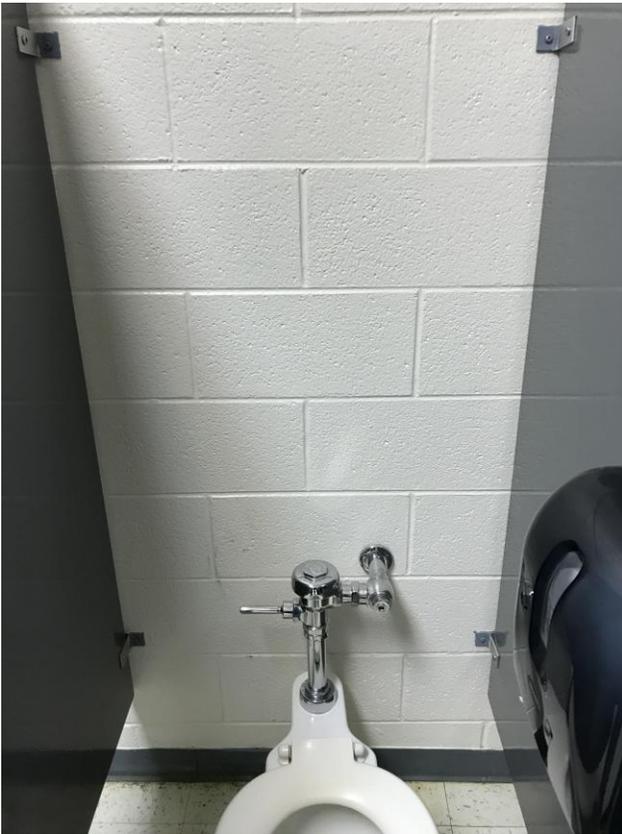
Finding 297941 Main Photo

Rear and side grab bars missing

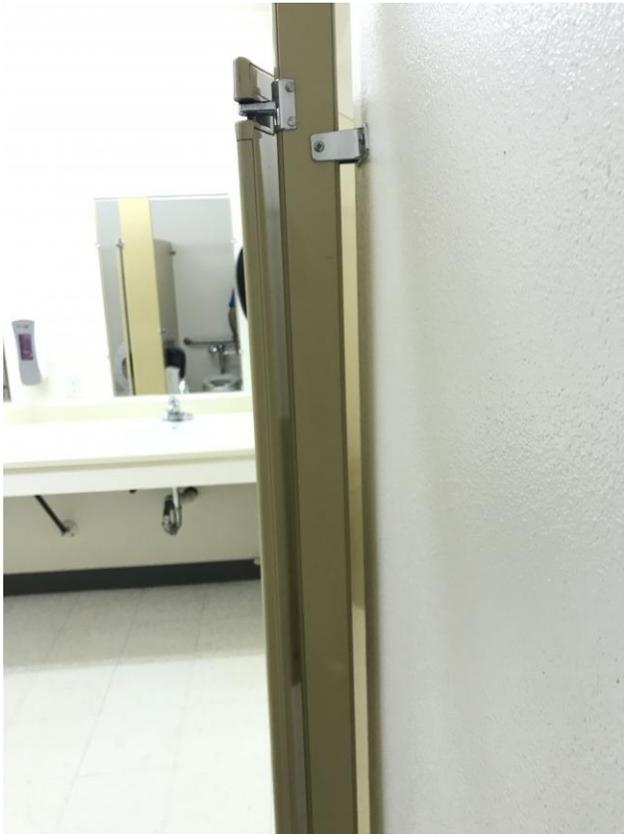
Finding 298069 Main Photo

The water closet compartment door is missing a loop handle on the inside.

Missing loop handle  
on compartment door

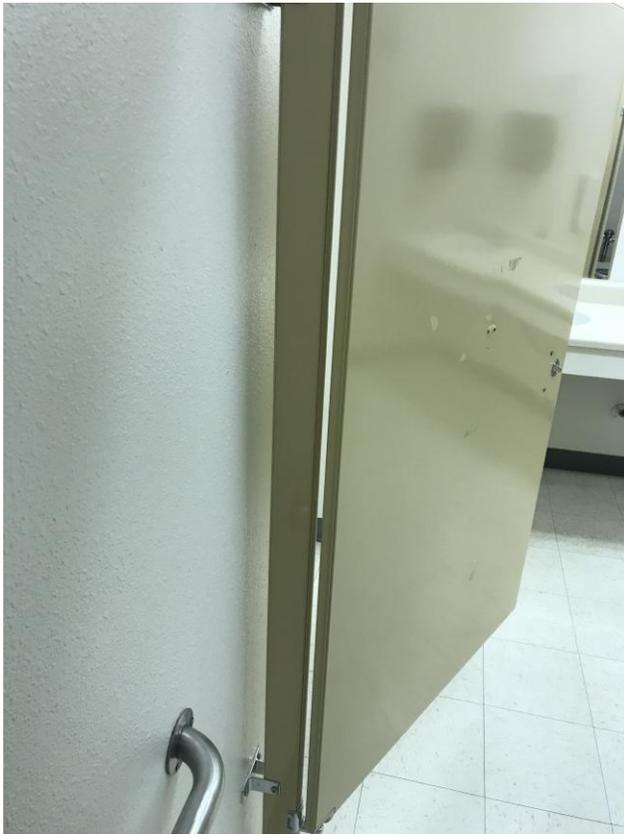
Finding 298274 Main Photo

The water closet compartment door is missing a loop handle on the inside.

Missing loop handle  
on compartment door

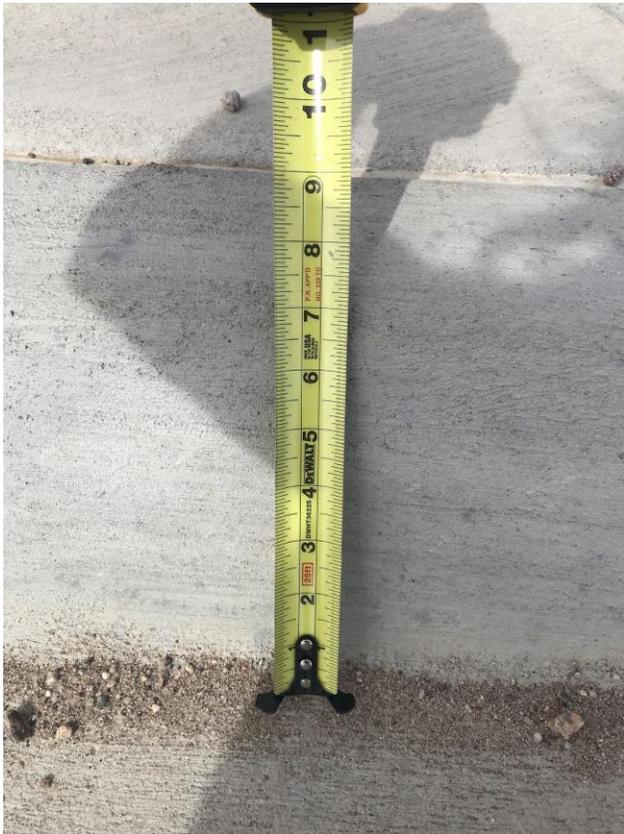
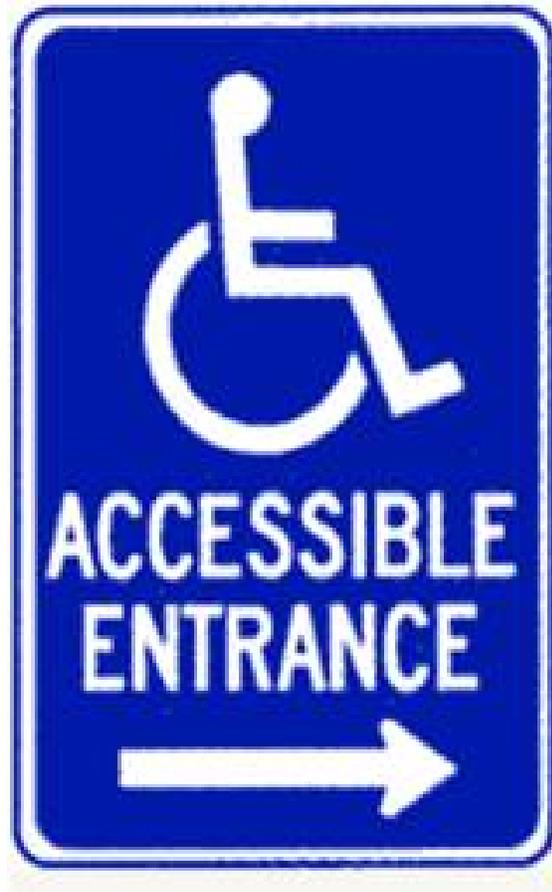
Finding 298287 Main Photo

Non-accessible entrance/s signage missing.

An identification sign identifying that this entrance is not accessible and directional signage pointing in the direction to the accessible entrance is needed. If an accessible entrance is not available and is not "readily achievable" to provide, we suggest signage indicating that curb side service is available upon request or that services may be provided at a different accessible location. We recommend that this sign have a working phone number that is always answered during regular business hours. Another option for consideration would be the installation of a door bell located at an accessible location on the exterior of the business that will alert an attendant.
