Site Accessibility Evaluation

Americans with Disabilities Act Title II (Public Services: State and Local Government)

EPC Veteran Services

**5850 Championship View
Colorado Springs, CO
80922**

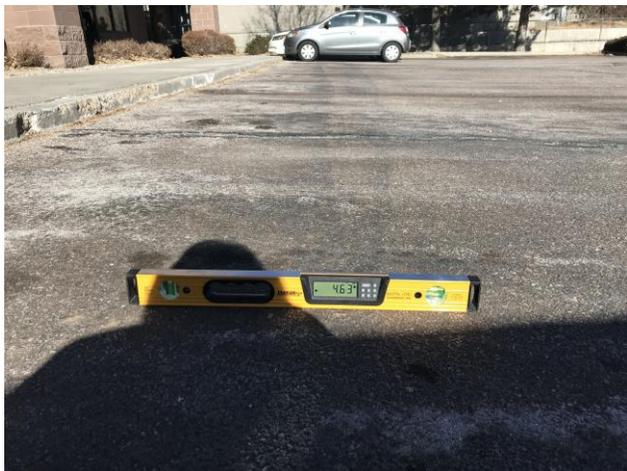
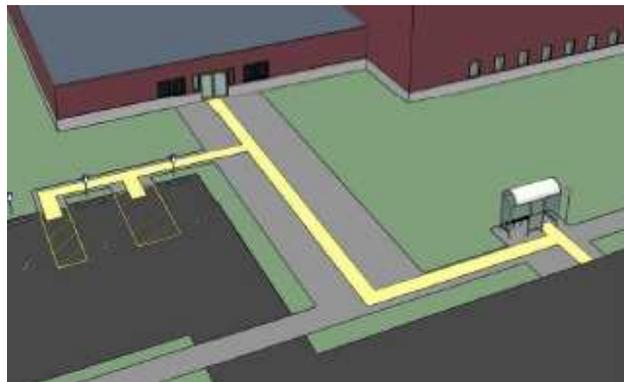
Finding 299063 Main Photo

The accessible parking is not located on an accessible route of travel to the accessible building entrance.

No accessible pedestrian ramp or access aisle exists

Move the existing accessible parking stall and access aisle 3 to 4 stalls over (north). The cross slope of that section of the parking lot is compliant or very close to meeting the 2% maximum. The running slope will have to be addressed as it currently exceeds the 2% maximum and is somewhere between 4 to 5%.

- It will require new asphalt/concrete and grading but it is easily achievable due to the minimal grade/slope of that section of the parking lot.
- Additionally, a parallel pedestrian ramp will be required to grant access to the sidewalk for wheelchair users thus allowing entrance to the veterans office. Parallel pedestrian ramp will have to be constructed and connect to the existing sidewalk

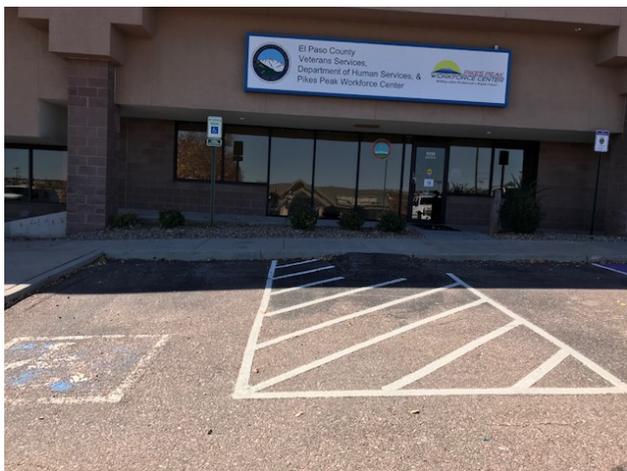
Finding 18195 Main Photo

The accessible parking stall's access aisle contains a built up curb ramp which results in significant slopes greater than 2 percent.

Asphalt ramp protruding into parking access aisle with a running slope of 12.3%

Remove protruding ramp and design/construct parallel curb ramp into existing sidewalk not to exceed 8.33% running slope and 2% cross slope. Note: that this property is a lease, and the landlord is responsible for the correction.

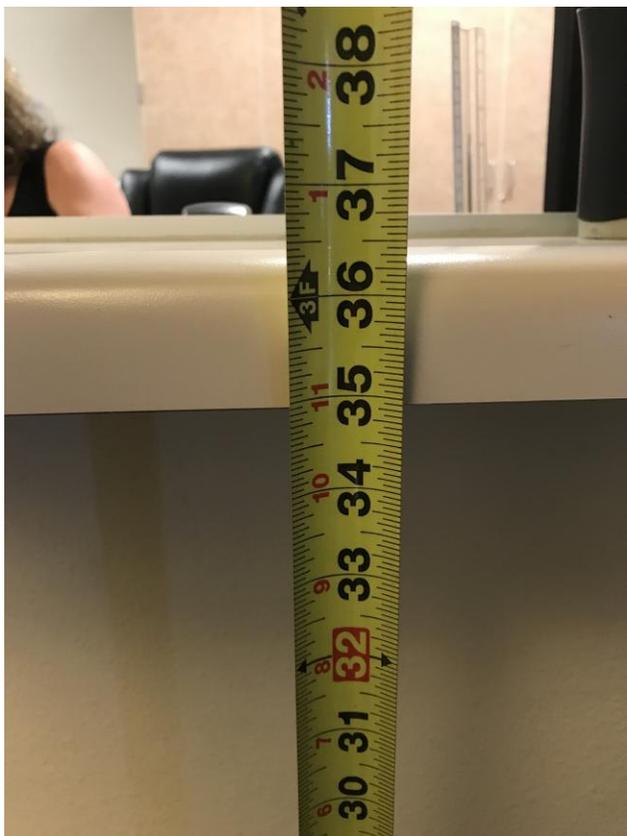
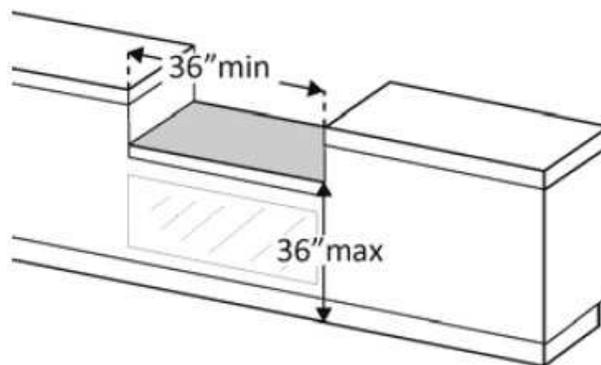
Finding #3 Continued

The transaction counter is too high.

36.25 inches above finished floor

Replace or re-configure a section of the transaction counter to provide a clearance of 36 inches high and a minimum of 36 inches wide.

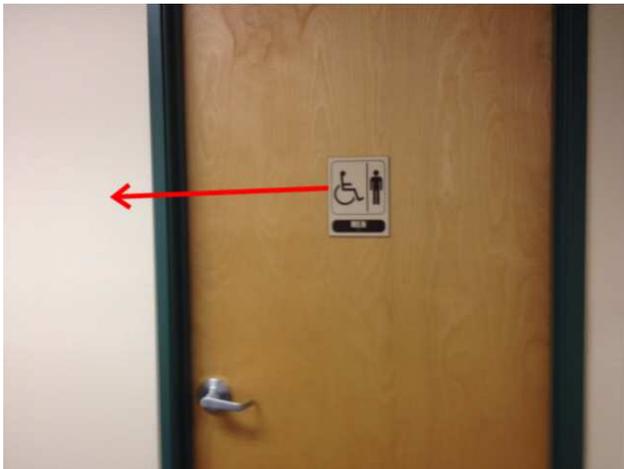
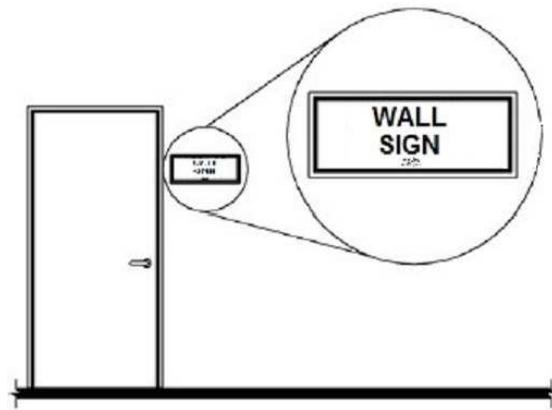
Finding 18204 Main Photo

The tactile sign is incorrectly located.

Located on door.
Submit w/o to relocate sign.

Submit a work order to have sign reinstalled.

Corrective Action: W/O 386286 submitted. Relocated sign on 4/03/2017.

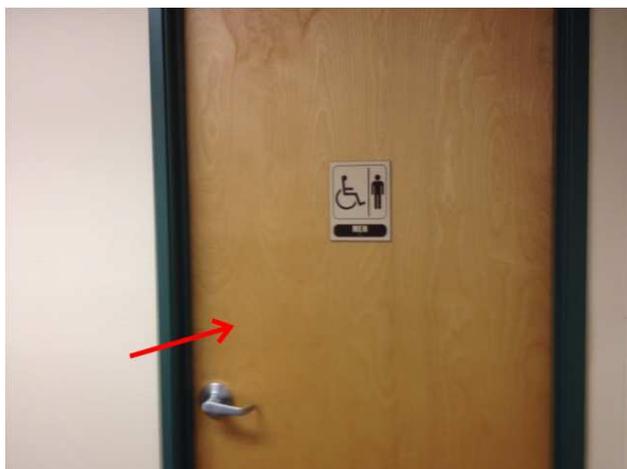
Finding 18205 Main Photo

The door exceeds the maximum pressure to open the door.

10 lbs force to open.

Submit work order to have door closer adjusted.

Corrective Action: W/O 381234 competed 2/1/2017.

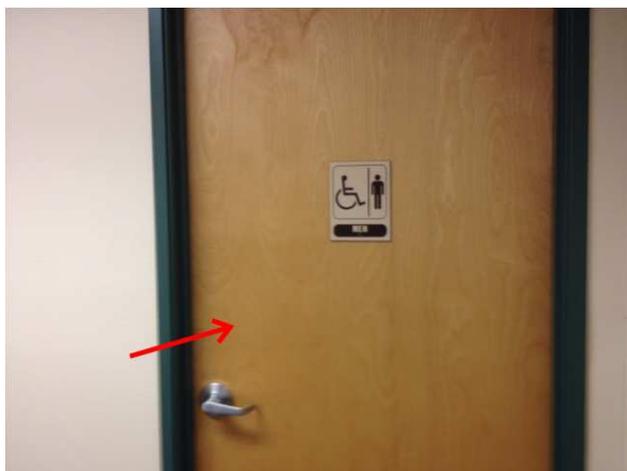
Finding 18207 Main Photo

The door is equipped with a door closer and returns to a closed position too quickly.

Closer takes 3.8 seconds to close.

Submit work order to have door closer adjusted.

Corrective Action: W/O 381234 completed 2/1/2017.

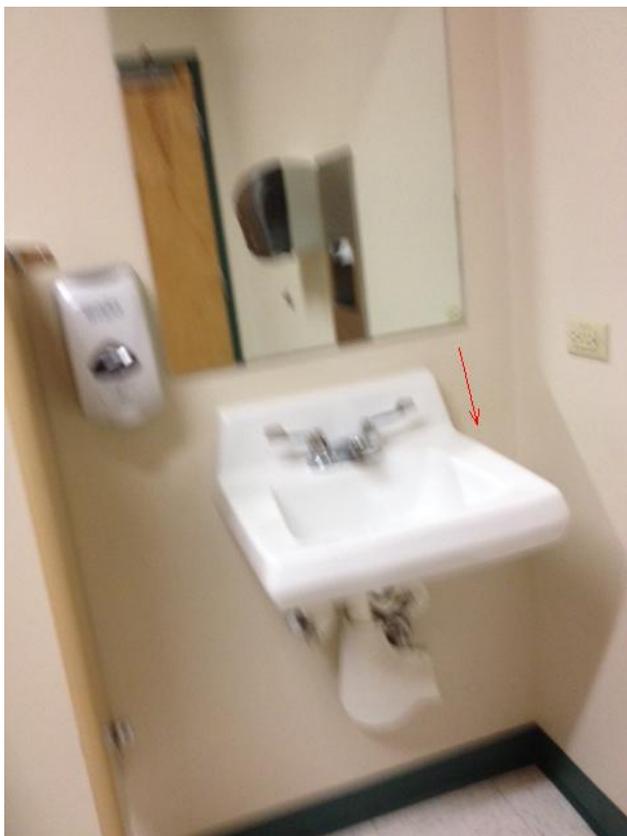
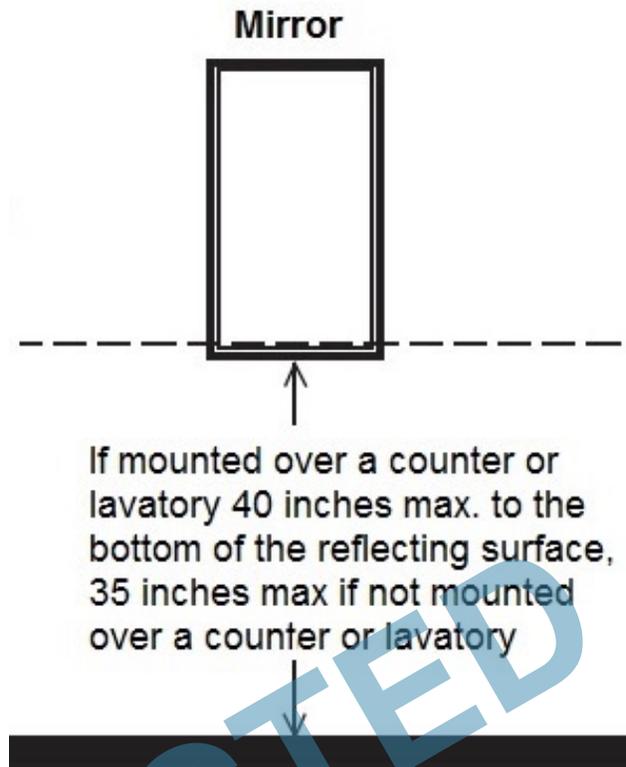
Finding 18208 Main Photo

The mirror is mounted too high.

Mounted at 43 inches
above finished floor

Submit work order to have mirror lowered to 40 inches.

Corrective Action: W/O 381233 submitted. Completed 4/6/17. Mirror added to right side of lavatory with bottom edge of the reflecting surface at 35 inches above finished floor. Verified on 8/7/19

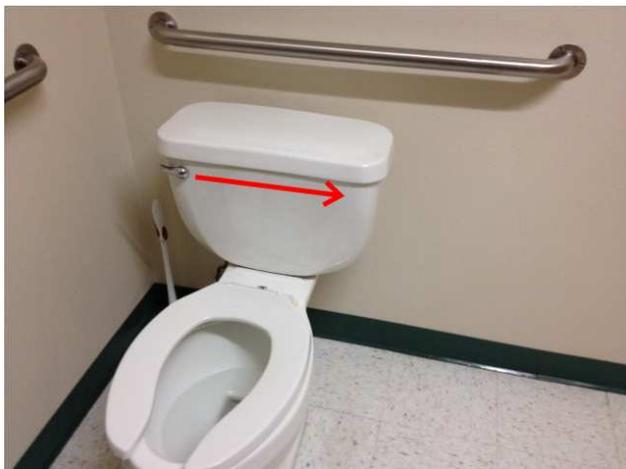
Finding 18222 Main Photo

The flush handle is located on the wrong side of the toilet.

Flush control located on closed side.

Submit a work order to move flush control to open side.

Corrective Action: W/O 381232 submitted. Installed new tank w/ handle on left side-completed 3/7/2017.

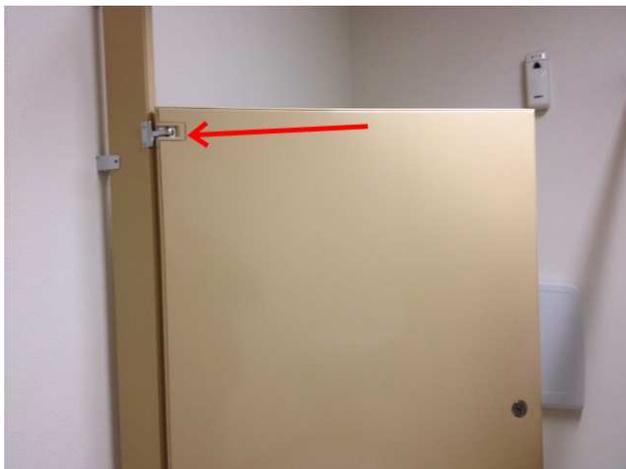
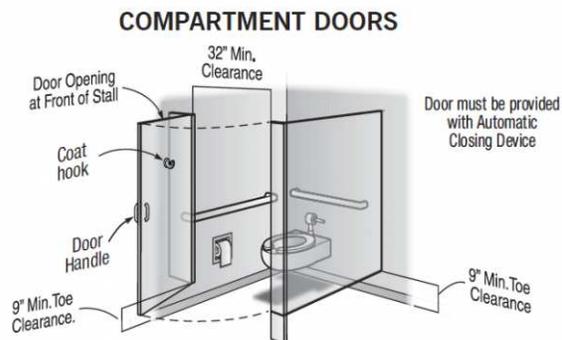
Finding 18249 Main Photo

The compartment door is not self closing.

Stall door does not self-close.

Submit a work order to replace or adjust existing door closer.

Corrective Action: W/O 381231 submitted.

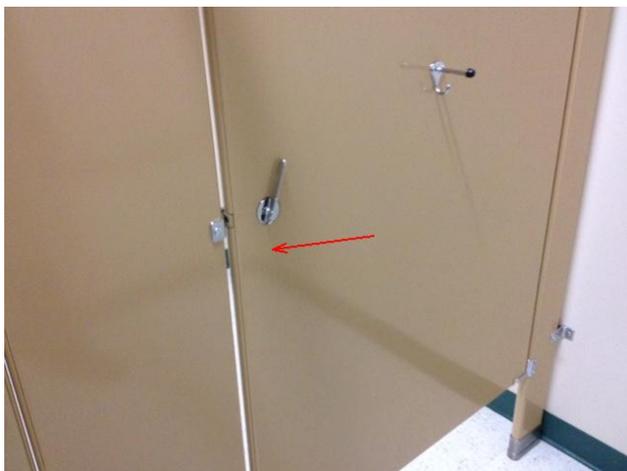
Finding 18276 Main Photo

The water closet compartment door is missing a loop handle.

No loop handles installed.

Submit a work order to have loop handles installed on stall door.

Corrective Action: W/O 381230 submitted. Corrected 2/1/2017.

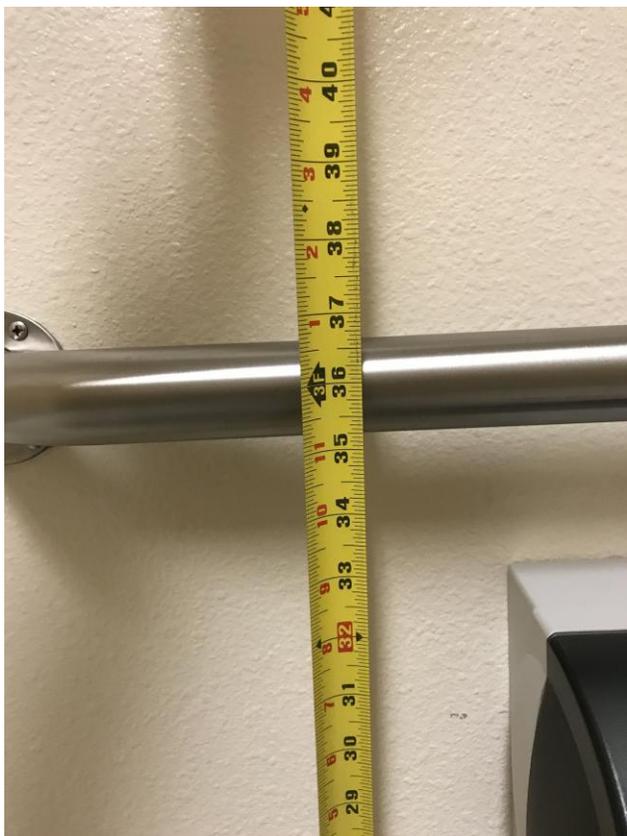
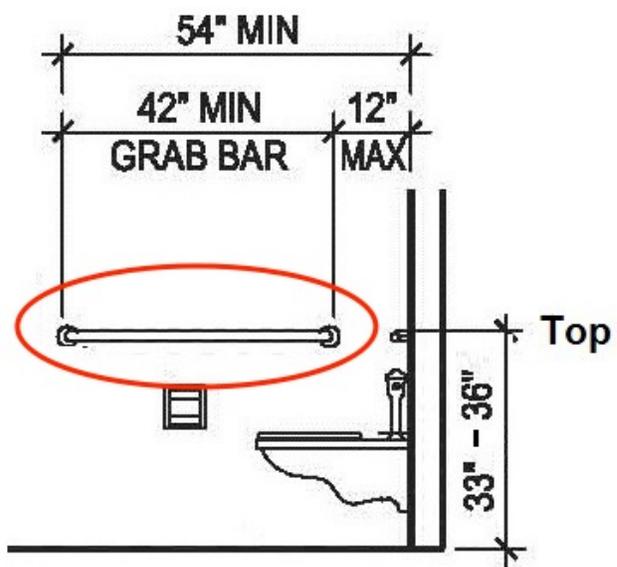
Finding 297268 Main Photo

The side grab bar is too high.

36.75 inches above
finished floor

Lower side grab bar 1 inch to meet compliance.

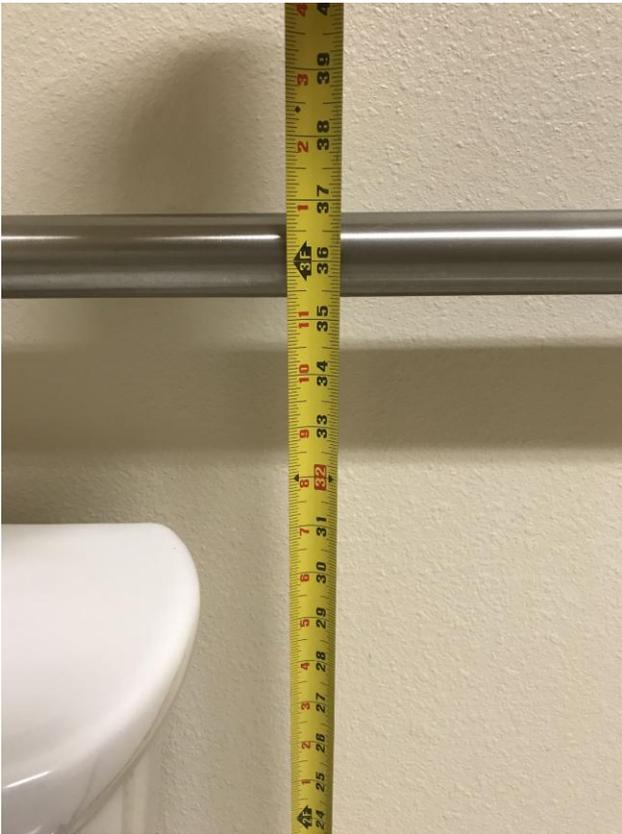
Finding 297269 Main Photo

The rear grab bar is too high.

37 inches above
finished floor

Lower rear grab bar 1 inch minimum to meet compliance.

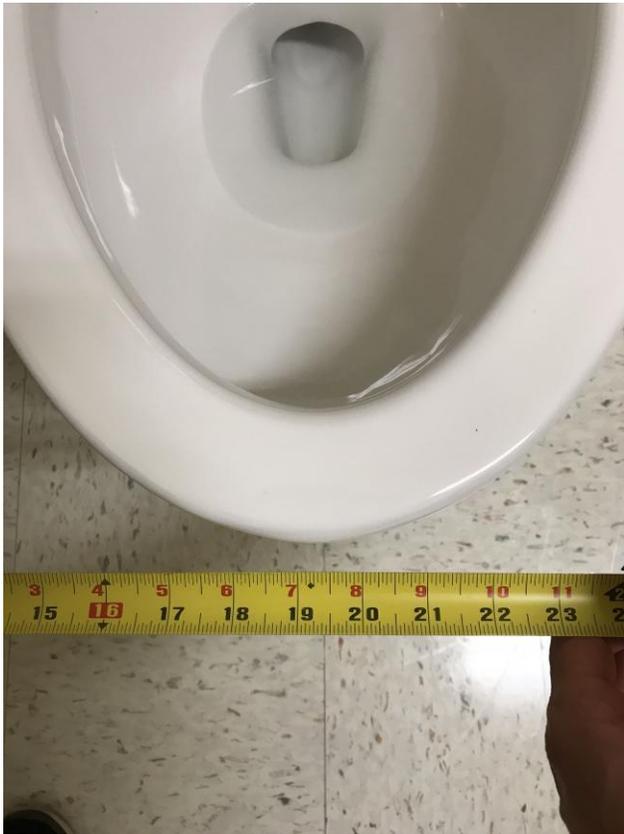
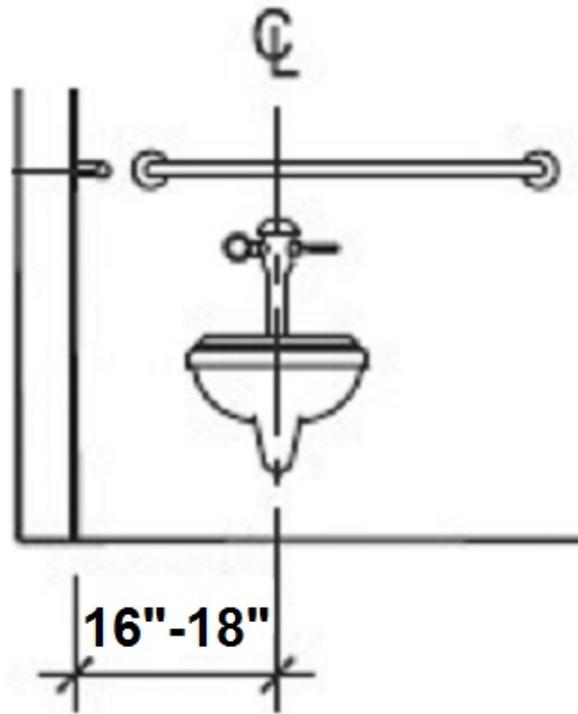
Finding 297270 Main Photo

The toilet is not located within the range allowed from the side wall or partition.

19.25 inches from side wall

Adjust toilet so that it measures between 16 and 18 inches measured from the side wall to the centerline of the toilet.

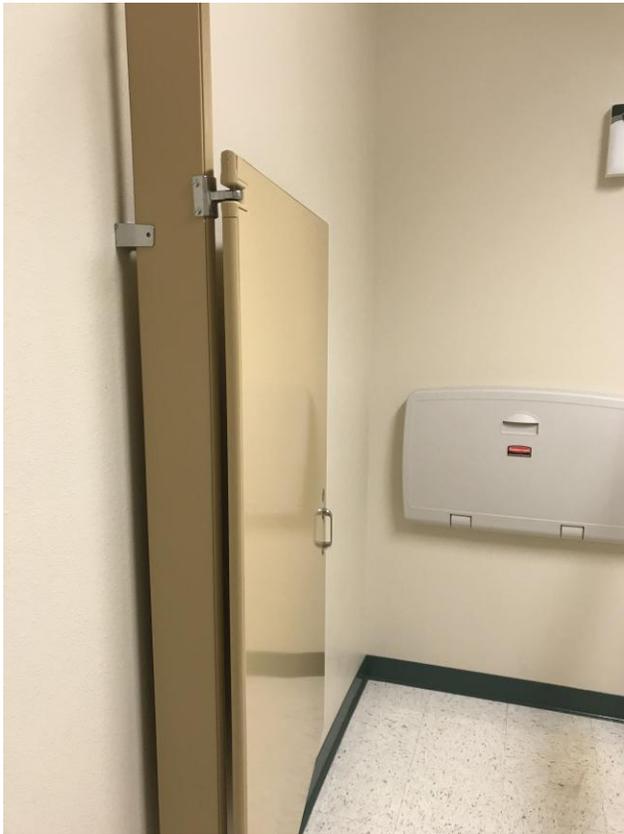
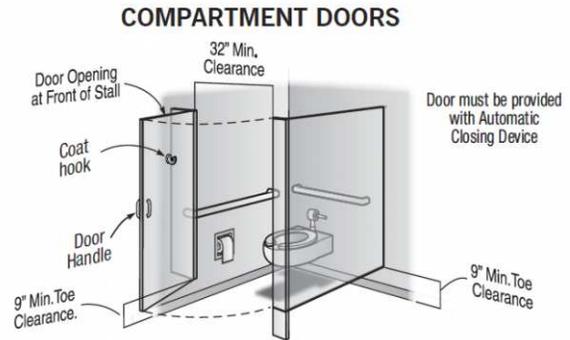
Finding 297271 Main Photo

The compartment door is not self closing.

Stall door not self closing

Install or adjust compartment door hinges to make compartment door self close.

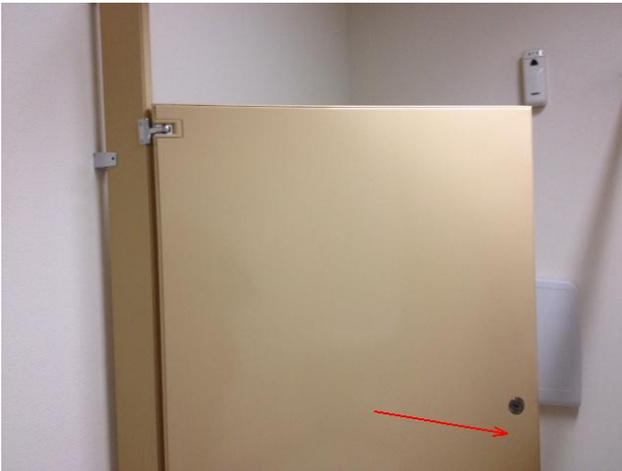
Finding 18292 Main Photo

The water closet compartment door is missing a loop handle.

Corrective Action: W/O 381223 submitted. Completed 2/1/2017.
