Site Accessibility Evaluation

Americans with Disabilities Act Title II (Public Services: State and Local Government)

Santa Fe Regional Trail Restroom

*Inspection Date: 07/09/2019
Inspector: David Mejia*

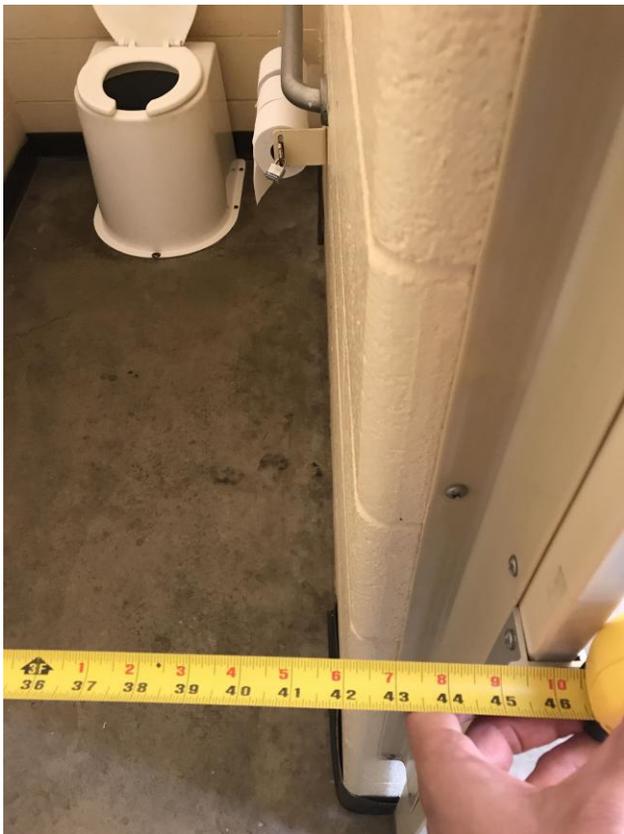
Finding 297235 Main Photo

The toilet compartment is not wide enough.

2010 ADAS Section: 604.8.1.1

42.5 inches wide

Toilet compartments should be a minimum of 60 inches. Due to space restrictions, meeting compliance may not be possible. A full project remodel is in the planning stages.

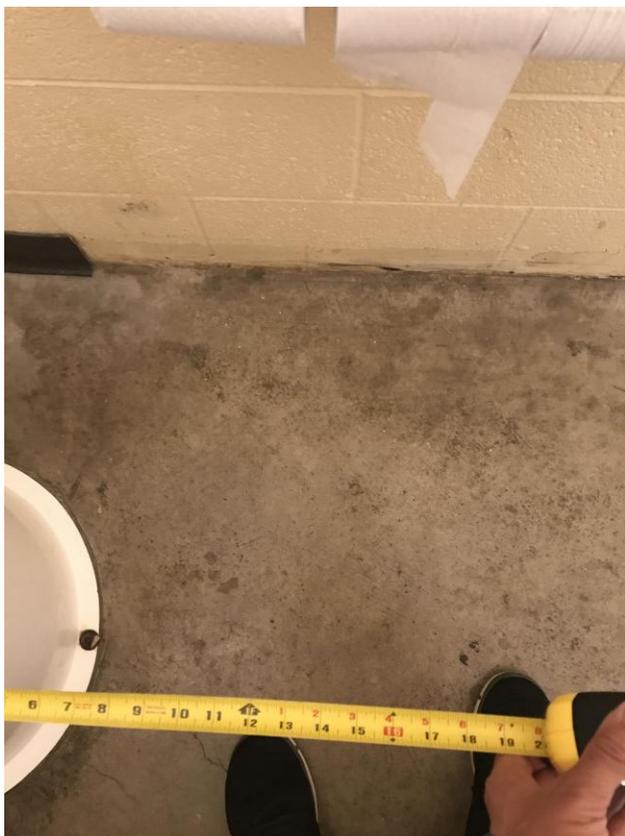
Finding 297239 Main Photo

The toilet paper is not installed within the compliant range in front of the toilet.

2010 ADAS Section: 604.7

13 inches in front of toilet

Re-position toilet paper dispenser between 7 to 9 inches in front of toilet measured to the centerline of the toilet paper dispenser.

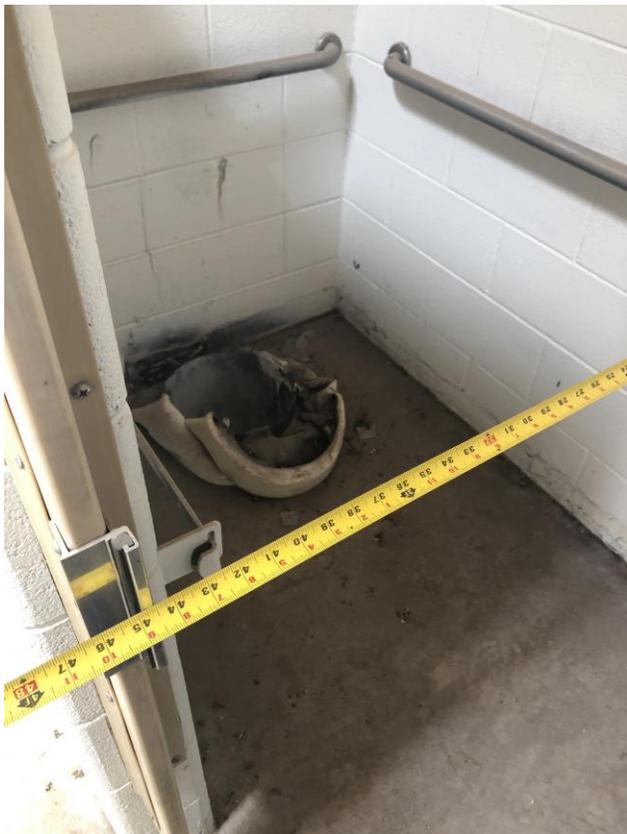
Finding #14 Continued

The toilet compartment is not wide enough.

2010 ADAS Section: 604.8.1.1

44 inches in width

Toilet compartments should be a minimum of 60 inches. Due to space restriction, meeting compliance may not be possible. A full project remodel is in the planning stages due to recent fire damage. The women's restroom adjacent is being utilized temporarily as a unisex restroom.
