Site Accessibility Evaluation

DOT Calhan Office

**1010 Golden St
Calhan, CO 80808**

Accessibility Evaluation

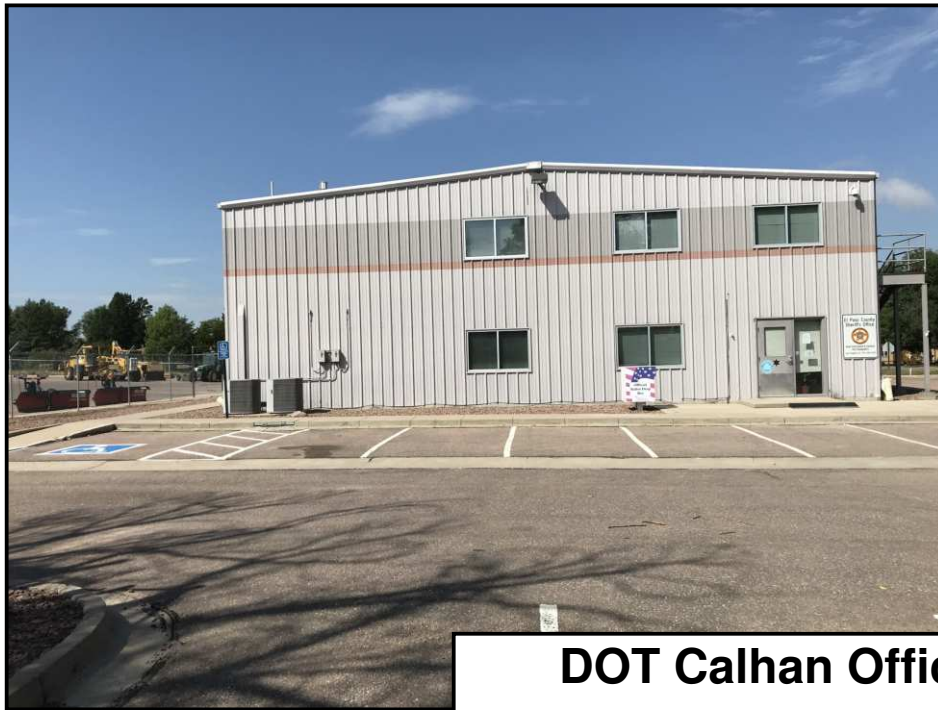
Finding: 1

Sheriffs Office Rural Enforcement Entrance

The ramps slope exceeds the maximum running slope (direction of travel) allowable of 8.33%.

2010 ADAS Section 405.2

Ramp runs shall have a running slope not steeper than 1:12.

19.20 % running slope

Create new concrete ramp and remove existing detachable metal ramp. New ramp at 4 feet in length would meet ADA compliance at 8.33%.

1 (High): Should be completed immediately. (Includes; Findings that have little or no cost, were in violation of the codes at the time of construction, or pose an imminent safety threat)

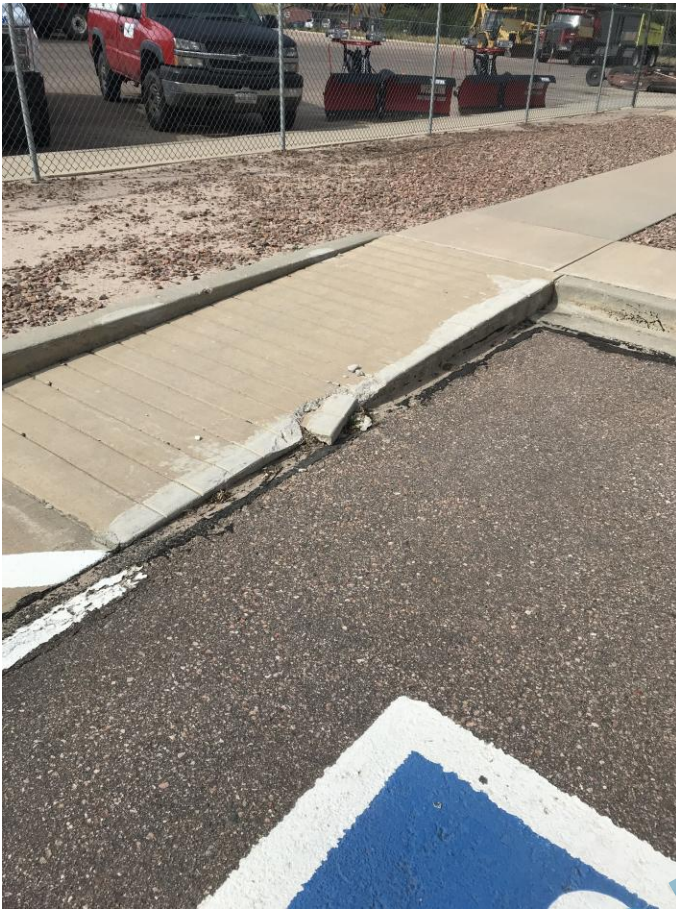
Finding 297747 Main Photo

Damage to existing path of travel

Re-construct existing path of travel ramp/sidewalk. Built to not exceed a 5.75 inch rise, 5% running slope and 2% cross slope to avoid treating path of travel as a ramp that will require hand rails and edge protection.
