Site Accessibility Evaluation

Americans with Disabilities Act Title II (Public Services: State and Local Government)

Fair and Events Complex

**366 10th St
Calhan, CO 80808**

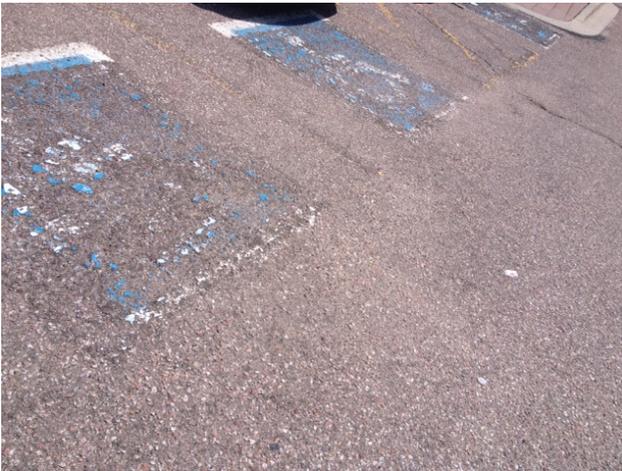
Finding 32569 Main Photo

The parking sign/s are missing.

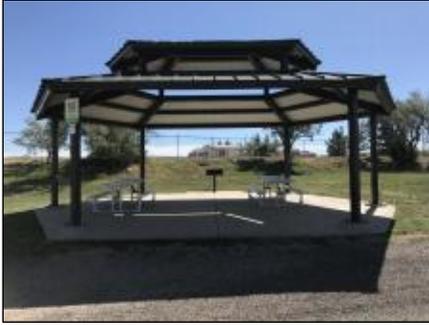
Finding 297967 Main Photo

CORRECTED

Entrance not accessible to mobility devices due to the obstruction at the entrance. Recommend backfilling dirt/gravel to ensure a change in level no more than 1/4 of an inch or install an ADA ramp as used in school playgrounds or construct concrete ramp.

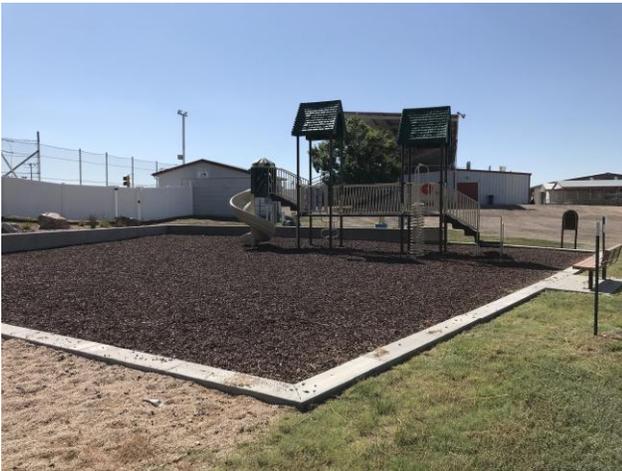
Finding 297911 Main Photo

CORRECTED

No accessible entrance to playground. Recommend installing an ADA ramp as used in school playgrounds or construct concrete ramp.

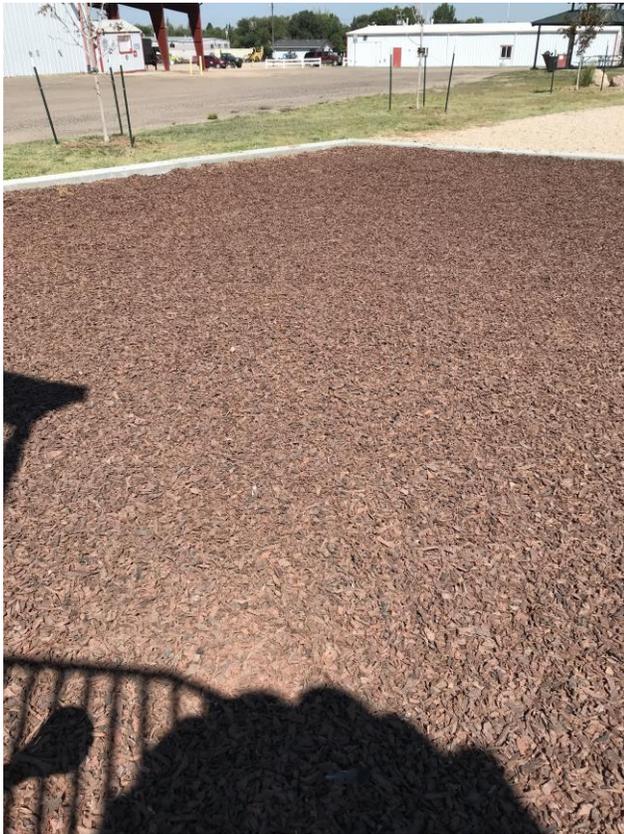
Finding 297914 Main Photo

The accessible route contains loose gravel and/or surfaces that do not provide for a stable, firm slip resistant surface.

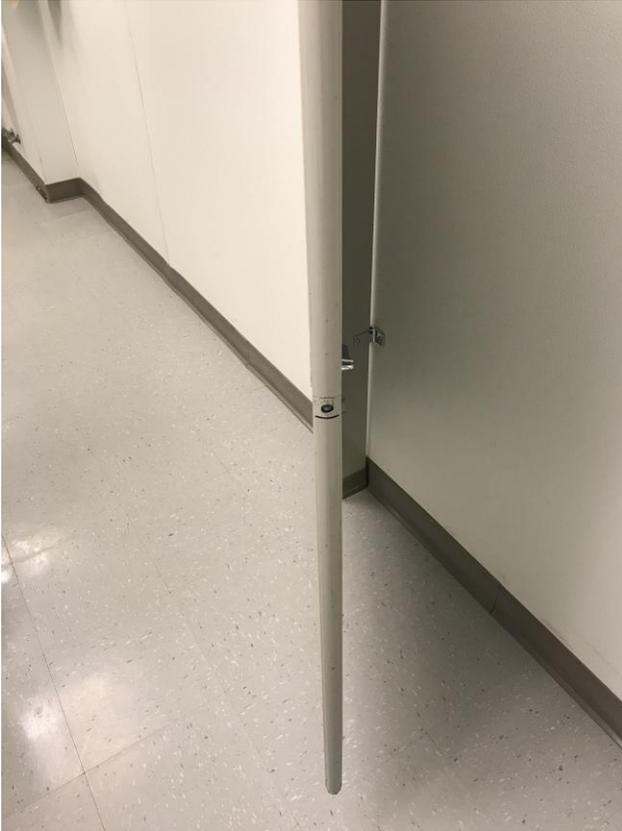
Finding 298005 Main Photo

Grand Stands Men's Restroom North

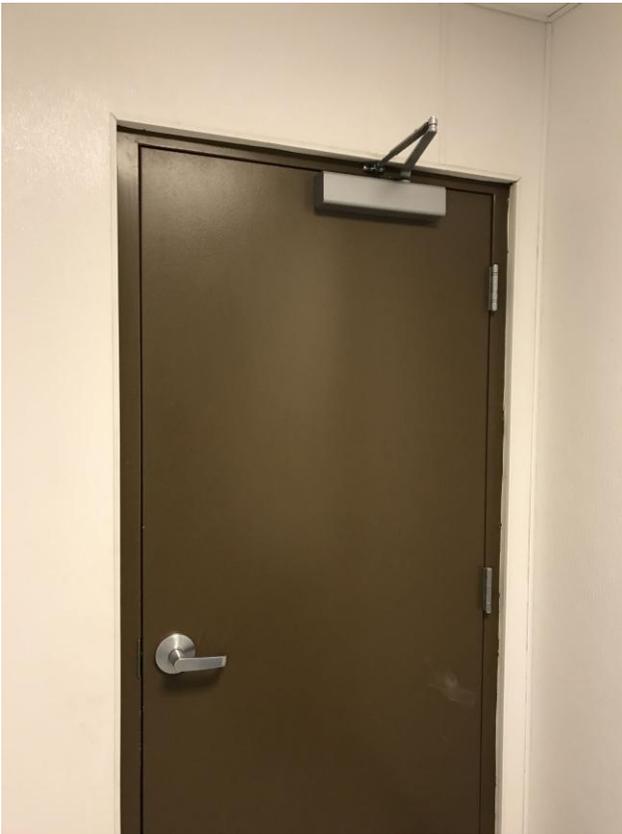
Finding 297923 Main Photo

Grand Stands Women's Restroom South

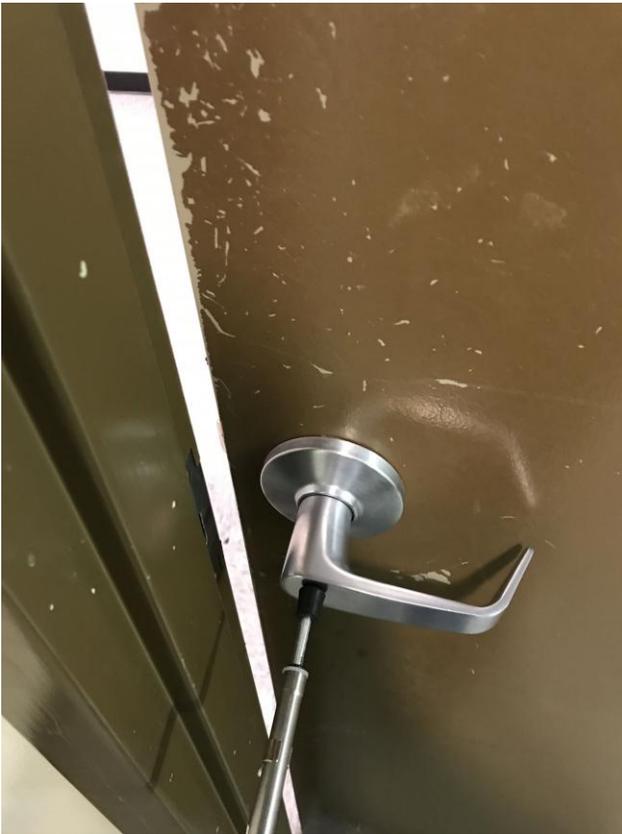
Finding 297927 Main Photo

Grand Stands Women's Restroom South

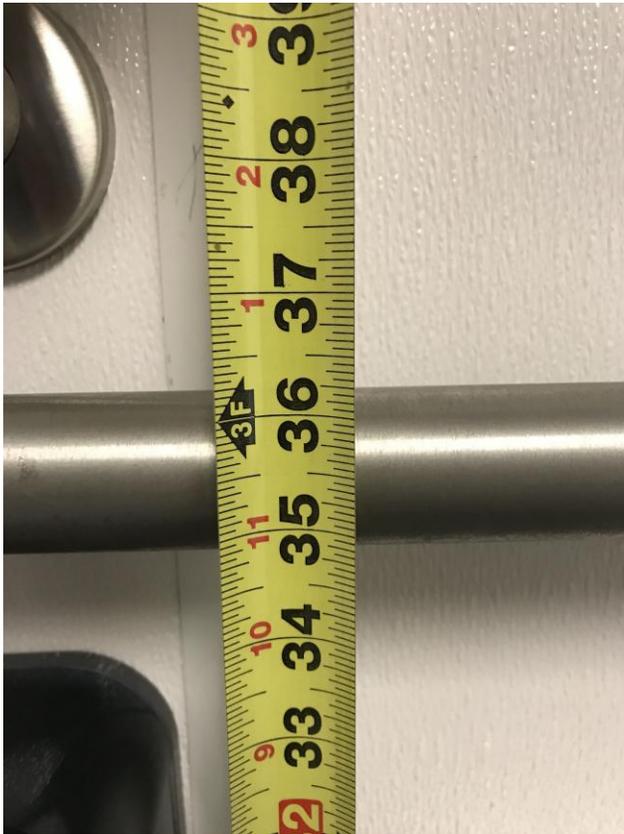
Finding 297928 Main Photo

Grand Stands Women's Restroom South

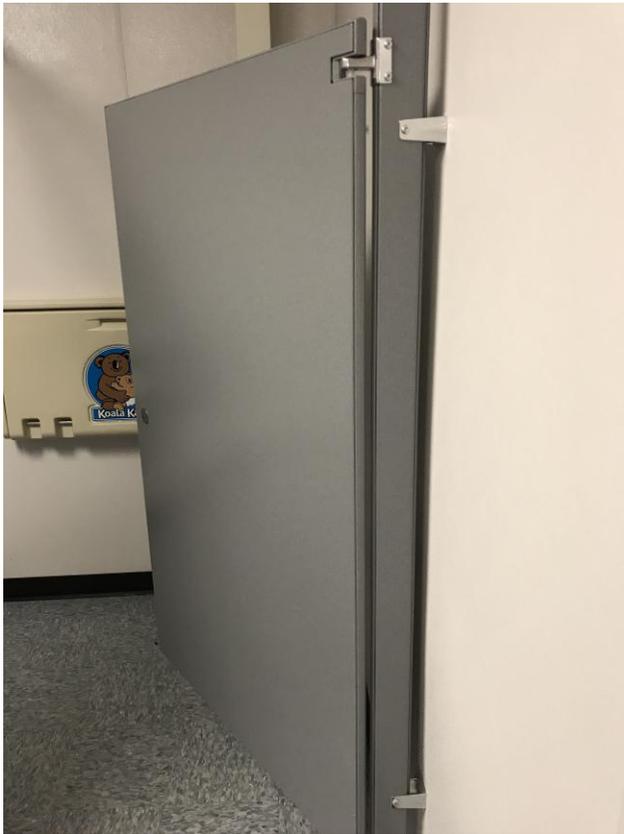
Finding 297924 Main Photo

Grand Stands Women's Restroom South

The water closet compartment door is missing a loop handle.

Missing loop handles
on compartment door

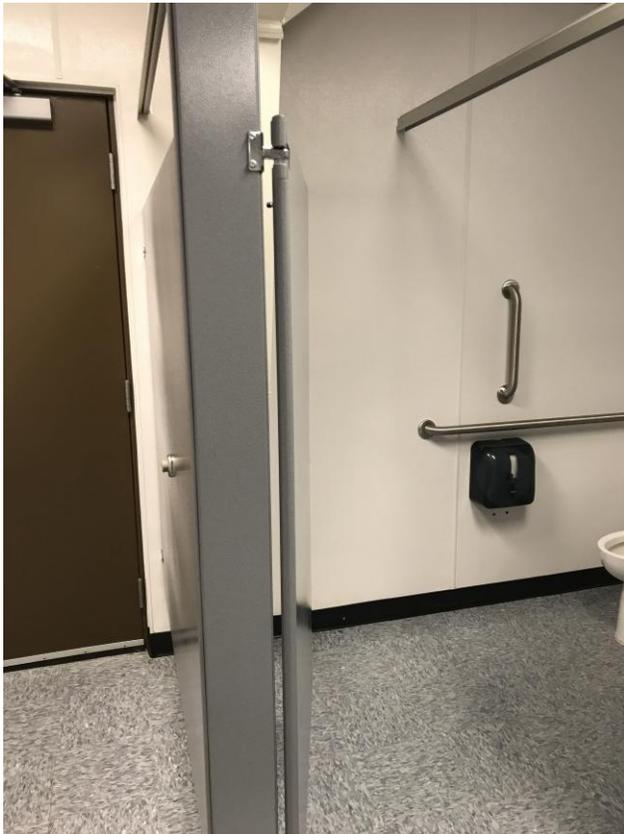
Finding 297917 Main Photo

Grand Stands Men's Restroom South

The water closet compartment door is missing a loop handle.

Missing loop handles
on compartment door

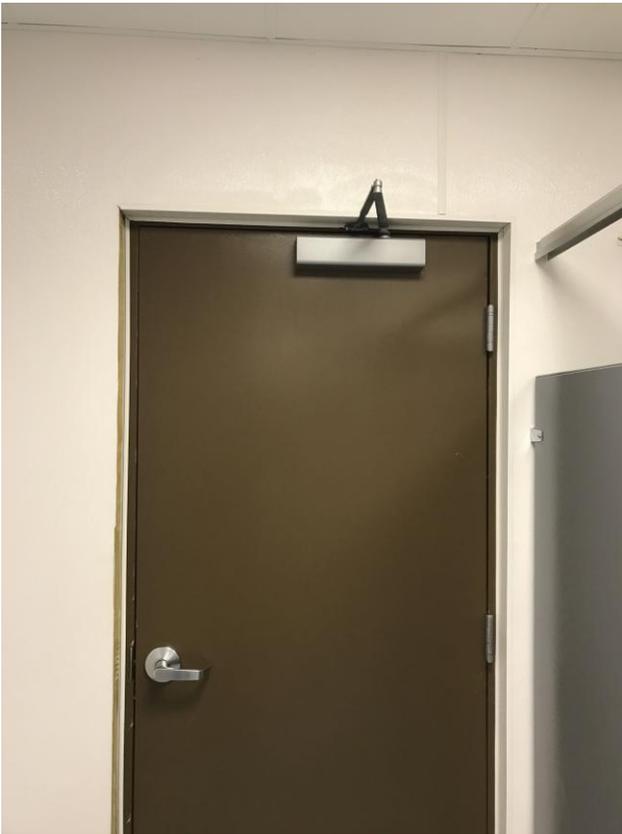
Finding 297920 Main Photo

Grand Stands Men's Restroom South

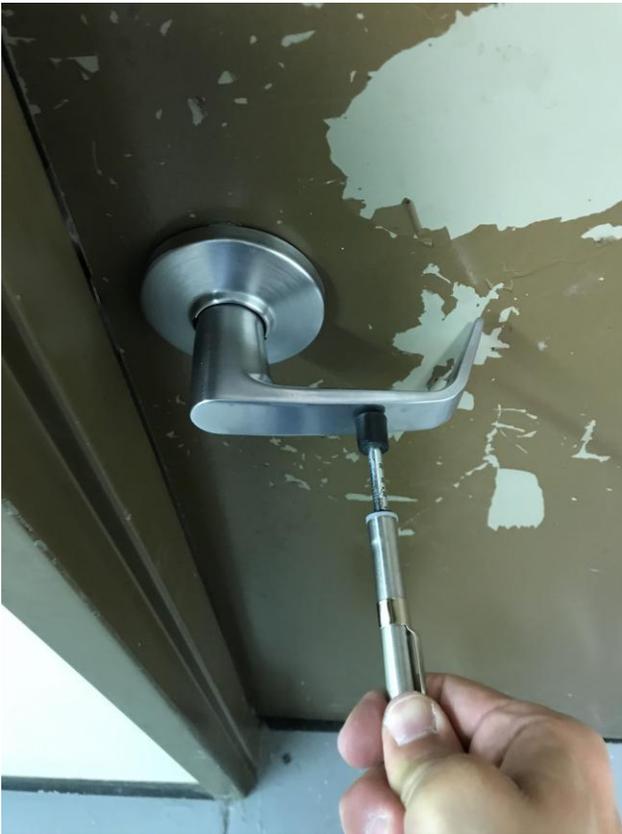
Finding 297921 Main Photo

Grand Stands Men's Restroom South

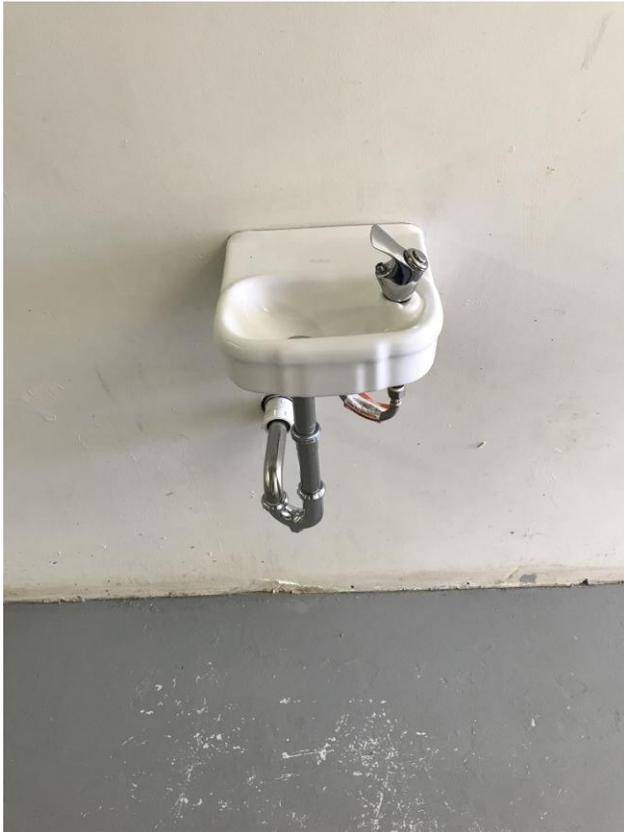
Finding 297981 Main Photo

Grand Stands North Food Counter

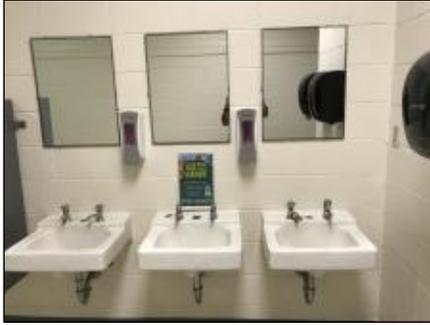
Finding 297952 Main Photo

Livestock Arena Men's Restroom

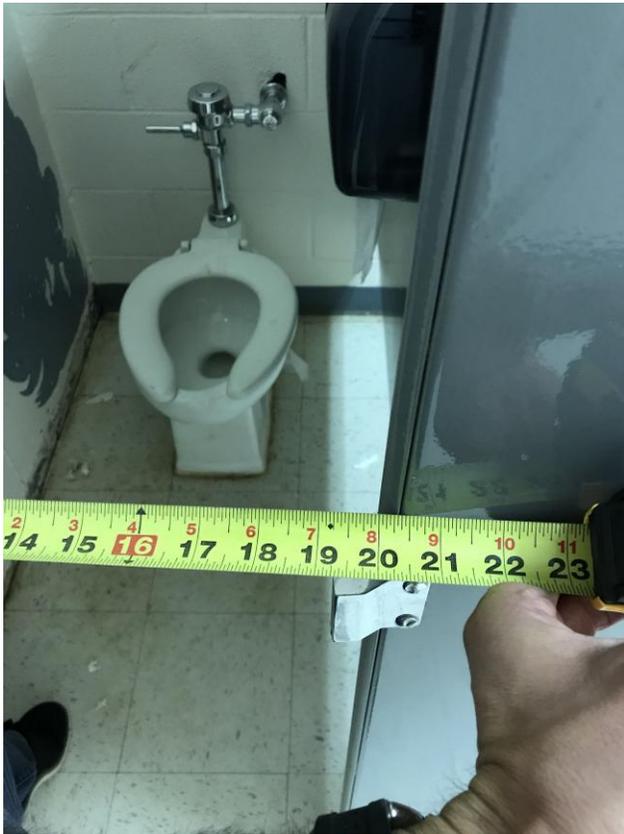
Finding 297957 Main Photo

Livestock Arena Men's Restroom

Rear and side grab bars missing

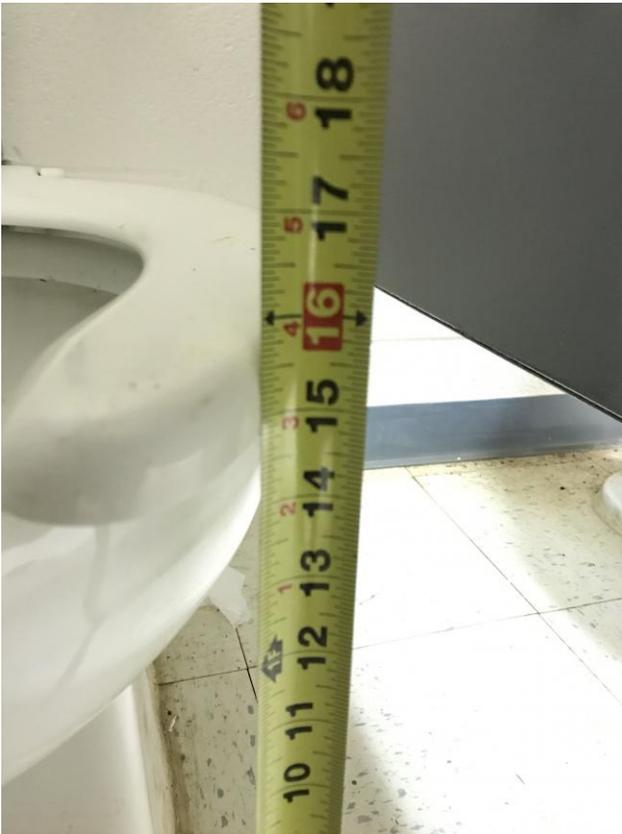
Finding 297959 Main Photo

Livestock Arena Men's Restroom

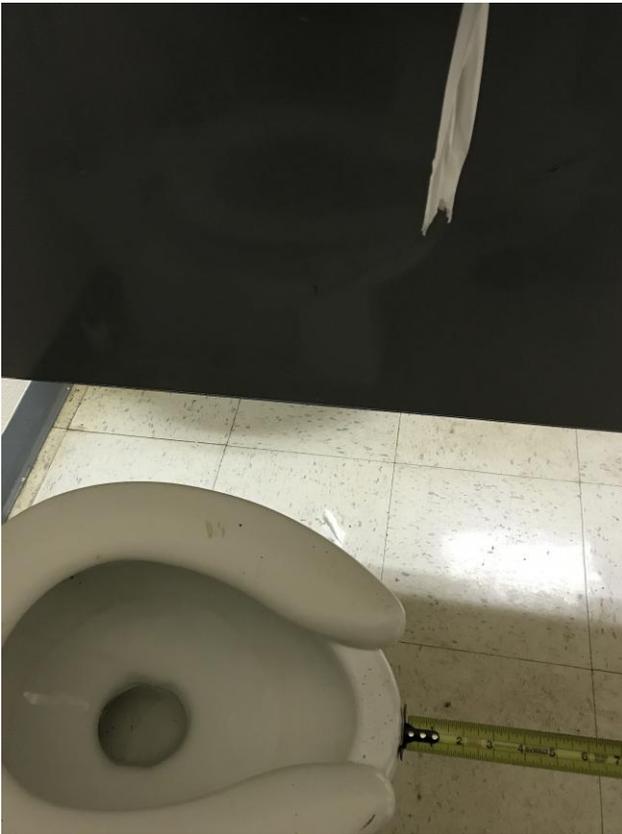
Finding 297960 Main Photo

Livestock Arena Men's Restroom

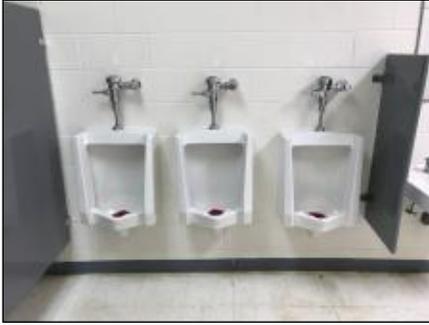
Finding 297965 Main Photo

Livestock Arena Men's Restroom

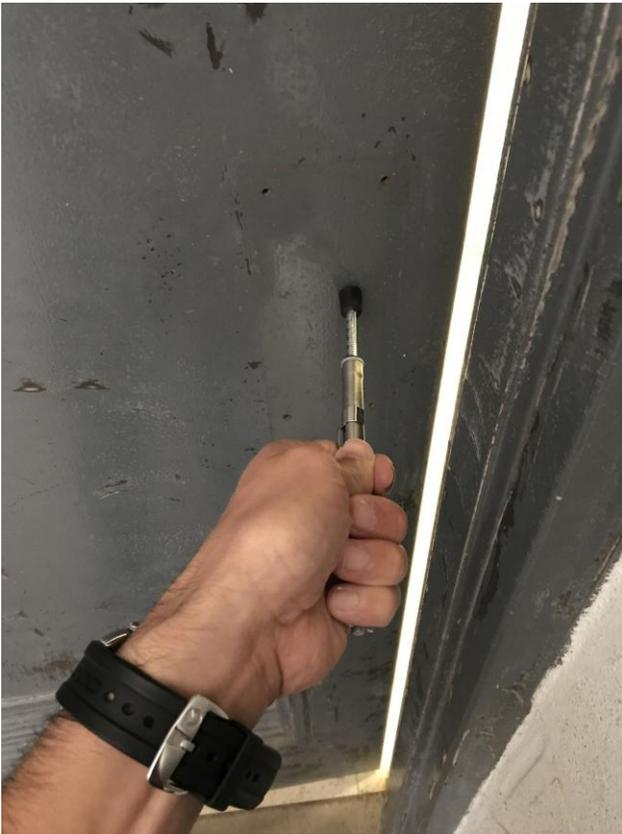
Finding 297949 Main Photo

Livestock Arena Men's Restroom

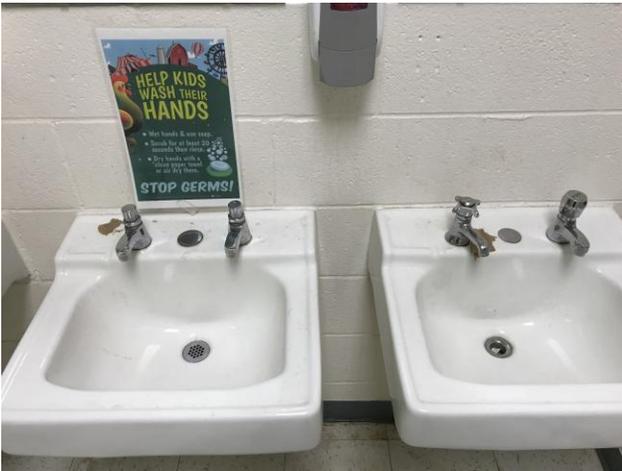
Finding 297951 Main Photo

Livestock Arena Men's Restroom

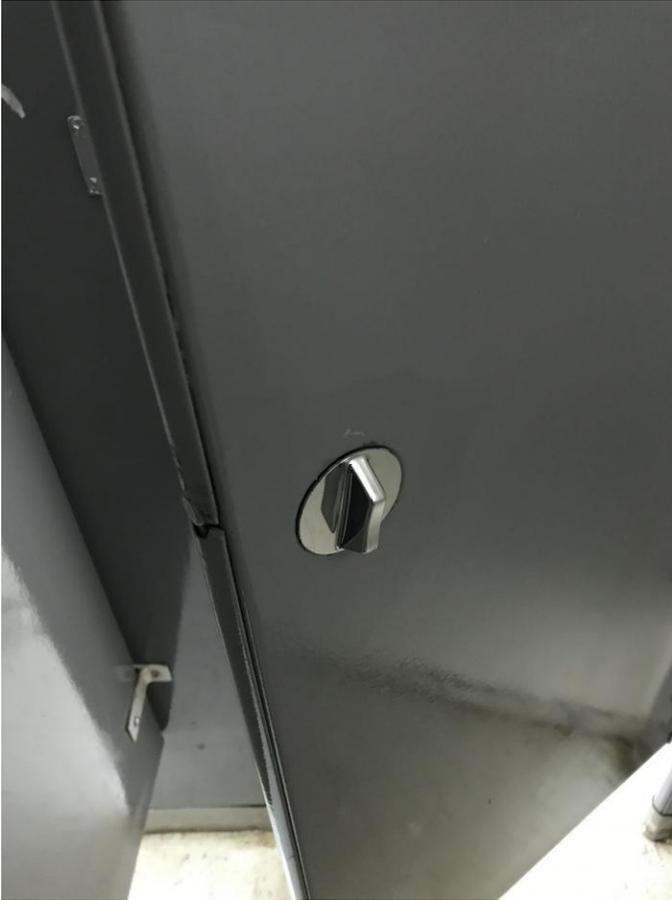
Finding 297963 Main Photo

Livestock Arena Men's Restroom

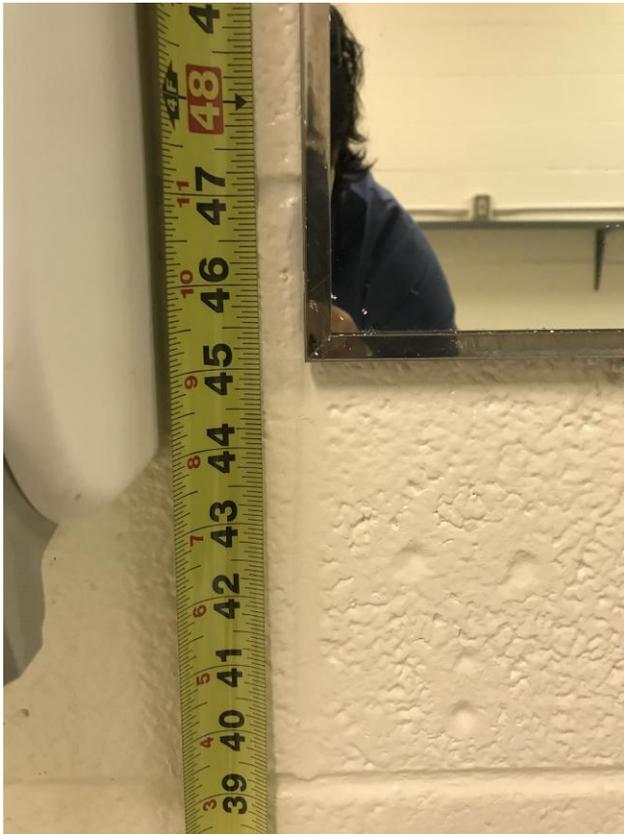
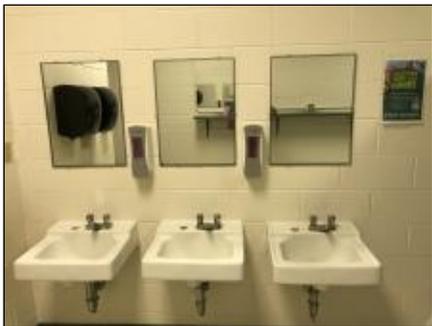
Finding 297935 Main Photo

Livestock Arena Women's Restroom

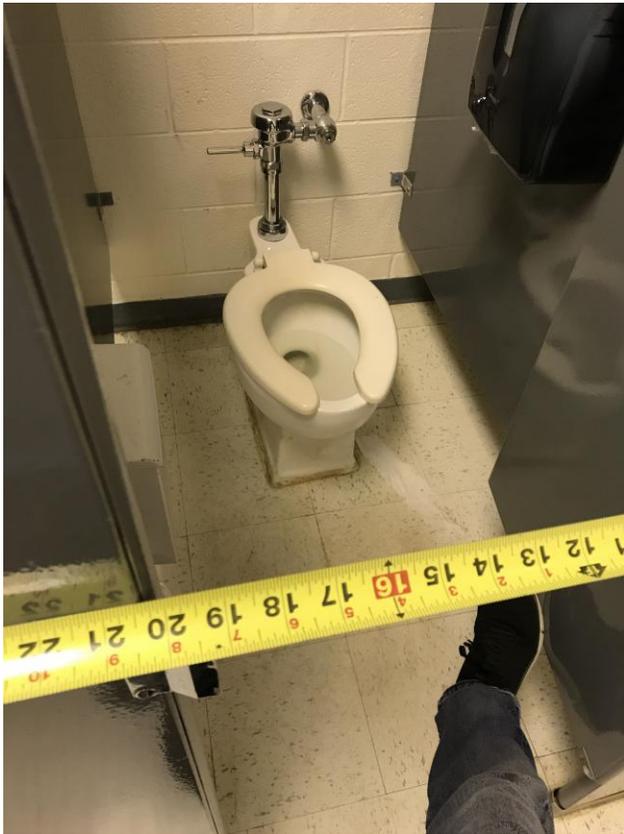
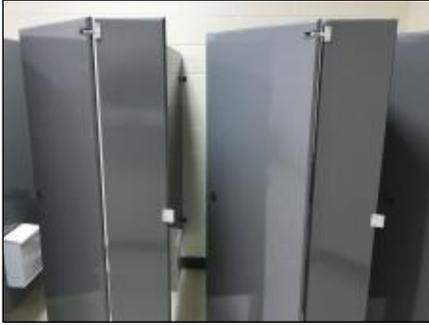
Finding 297940 Main Photo

Livestock Arena Women's Restroom

Adjust toilet height, replace toilet or replace toilet seat with one that will meet the minimum height requirement of 17 inches.

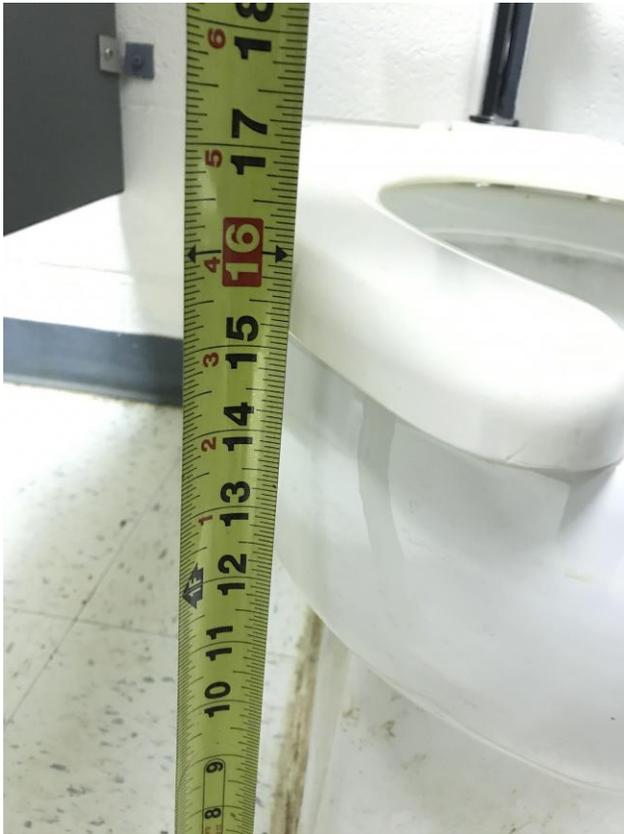
Finding 297942 Main Photo

Livestock Arena Women's Restroom

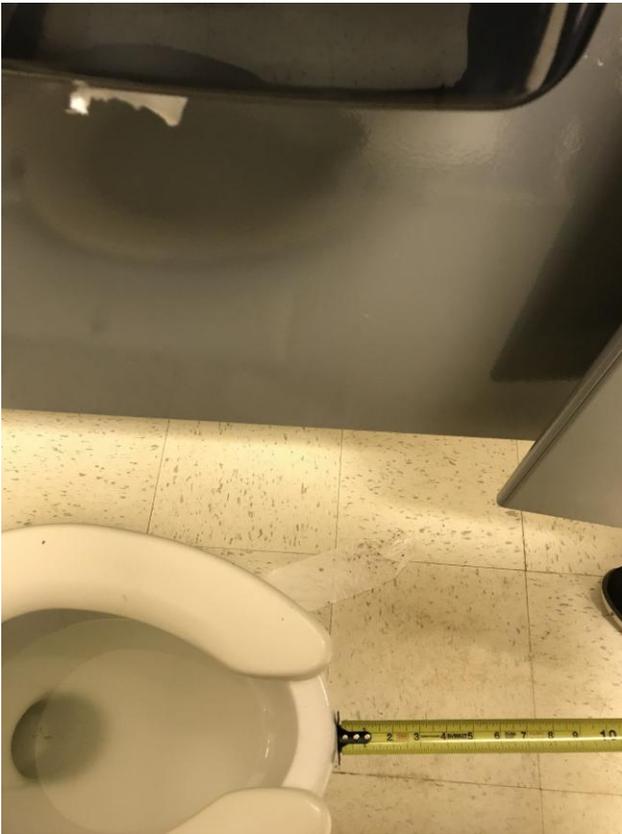
Finding 297943 Main Photo

Livestock Arena Women's Restroom

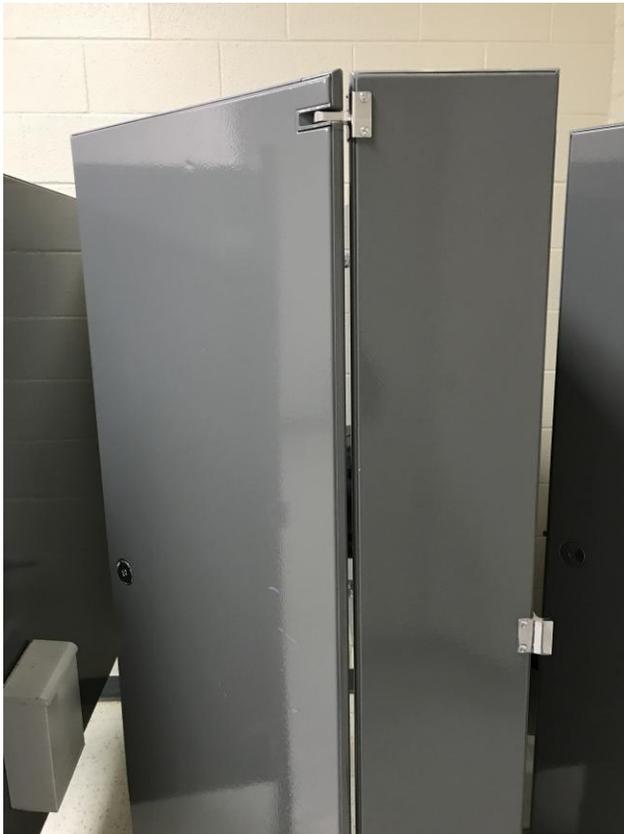
Finding 297944 Main Photo

Livestock Arena Women's Restroom

The water closet compartment door is missing a loop handle.

Missing loop handles
on both sides of
compartment door

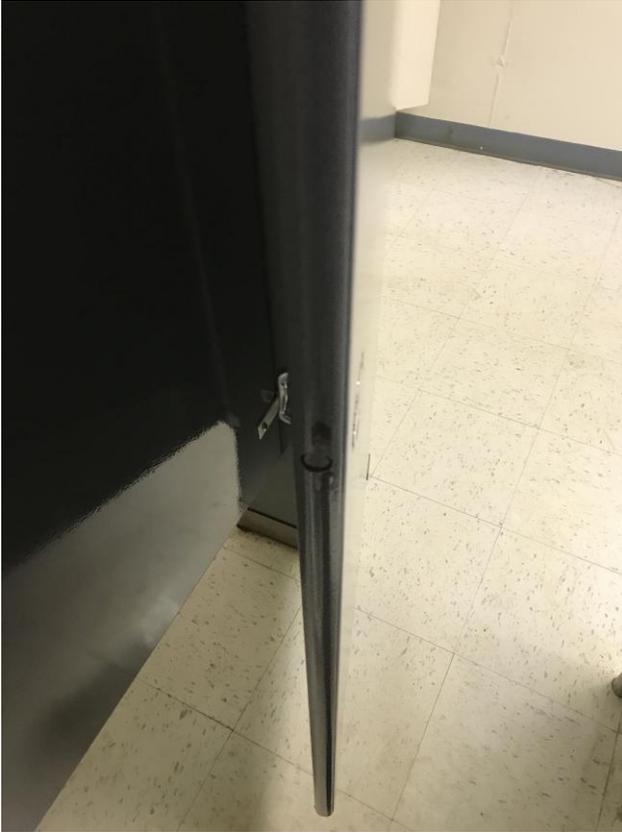
Finding 297945 Main Photo

Livestock Arena Women's Restroom

Replace locking hardware with locking lever that does not require tight grasping, tight pinching or twisting of the wrist to operate.

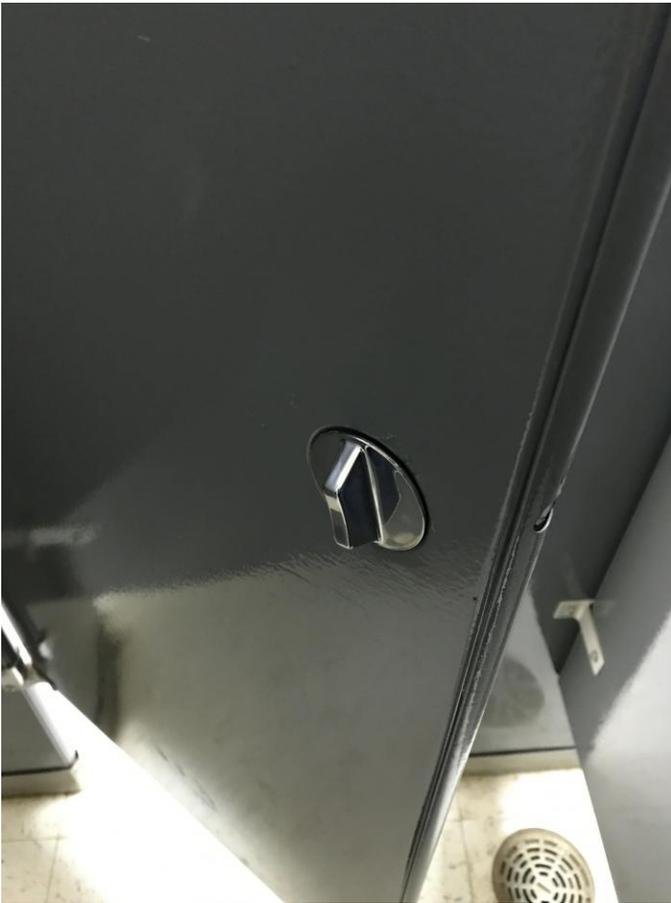
Finding 297946 Main Photo

Livestock Arena Women's Restroom

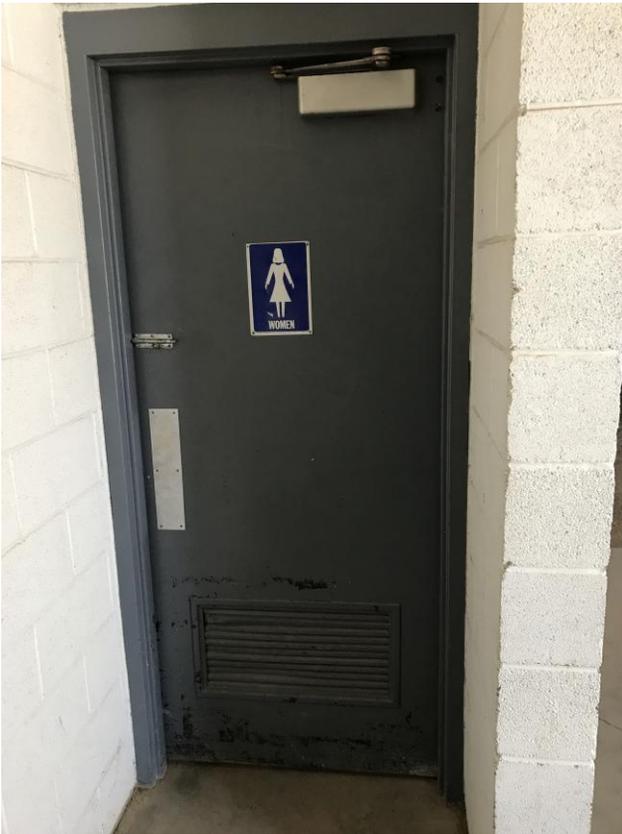
Finding 297948 Main Photo

Livestock Arena Women's Restroom

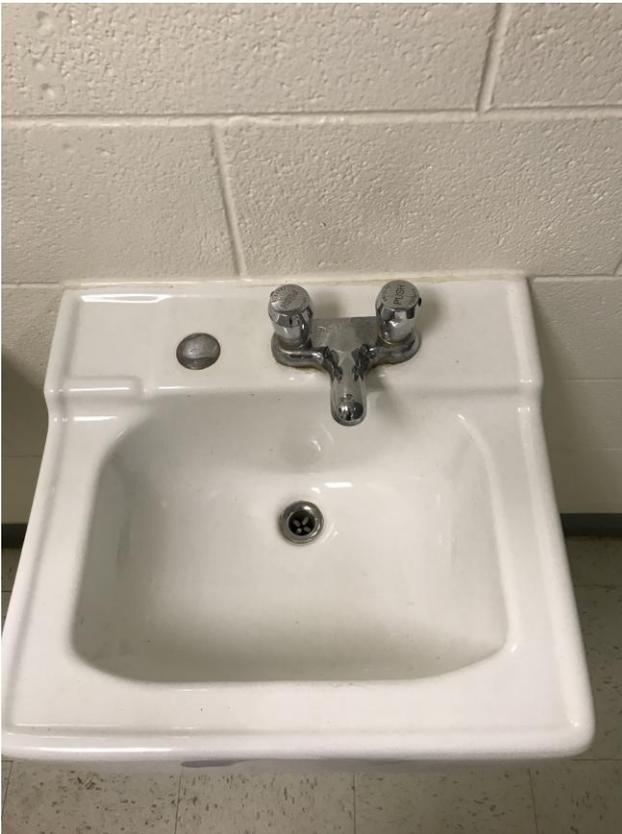
Finding 297934 Main Photo

Livestock Arena Women's Restroom

Replace lavatory with one that provides a minimum height from the bottom edge of no less than 27 inches above finished floor and 8 inches minimum in depth for knee clearance.

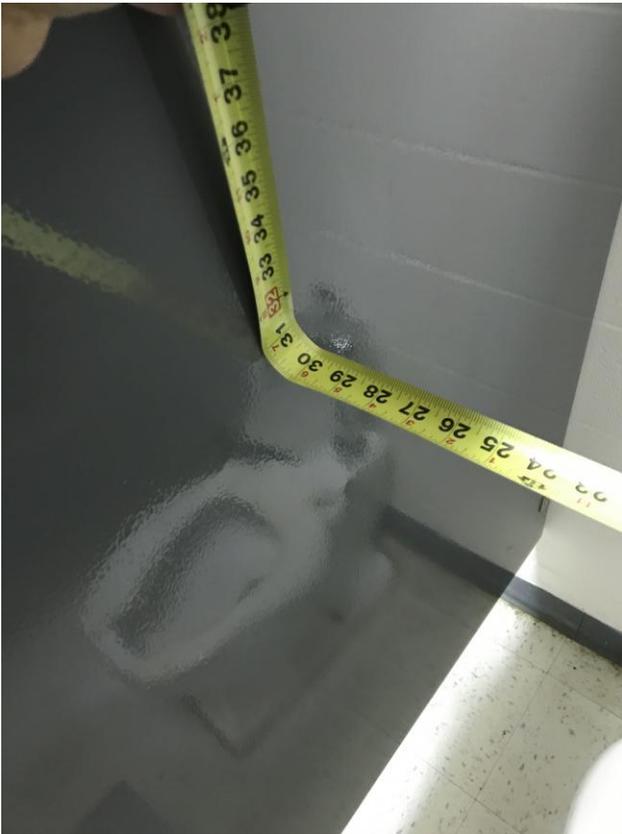
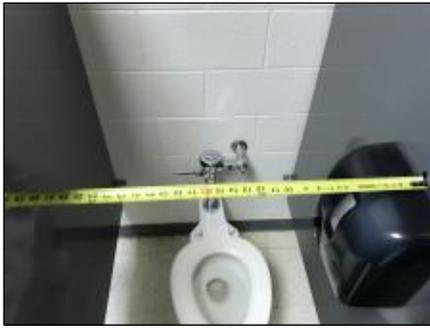
Finding 297938 Main Photo

Livestock Arena Women's Restroom

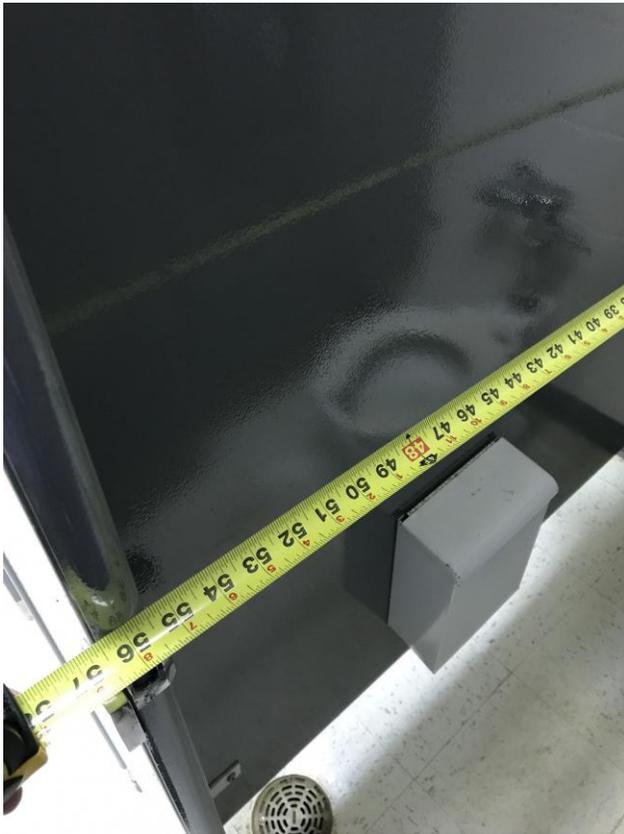
Finding 297939 Main Photo

Rear and side grab bars missing

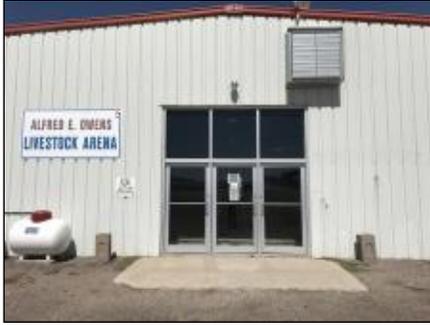
Finding 297930 Additional Photo

CORRECTED

South entrance to the livestock arena not accessible to mobility devices due to the obstruction at the entrance. Recommend backfilling dirt/gravel to ensure a change in level no more than 1/4 of an inch or install an ADA ramp as used in school playgrounds or construct permanent concrete ADA compliant ramp.

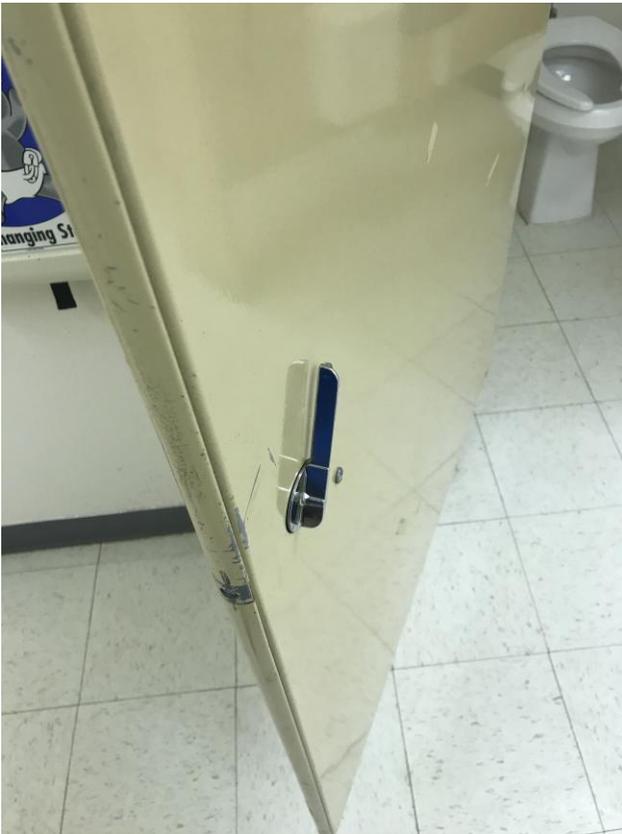
Finding 298070 Main Photo

The water closet compartment door is missing a loop handle on the inside.

Missing loop handle
on compartment door

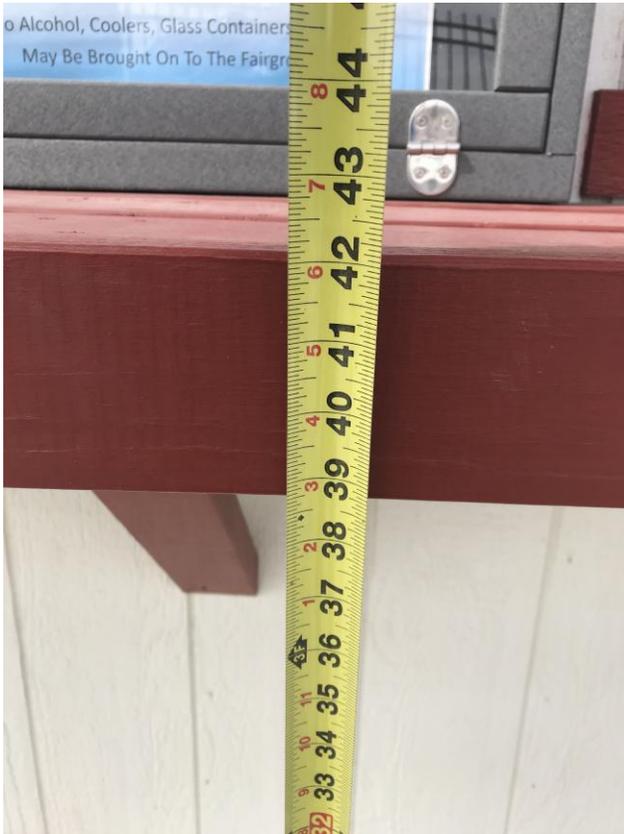
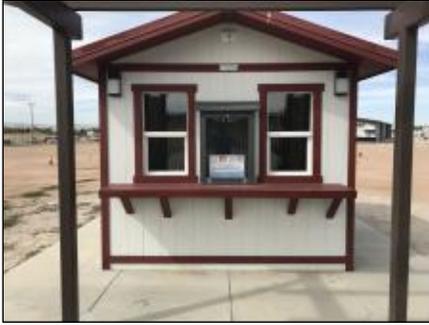
Finding 298296 Main Photo

Non-accessible entrance/s signage missing.

An identification sign identifying that this entrance is not accessible and directional signage pointing in the direction to the accessible entrance is needed. If an accessible entrance is not available and is not "readily achievable" to provide, we suggest signage indicating that curb side service is available upon request or that services may be provided at a different accessible location. We recommend that this sign have a working phone number that is always answered during regular business hours. Another option for consideration would be the installation of a door bell located at an accessible location on the exterior of the business that will alert an attendant.
