Site Accessibility Evaluation

Americans with Disabilities Act Title II (Public Services: State and Local Government)

Pikes Peak Center

***Inspection Date: 04/10/2018
Inspector: David Mejia***

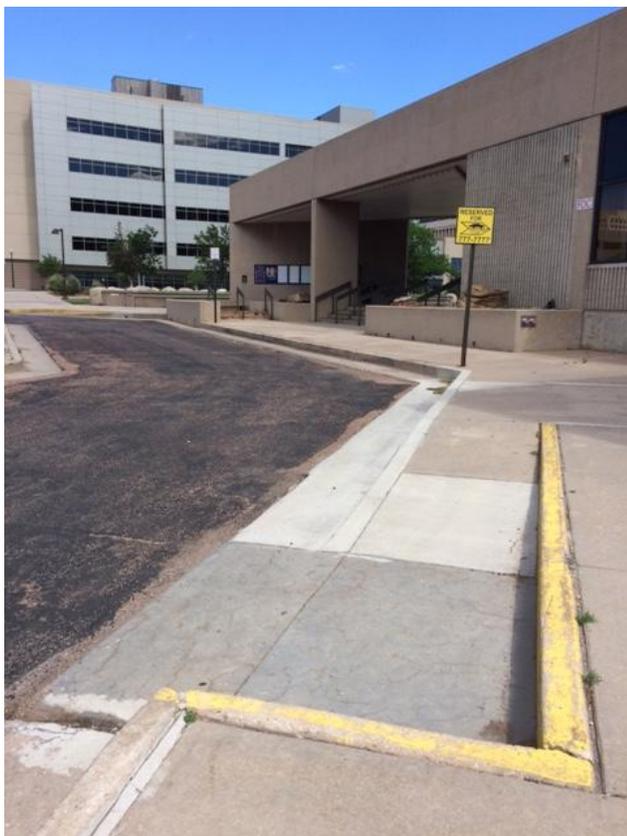
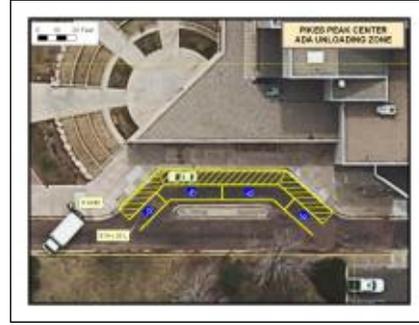
Finding 31107 Main Photo

The passenger drop-off and loading area is not accessible.

Area was wide enough, but not marked.

1. Stripe area to designate accessible drop-off and loading zone and two permanent Van Accessible stalls as depicted on attached map. 2. Add ISA signage as depicted on attached map. 3. Add directional signs to Box Office and Studio Bee as depicted on attached map.

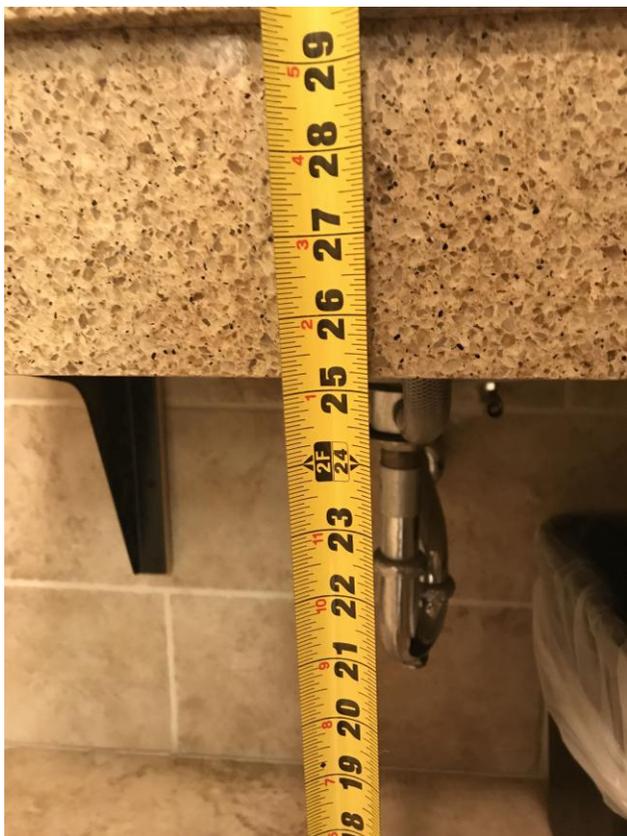
Finding 299078 Main Photo

Missing pipe
insulation

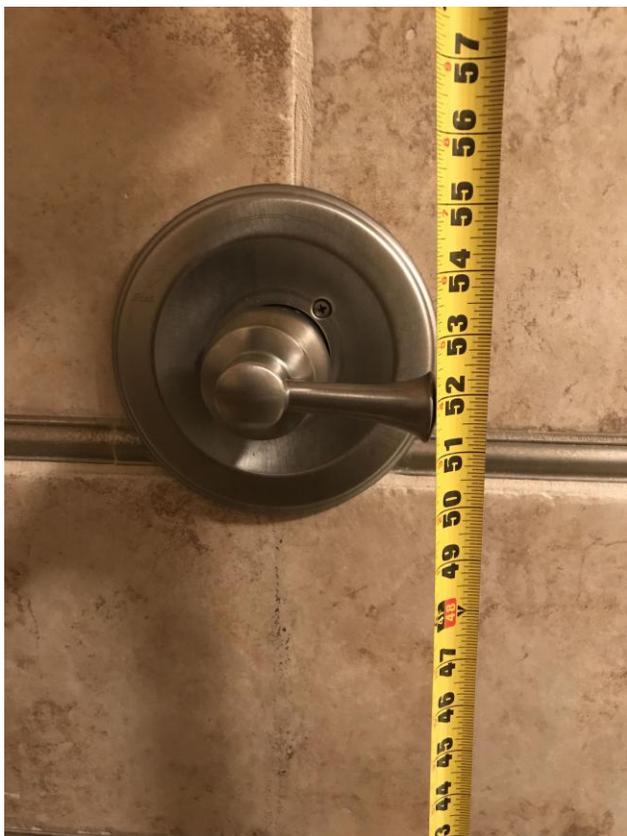
Finding 299083 Main Photo

The grab bars for the shower are missing.

Missing grab bars

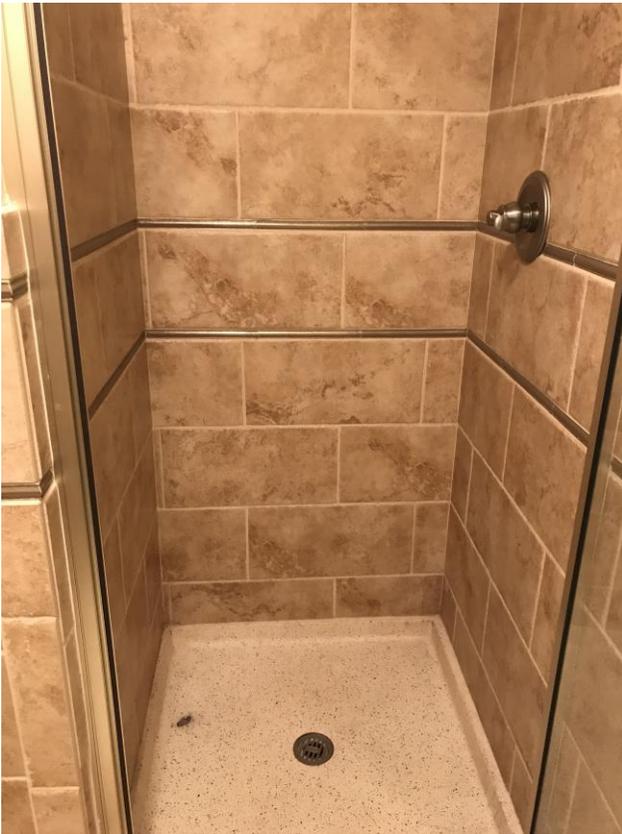
Finding 299084 Main Photo

The shower compartment is missing a seat.

Missing folding or non-folding shower seat

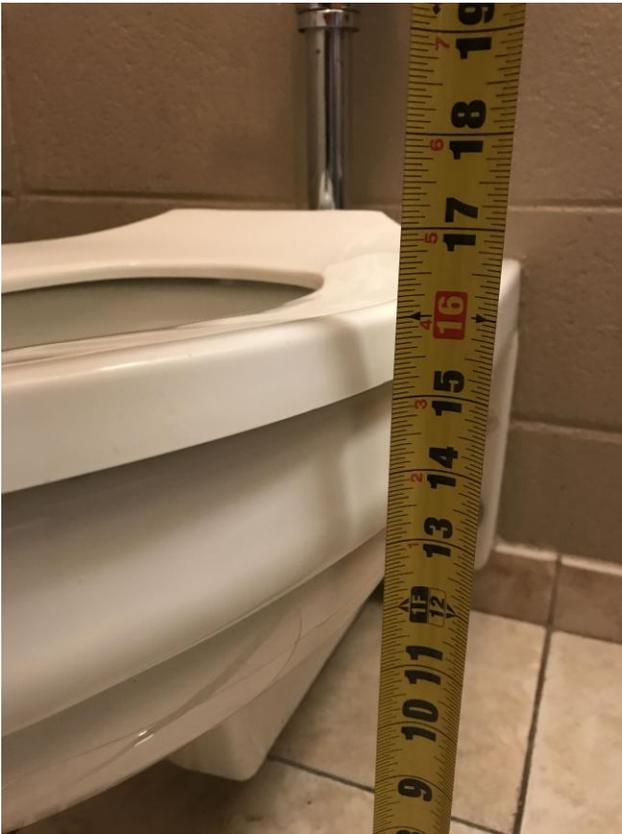
Finding 298995 Main Photo

Missing side and rear grab bars

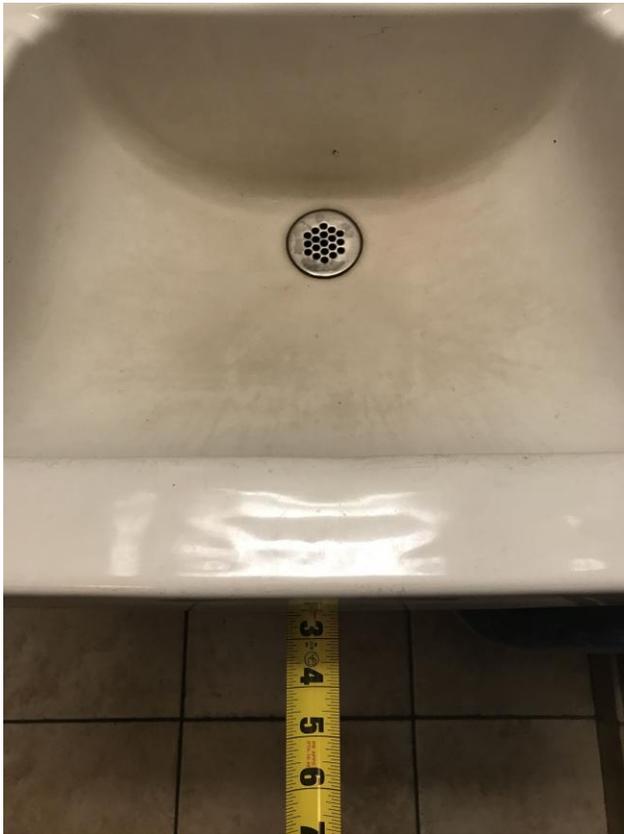
Finding 298998 Main Photo

1st Floor, N. side, Performers Mens ADA Restrooms (Orchestra Level)

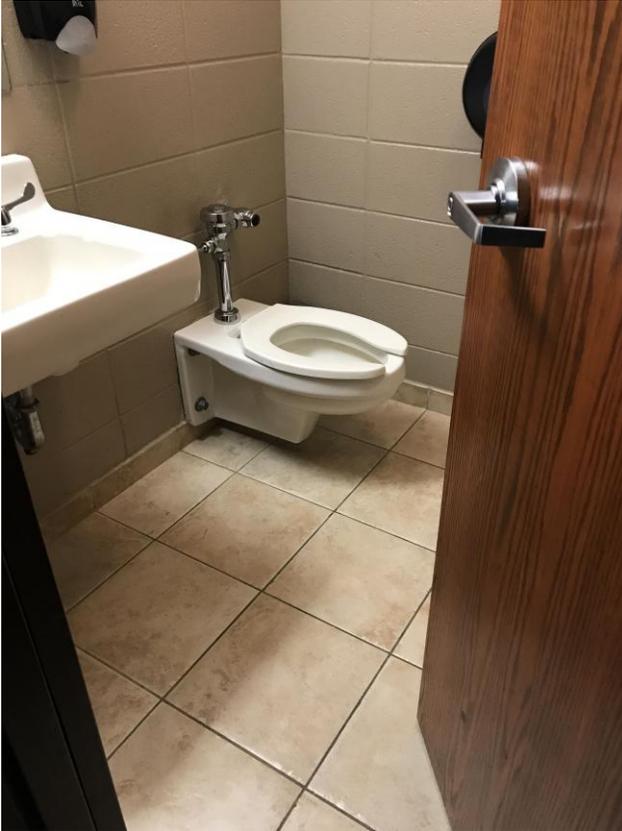
Finding 299015 Main Photo

1st Floor, N. side, Performers Womens ADA Restrooms (Orchestra Level)

Adjust toilet height, replace toilet or replace toilet seat with one that will meet the minimum height of 17 inches but no more than maximum height of 19 inches.

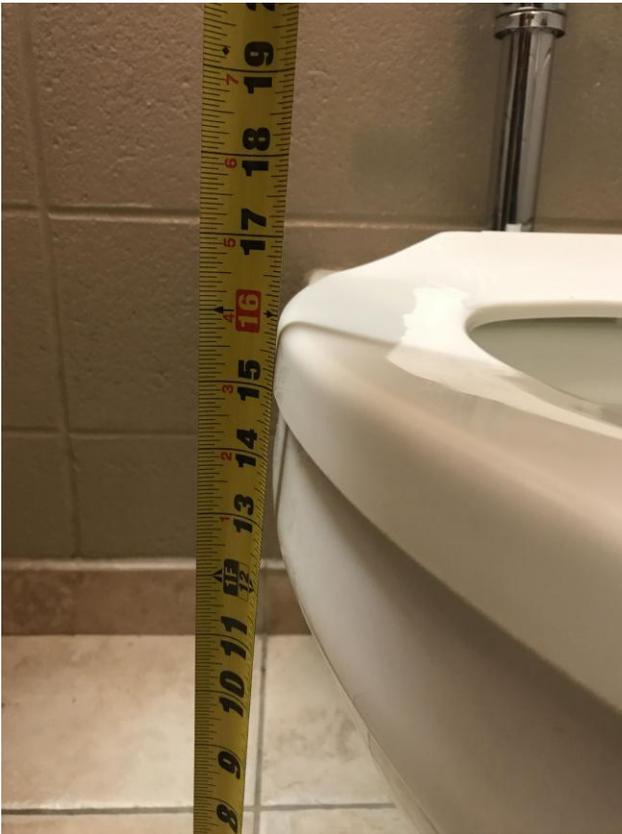
Finding 299017 Main Photo

1st Floor, N. side, Performers Womens ADA Restrooms (Orchestra Level)

Missing side and rear grab bars

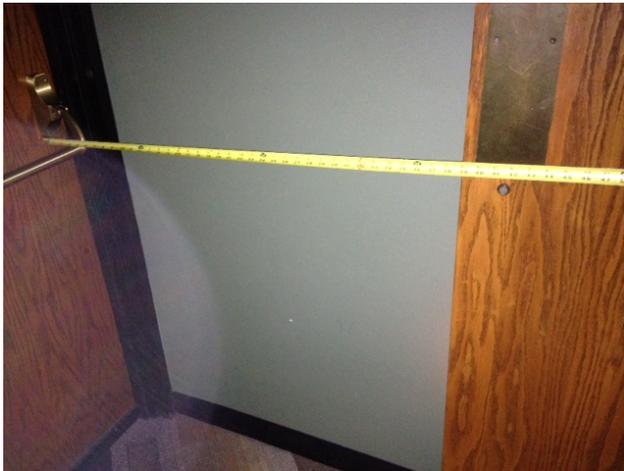
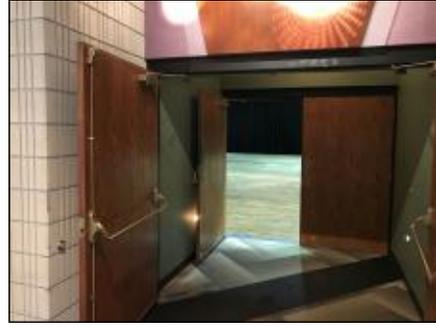
Finding 17116 Main Photo

1st Floor, N. side, Studio Bee (Orchestra Level)

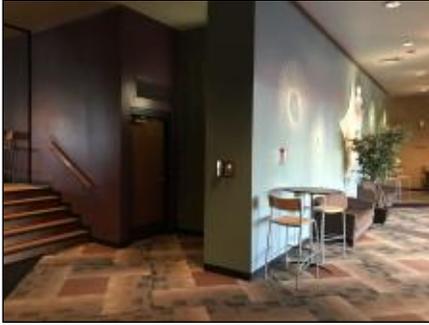
Finding 299022 Additional Photo

CORRECTED

Providing the minimum required maneuvering space on the pull side of the door is technically infeasible at this time because existing structural conditions would require removing or altering a load-bearing member that is an essential part of the structural frame; or because other existing physical or site constraints prohibit modification or addition of elements, spaces, or features that are in full and strict compliance with the minimum requirements. Best practice measures are recommended to ensure restroom is accessible to the maximum extent feasible.

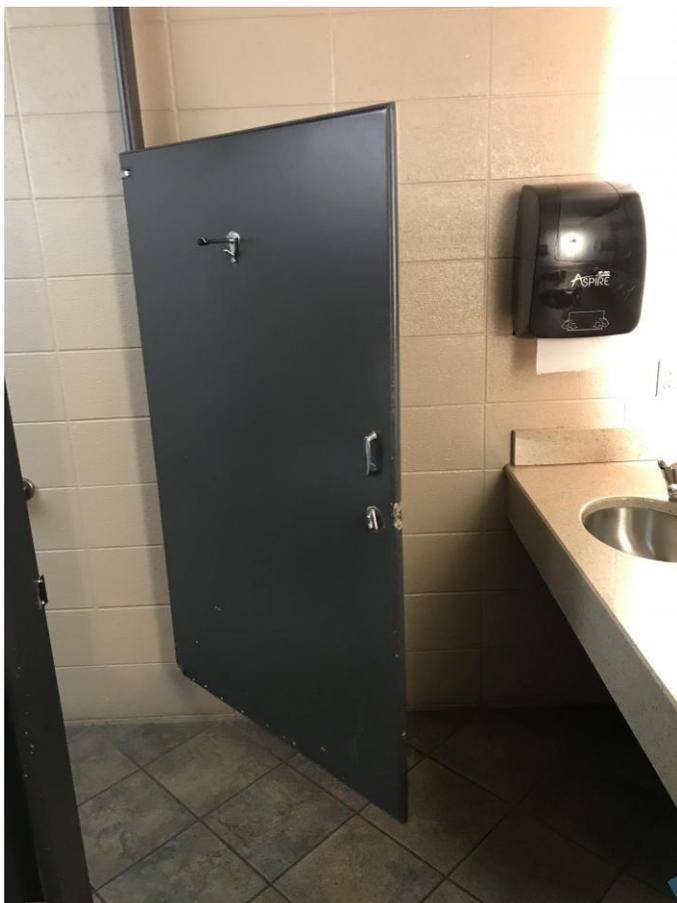
Finding 298938 Main Photo

CORRECTED

Replace locking hardware with locking lever that does not require tight grasping, tight pinching or twisting of the wrist to operate.

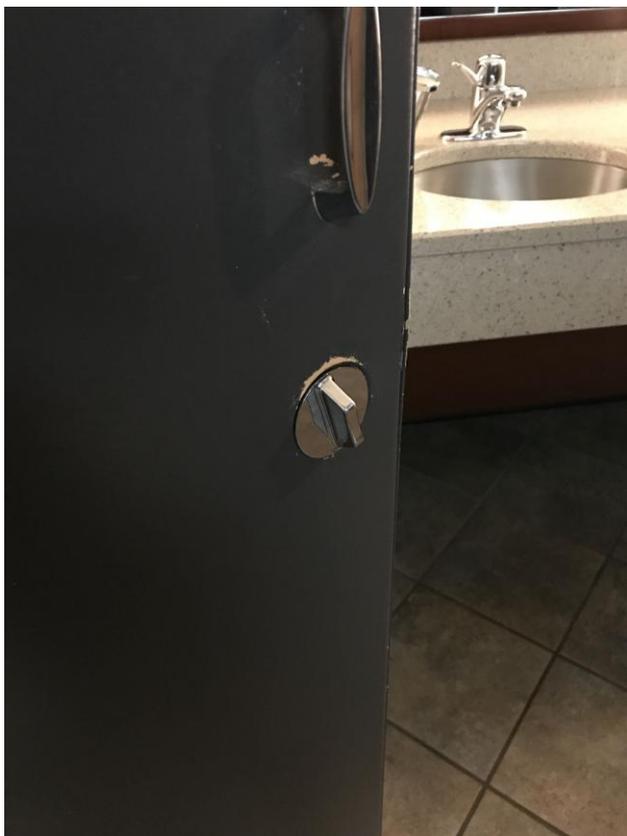
Finding 298949 Main Photo

CORRECTED

1st Floor, N. side, Studio Bee, Womens Restrooms (Orchestra Level)

The water closet compartment door is missing a loop handle on the outside.

Missing loop handle on outside of compartment door

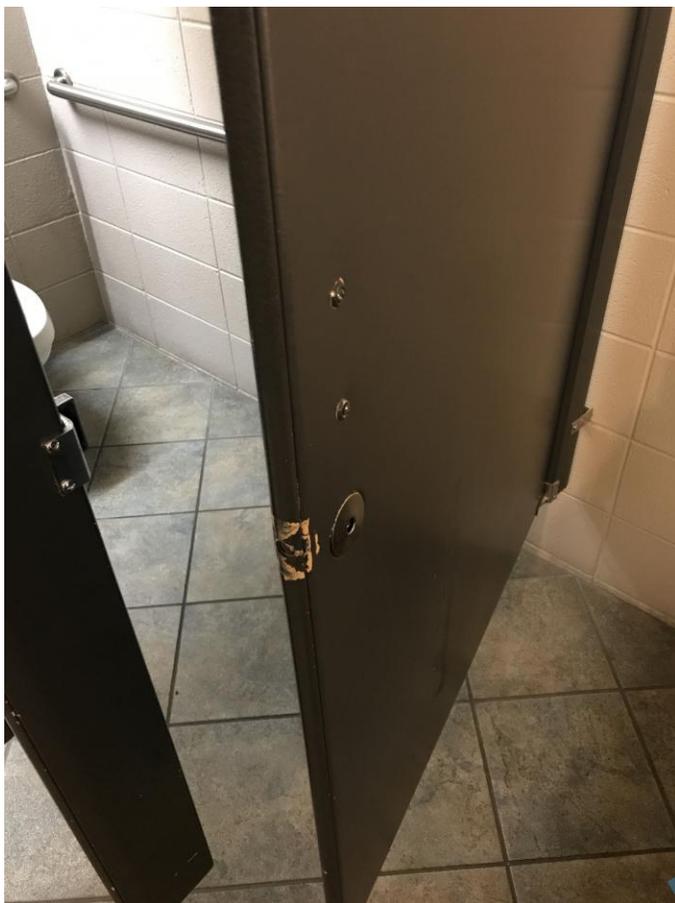
Finding 298939 Main Photo

CORRECTED

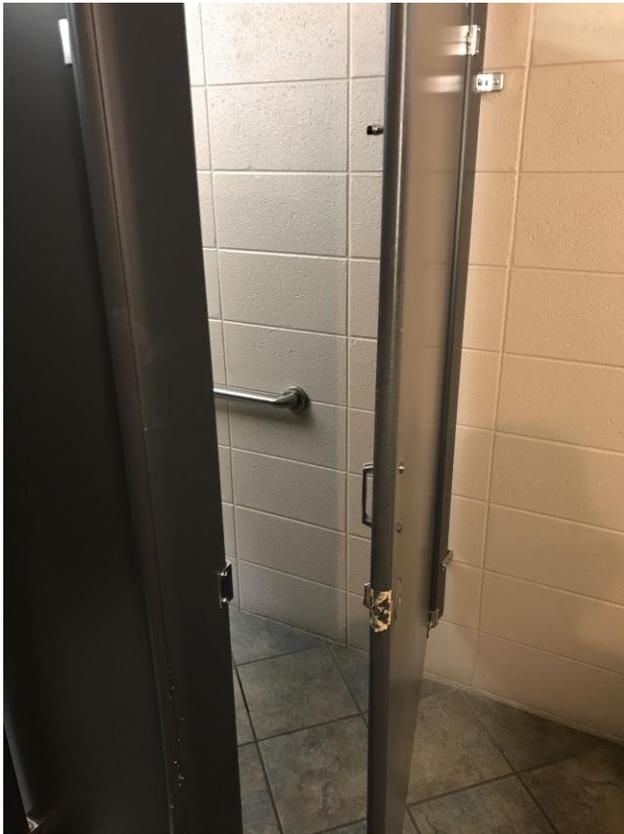
Finding 298940 Main Photo

CORRECTED

1st Floor, N. side, Studio Bee, Womens Restrooms (Orchestra Level)

Providing the minimum required width clearance to the restroom is technically infeasible at this time because existing structural conditions would require removing or altering a load-bearing member that is an essential part of the structural frame; or because other existing physical or site constraints prohibit modification or addition of elements, spaces, or features that are in full and strict compliance with the minimum requirements. Best practice measures are recommended to ensure restroom is accessible to the maximum extent feasible. Signage will be displayed at restroom door entrance directing customers to wheelchair accessible restrooms located on the south side of the orchestra level.

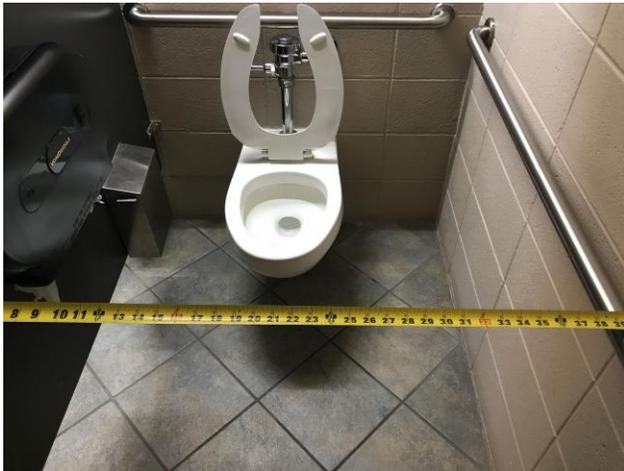
Finding 298941 Main Photo

CORRECTED

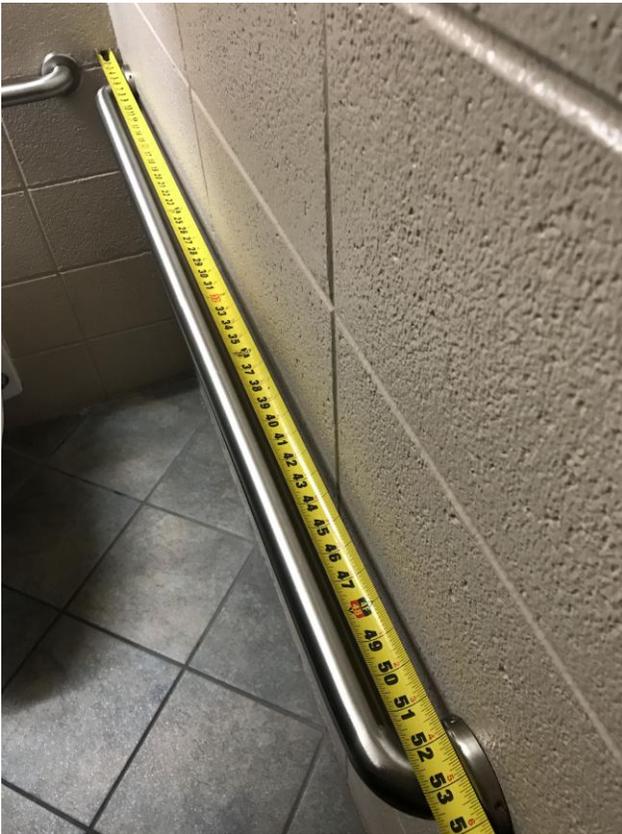
Finding 298942 Main Photo

CORRECTED

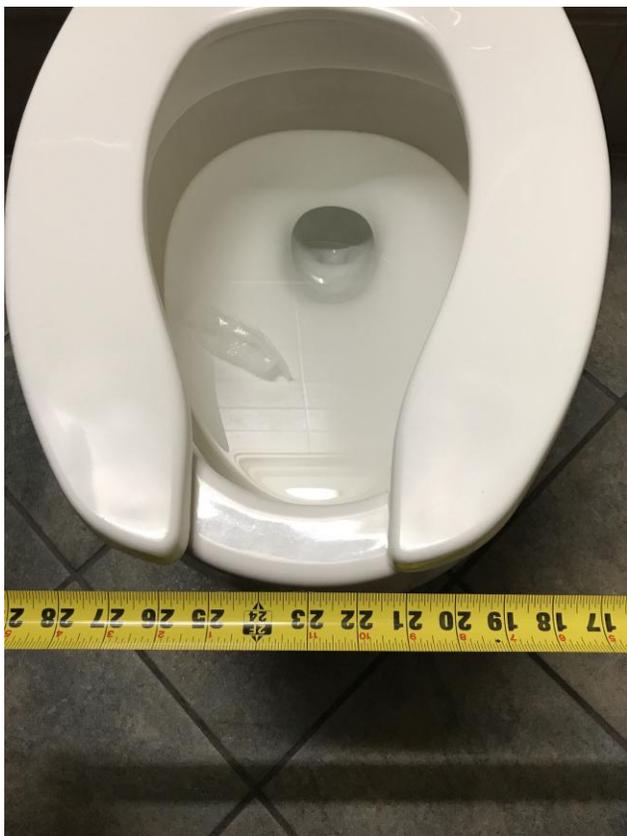
Finding 298943 Main Photo

CORRECTED

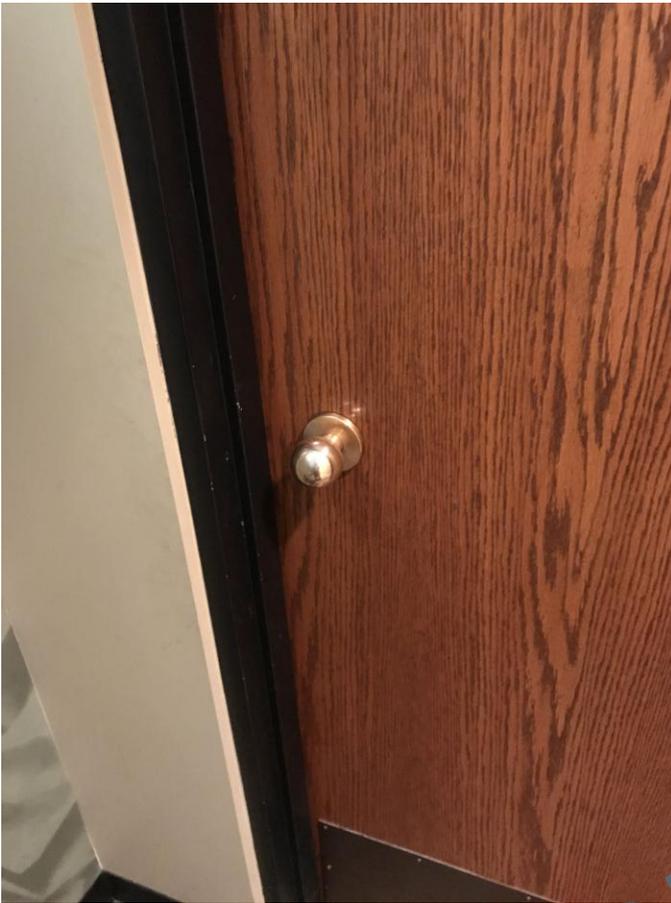
Finding 298946 Main Photo

Automatic door openers are not required under ADA standards but highly recommended due to building structural barriers/constraints that predate 1991 ADA Standards.

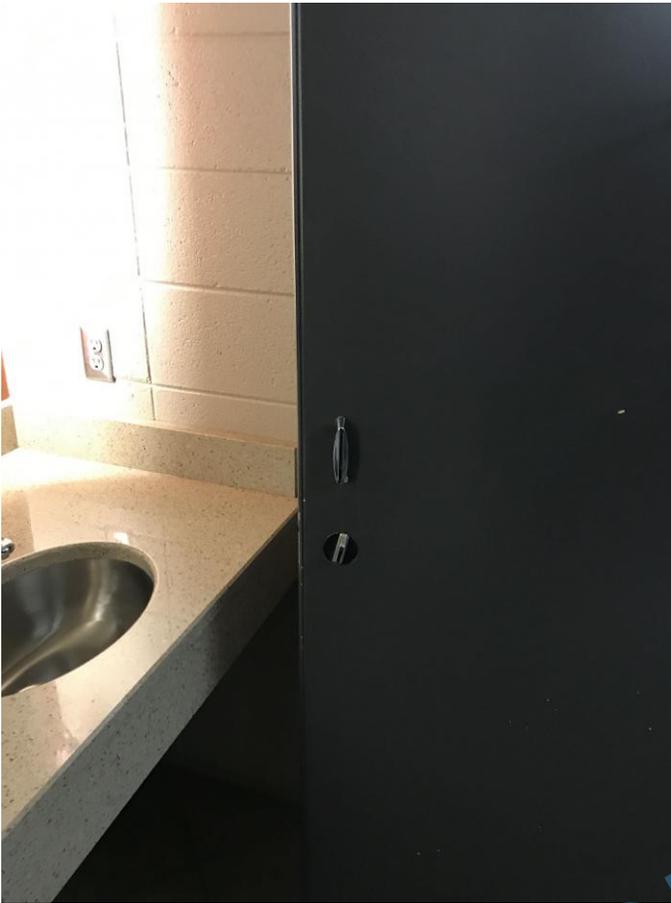
Finding 298954 Main Photo

The water closet compartment door is missing a loop handle on the outside.

Missing loop handle on outside of compartment door

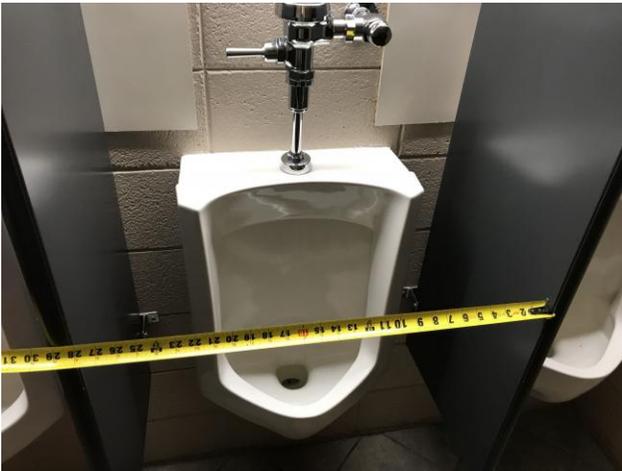
Finding 298965 Main Photo

URINAL CLEAR SPACE
PARTITION 24" OR LESS

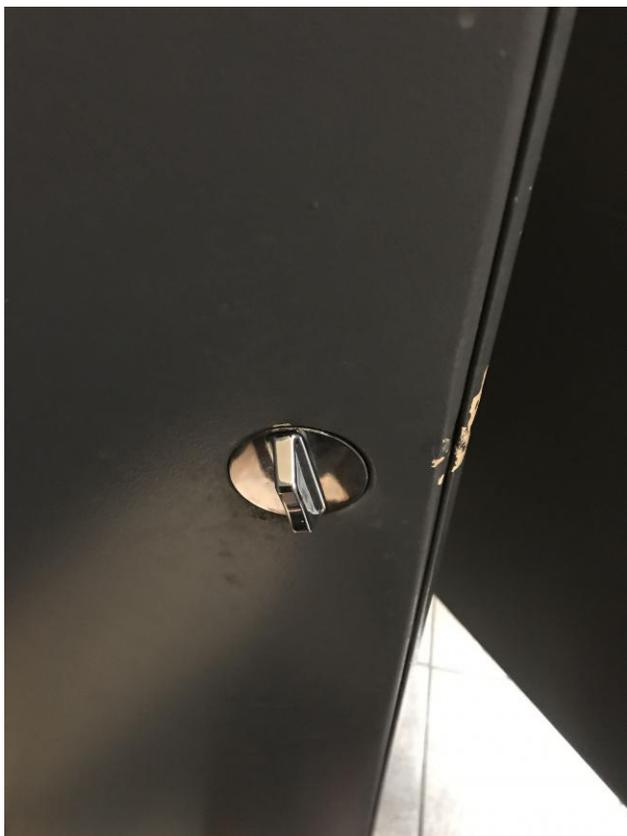
Finding 299426 Main Photo

The water closet compartment door is missing a loop handle on the outside.

Missing loop handle
on outside of
compartment door

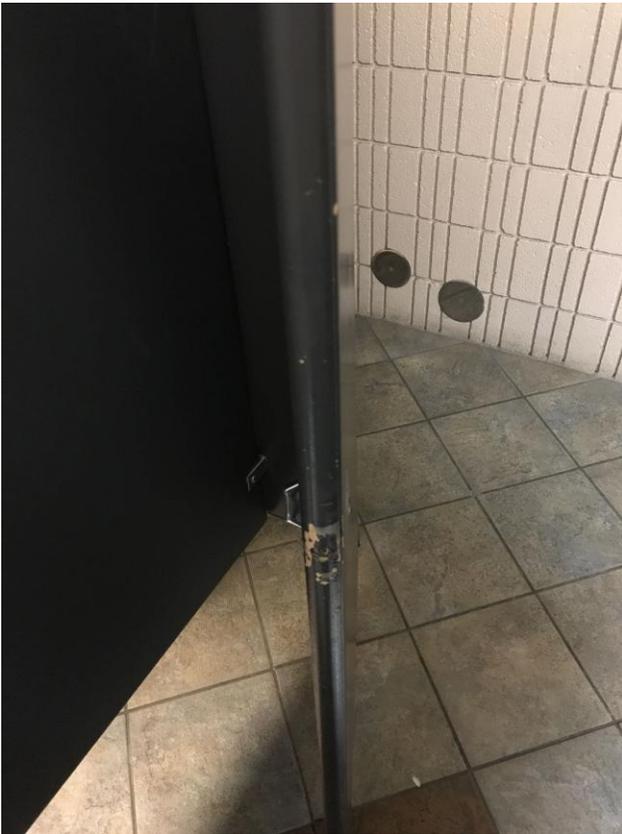
Finding 299432 Main Photo

Grab bars missing
inside ambulatory stall

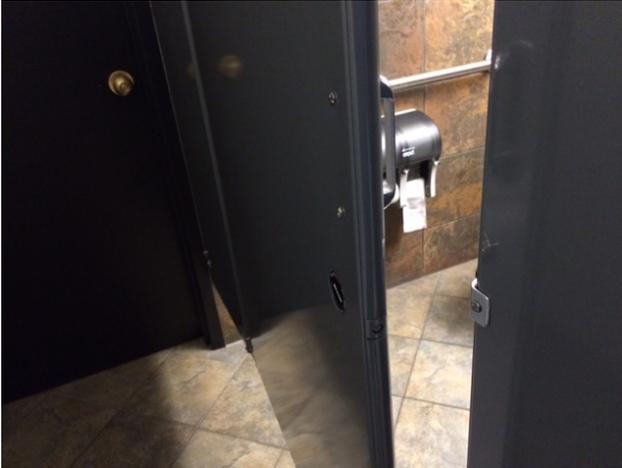
Finding 137858 Main Photo

Grab bar missing
inside ambulatory stall

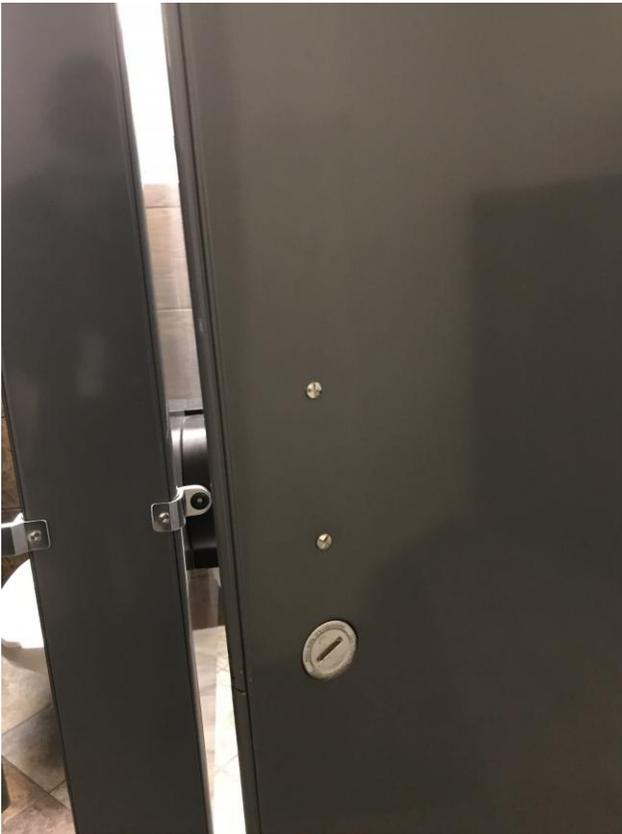
Finding 299442 Main Photo

Compliant room identification signs are missing.

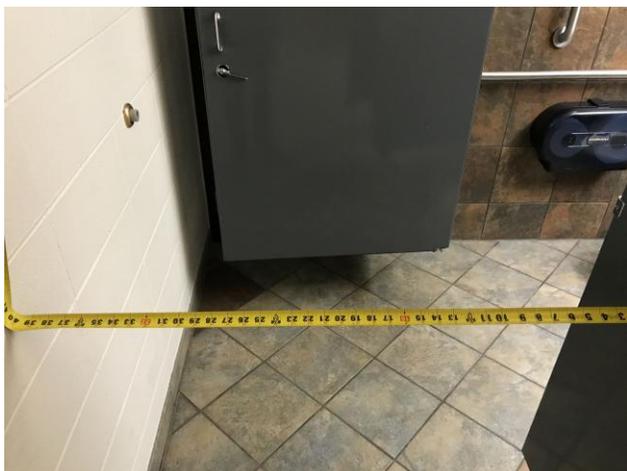
Finding 299009 Main Photo

The water closet compartment door is missing a loop handle on the outside.

Missing loop handle on outside of compartment door

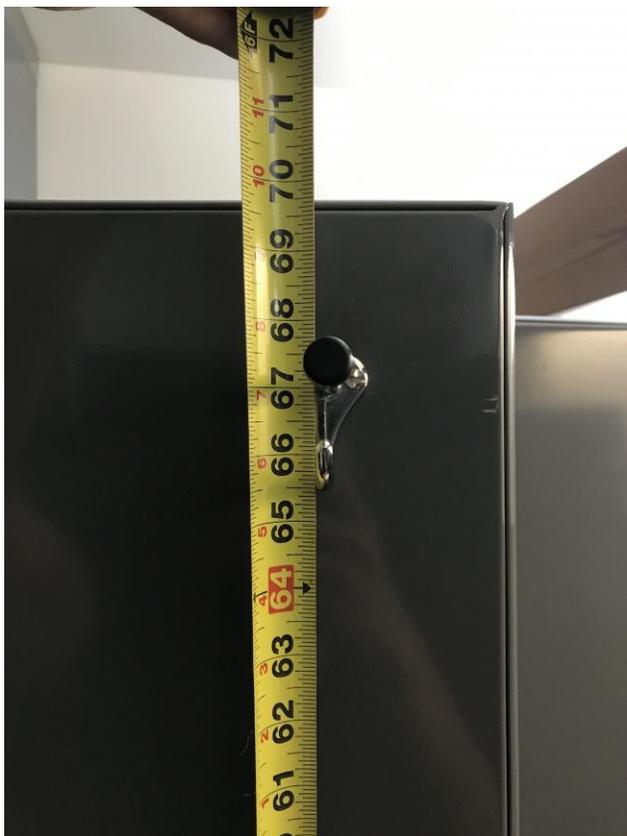
Finding 299441 Main Photo

The water closet compartment door is missing a loop handle.

Loop handles missing on ambulatory stall door

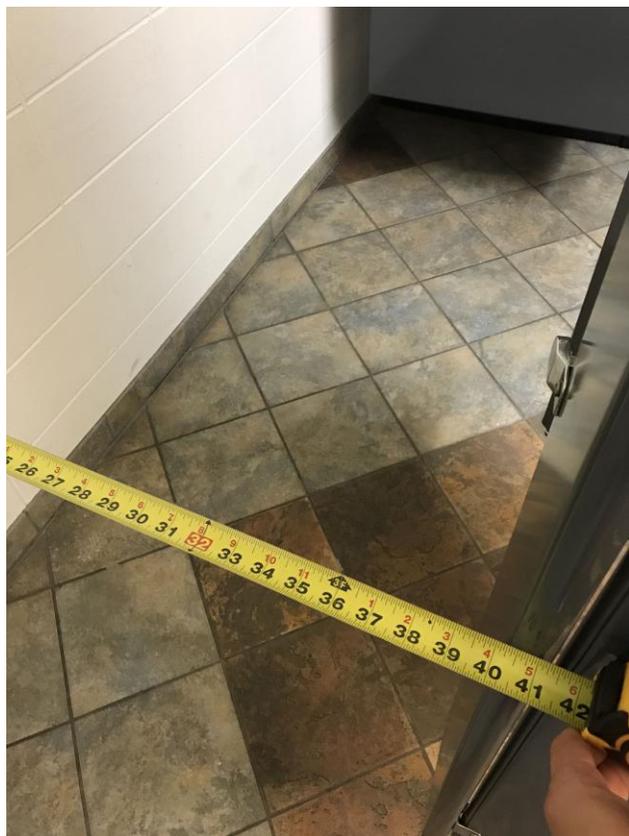
Finding 299447 Main Photo

CORRECTED

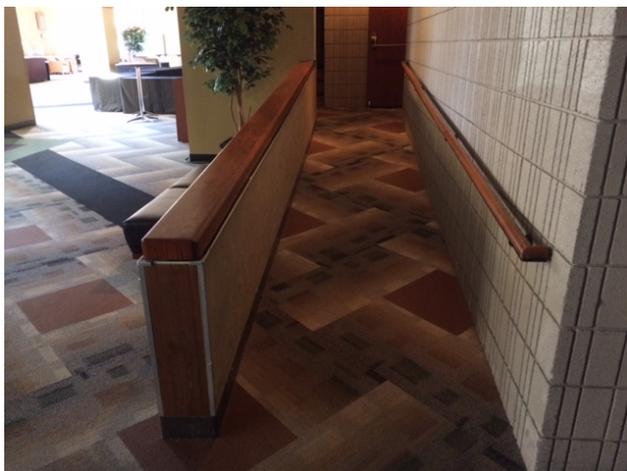
Finding 17172 Main Photo

Right-side handrail measures 31½ inches in height. Missing left-side handrail.

CORRECTED

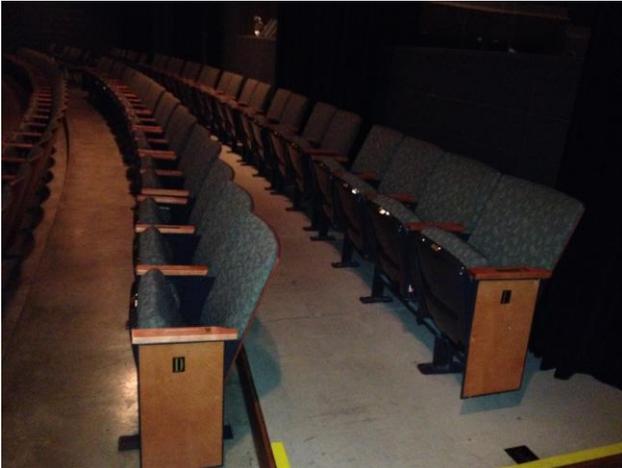
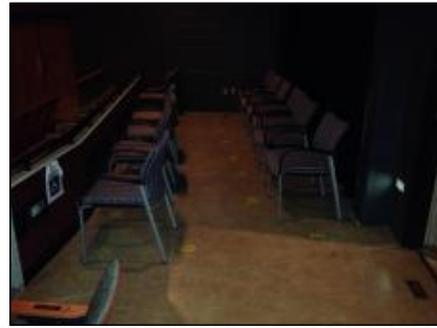
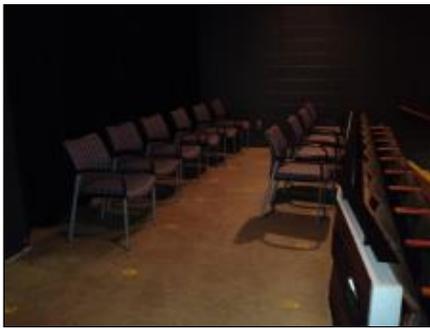
Finding 17223 Main Photo

CORRECTED

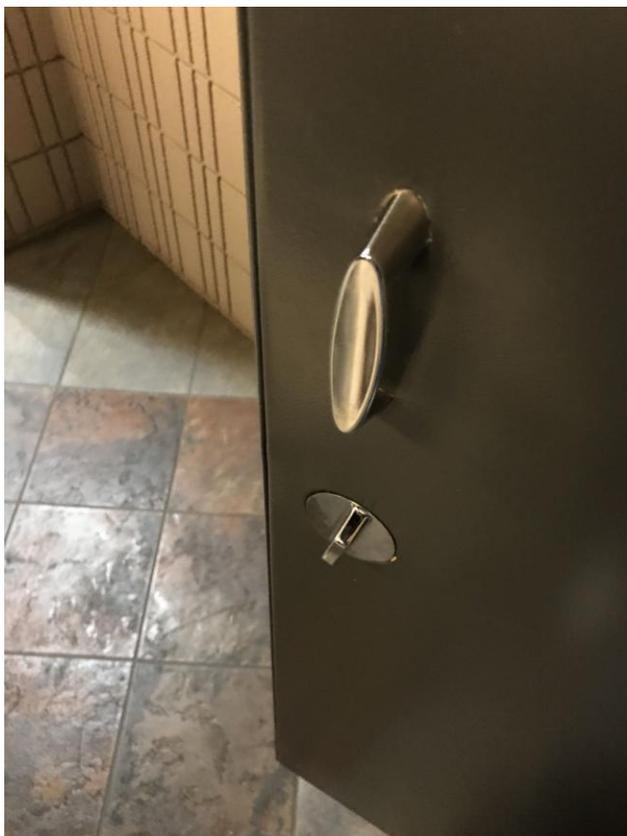
Finding 299028 Main Photo

CORRECTED

Replace locking hardware with locking lever that does not require tight grasping, tight pinching or twisting of the wrist to operate.

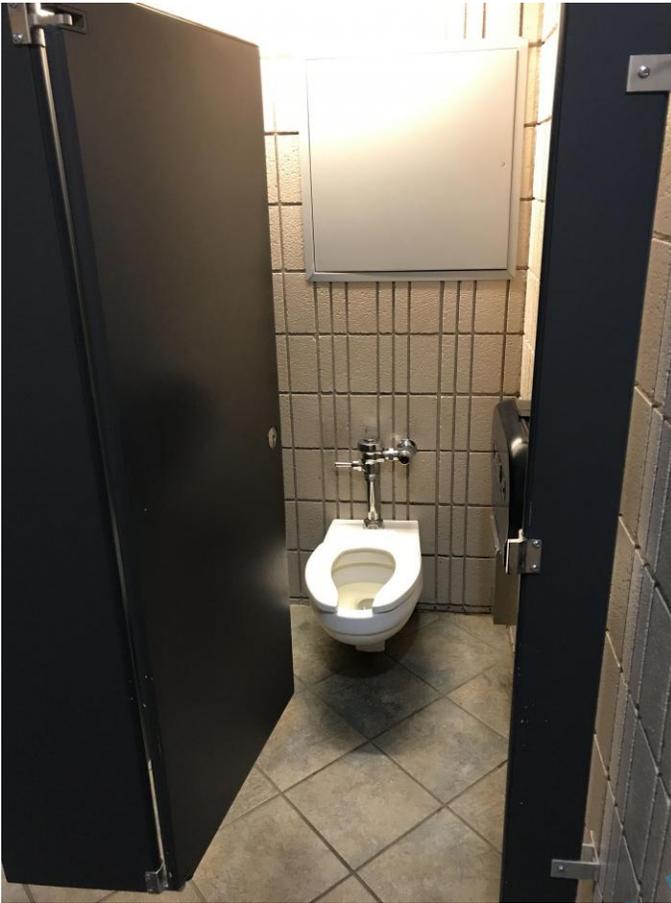
Finding 299460 Main Photo

The water closet compartment door is missing a loop handle.

Both loop handles missing on ambulatory stall door

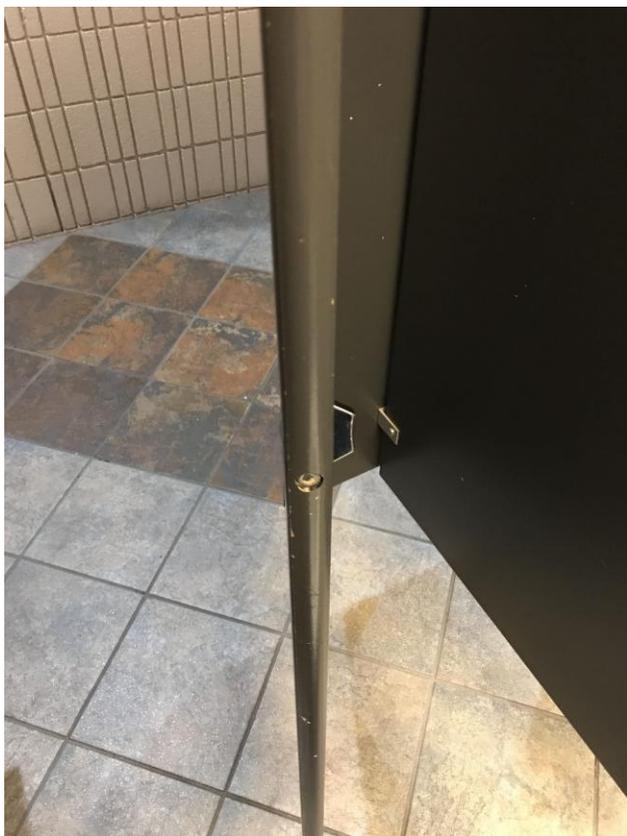
Finding 299461 Main Photo

Grab bars missing
inside ambulatory stall

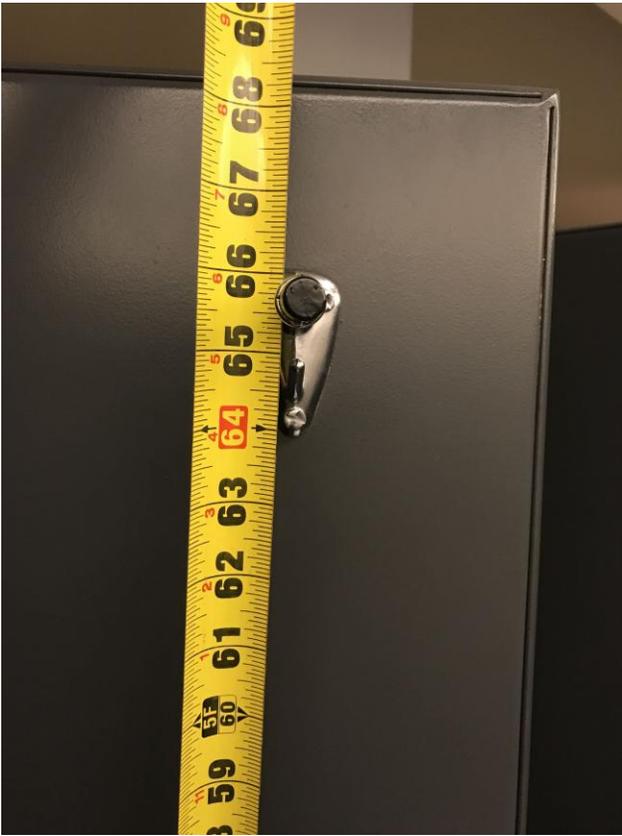
Finding 299466 Main Photo

The water closet compartment door is missing a loop handle.

Loop handles missing on ambulatory stall door

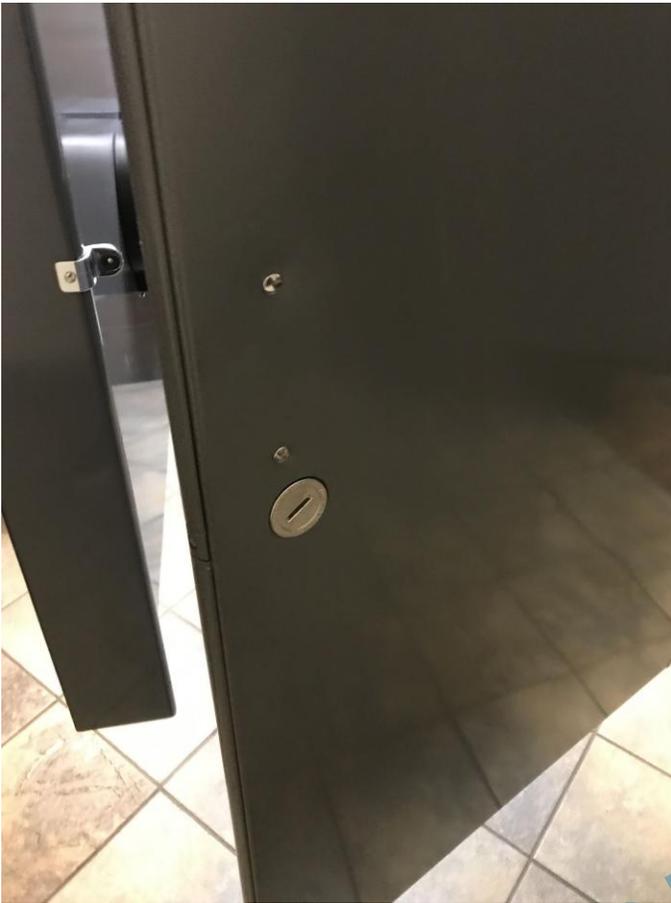
Finding 299418 Main Photo

Grab bar missing
inside ambulatory stall

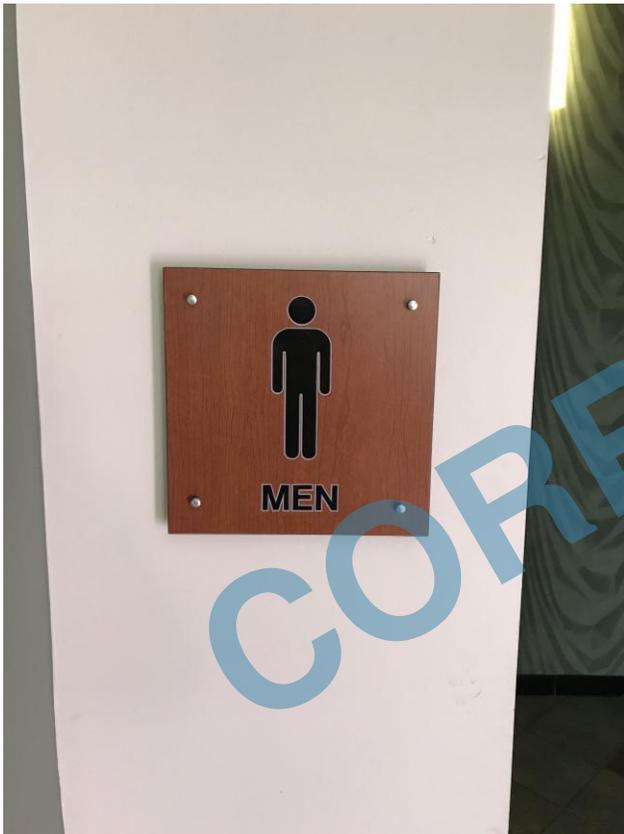
Finding 299058 Main Photo

2nd Floor, S. side, Mens Restroom (Mezzanine Level)

Providing the minimum required width clearance to the restroom is technically infeasible at this time because existing structural conditions would require removing or altering a load-bearing member that is an essential part of the structural frame; or because other existing physical or site constraints prohibit modification or addition of elements, spaces, or features that are in full and strict compliance with the minimum requirements. Best practice measures are recommended to ensure restroom is accessible to the maximum extent feasible. Would recommend updating restroom when feasible or during alteration or new construction to meet current ADA standards.

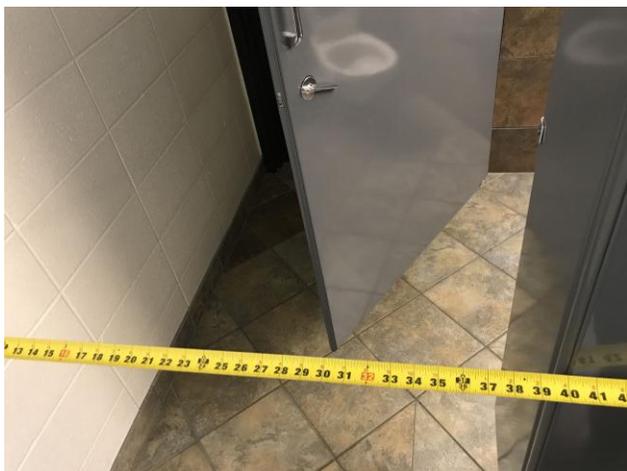
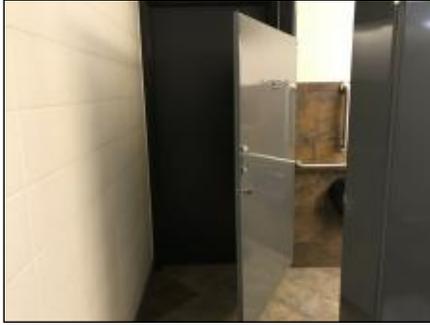
Finding 299060 Main Photo

The water closet compartment door is missing a loop handle.

Outer door handle missing.

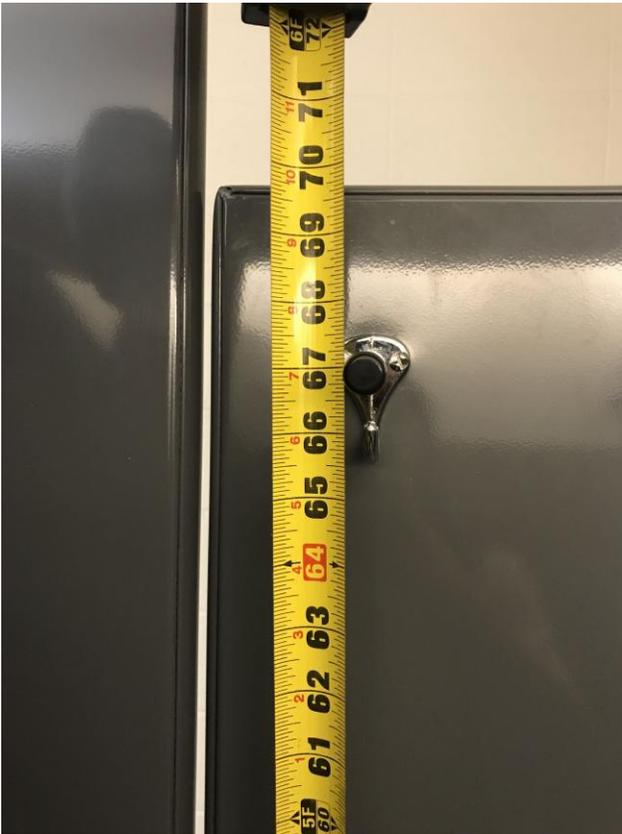
Finding 299452 Main Photo

The water closet compartment door is missing a loop handle.

Loop handles missing on ambulatory stall door

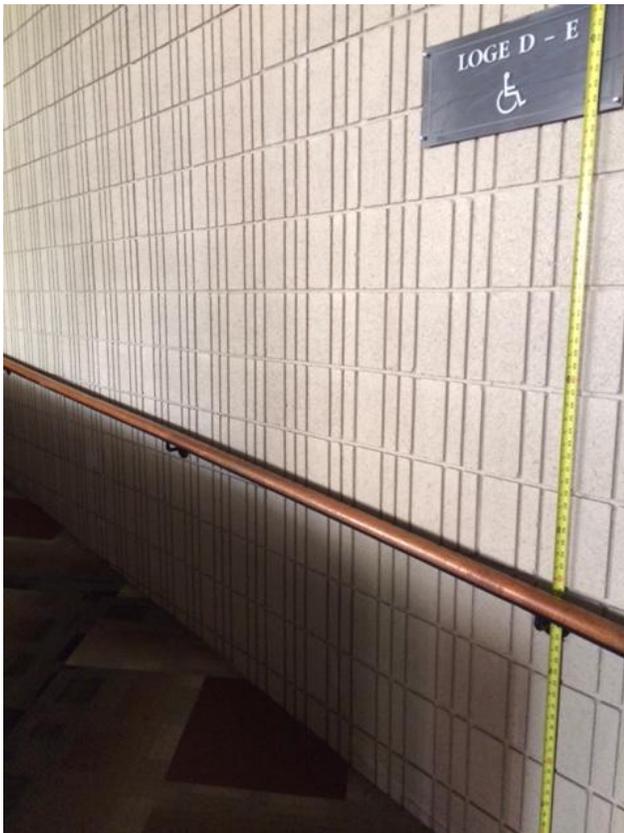
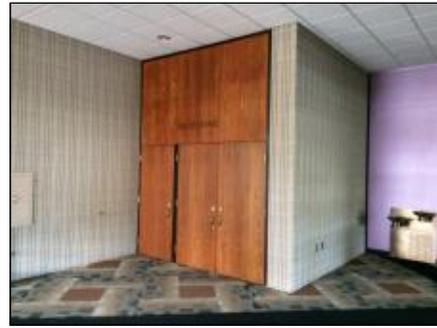
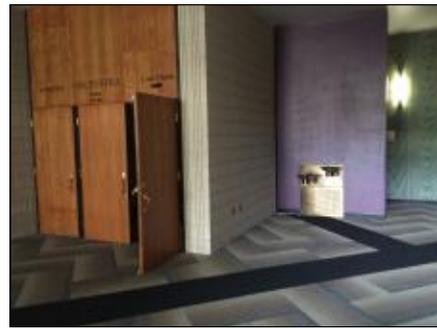
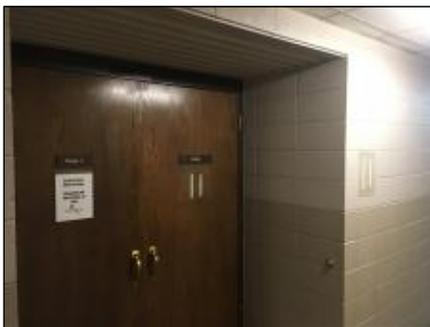
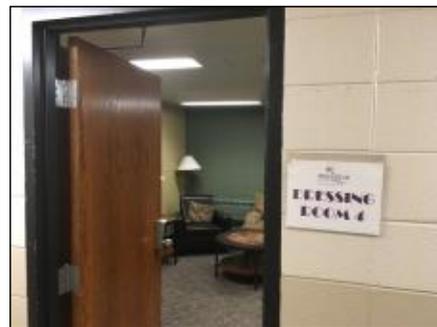
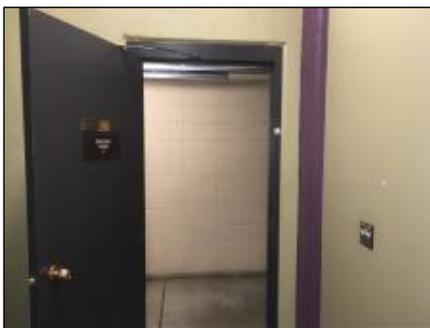
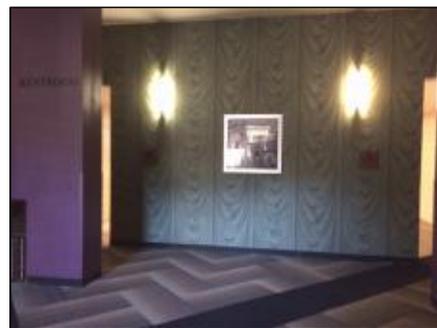
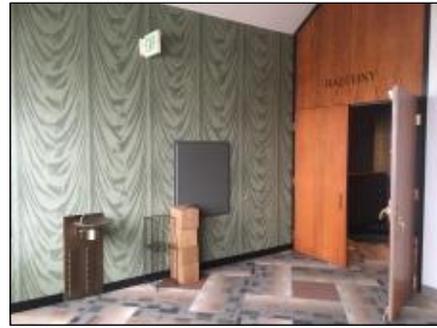
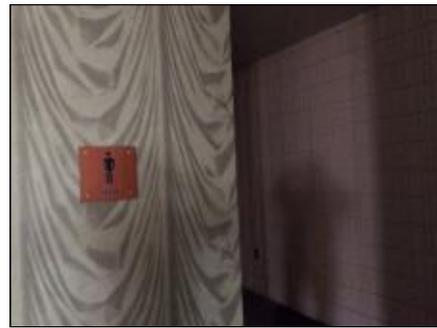
Finding 53938 Main Photo

Compliant room/area identification signs are missing on the strike side of the door or appropriate location.

ADA signs are missing throughout facility. See attachments for details and photos for examples.

94 new ADA compliant signs. This includes (7) signs for the future restrooms and showers in the basement, only (6) if they aren't built. Since the signs are all different styles and sizes (some are 8" x 18"). Estimates give some idea of potential costs. At \$150.00 each, a set would cost between \$13,500.00 and \$15,000.00.
